Inspection Repair List  
3021 Barrow St North Pole, 99705

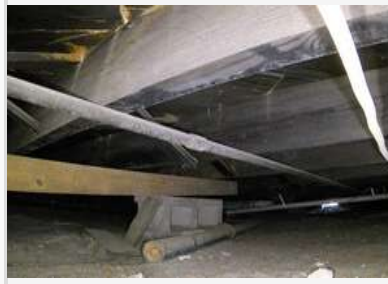
Location: Under Living Room Area

1.1.3 Unprofessional / Temporary Support Seller To Correct Repair

Unprofessional / temporary support was observed. Although no immediate concern was observed, client should contact a qualified foundation contractor for further information and / or evaluation.

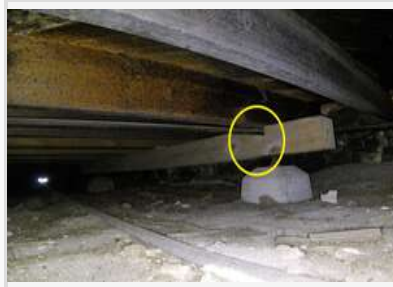
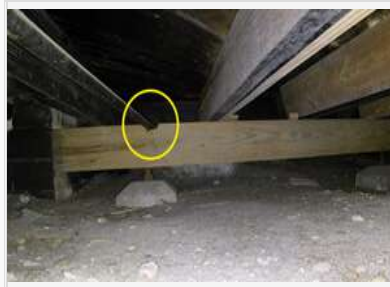
1.1.5 Structural Beam Notched Seller To Correct Repair

A structural support beam at one or more locations has been notched to allow for plumbing or electrical runs. Generally notching of support beams is not acceptable. We recommend a licensed foundation contractor evaluate and repair as needed.

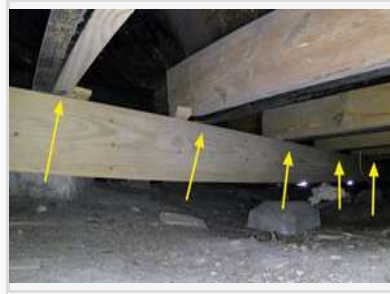
### 1.1.6 Sistered Joists Seller To Correct Repair

Joists were sistered at one or more locations. This generally indicates the original beams have been damaged and/or where not adequately supporting the load. We recommend further evaluation by a licensed foundation contractor.

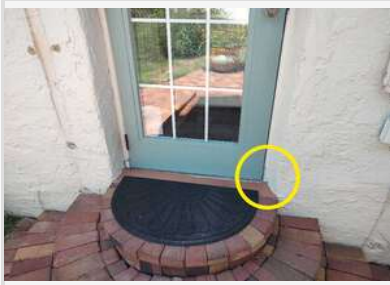
Location: Rear Exterior

#### 2.7.1 Wood Decay Seller To Correct Repair

Repair the area of wood decay at the one or more locations. Replacement of affected materials is considered the best solution.

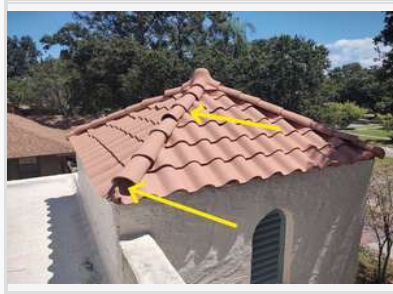
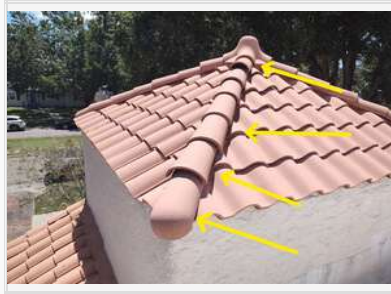
### 3.1.2 Tile Roof - Tiles Damaged

Damaged and/or missing tiles were observed at one or more locations. The inspector can not offer an opinion as to whether the roof leaks today unless it is moderately raining at the time of inspection.

Note: The conditions noted are an indication that repairs are warranted and are not intended to define all areas that may require repairs. It is recommended a professional roofing contractor evaluate the entire system and repair all areas as needed.

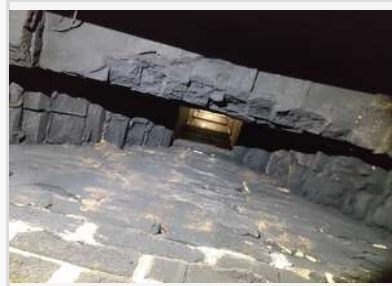
#### 4.3.3 Damper Missing

The unit is not equipped with a flue damper. A qualified chimney sweep can evaluate and repair.

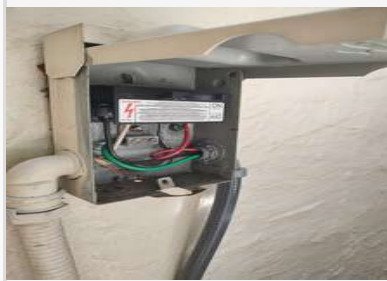
Location: Left exterior

#### 6.5.1 Panel/J-Box - HVAC Quk Disc Cover Missing

The deadfront cover plate at the HVAC quick disconnect box is missing. Lack of proper covers on junction boxes is a shockhazard. It is suggested that a "Licensed Electrical Contractor" be contacted for further evaluation and repair.

6.5.1.1 HVAC condenser unit disconnect

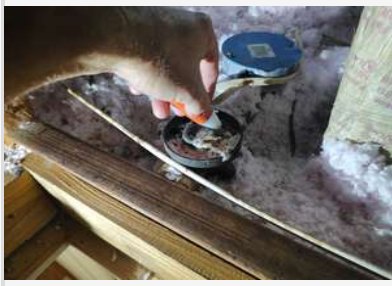
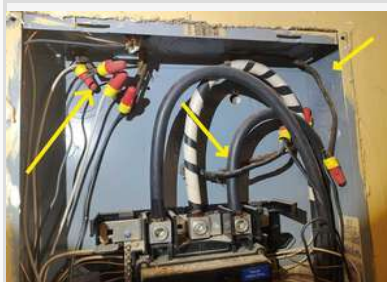
Location: Attic, near hatch

## 6.5.2 Wiring - Cloth Wiring Seller To Correct Repair

Cloth jacketed cable was observed at one or more locations in the home. This type of wiring was commonly used in structures built in the 1950's and 1960's and may or may not contain a ground wire for safety. Although it is still functional, given the age of this wiring system repairs may be warranted and replacement should be considered. It is beyond the scope of the inspection to determine the overall condition of this wiring and/or identify every location it may exist in the structure. A "Licensed Electrician" can evaluate the system and repair or replace as needed.

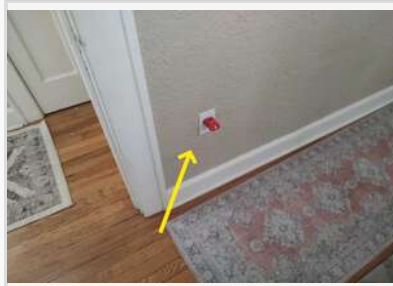
Location: Dining room

### 6.6.2 Reverse Polarity Seller To Correct Repair

Reverse polarity was noted at one or more outlet(s). Reverse polarity, (hot and ground / neutral reversed) are usually corrected by minor wiring adjustments at the specified item. However, when a number of these conditions are observed, client should consult a licensed electrician.

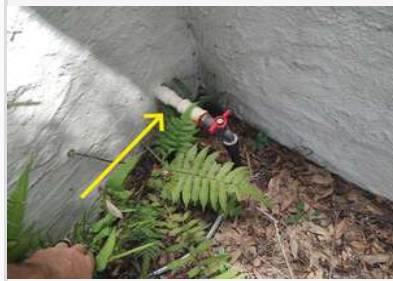
Location: Front left corner

### 7.3.2 Galvanized Piping Seller To Correct Repair

Galvanized piping was observed. Although this type of piping was commonly used in older homes, galvanized piping is no longer used in today's construction. Galvanized piping has a tendency to rust from the inside out resulting in water clarity conditions, leaks, and reduced water flow/pressure. The best-known remedy for this type of piping is replacement. The client is advised to consult with a licensed plumber for additional information. Note: This observation requires the inspector to specify the existence of this piping on the separate 4 Point Inspection Report that most insurance companies require. Some insurance companies may not insure a house with this type of piping. We advise you to consult with your insurance agent or underwriter regarding insurability.

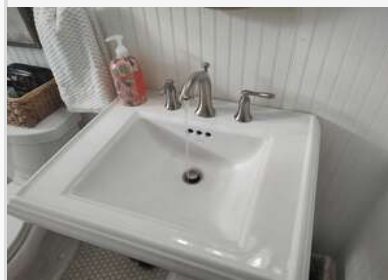
Location: Bathroom

### 7.3.3 Low Pressure - 1+ Locations Seller To Correct Repair

There was visible evidence of low water pressure at one or more locations when multiple fixtures were operating. A licensed plumber can evaluate and repair as needed.

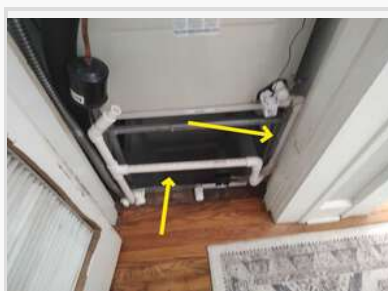
#### 8.4.1 Line Insulation - Condensation Line Seller To Correct Repair

Insulation pipe wrap should be installed on the condensation line until it exits the structure to stop the condensation from forming and dripping from the line causing damage to the surrounding areas. A "Qualified Person" can perform the work.

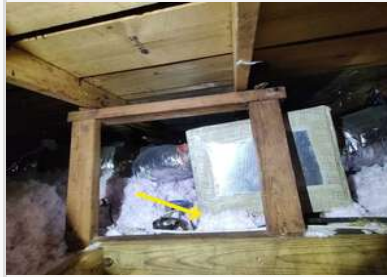
Location: Near atticatch under mixing box

### 8.5.1 Ductwork - Leak Seller To Correct Repair

One or more leaks are evident in the ductwork in allowing conditioned air to escape. It is recommended a qualified HVAC contractor make repairs as needed.

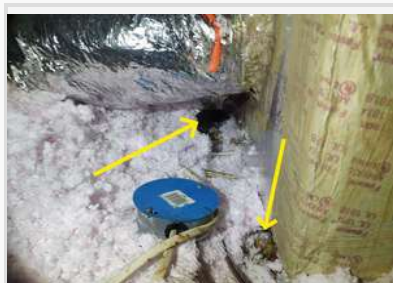
9.4.1.1 Trails

#### 9.4.1 Rodent Evidence Seller To Correct Repair

There is evidence of rodent activity in the attic (trails, droppings, carcasses, etc.). Rodent activity is very common but is fixable. These pests can damage wiring, ductwork, etc. All possible openings (cracks, holes, gaps, etc.) should be properly sealed to eliminate rodent entry. A qualified exterminator is recommended.

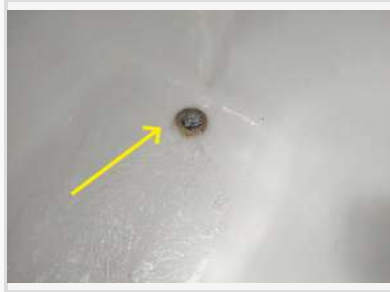
#### 11.2.1 Drain Stopper, Missing/Damaged/Not Operable Seller To Correct Repair

The drain stopper was missing, damaged or not operational. A qualified plumber should make repairs.

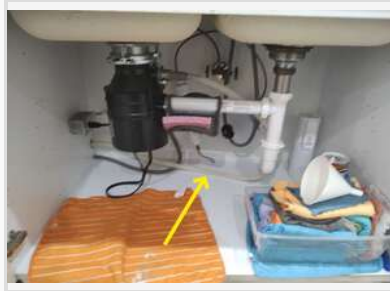
#### 12.6.1 No High Loop Seller To Correct Repair

No high loop was evident for the drain hose for the dishwasher. A high loop is required to keep drainage from back flowing into the dishwasher. High loops are generally built into the newer dishwashers however, the manufacturers still recommend an additional high loop under the sink before the drain hose is connected. Recommend routing the hose so a high loop is present. A "Qualified person" can perform the work.

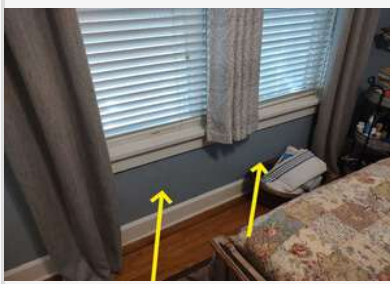
Location: Rear bedroom

#### 13.1.1 Moisture Stains - Active Seller To Correct Repair

Moisture stains were observed at one or more locations. When checked with a moisture meter the area indicated a wet / active leak condition. Recommend further evaluation and repair as needed by a licensed contractor. Please refer to limitations of inspection regarding mold / moisture related conditions. Note; We are required to report past or present leak conditions on the 4 point inspection report (if applicable).

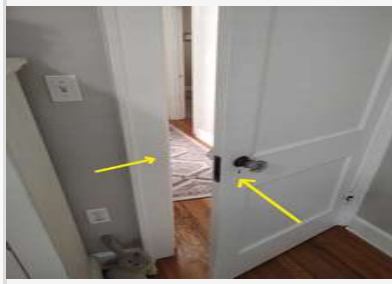
Location: Front bedroom

### 13.5.1 Door - Latching Hardware Problem

The latching hardware on one or more doors did not function properly. Although replacement is sometimes necessary, in most cases this can be repaired with minor adjustments. A qualified person can perform the work.
