**3021 Barrow St, North Pole, Alaska 99705**  
**Sample Report - Condo**  
**Prepared for**  
**Bruce Wayne**  
**Jan 05, 2023 at 06:00 AM**

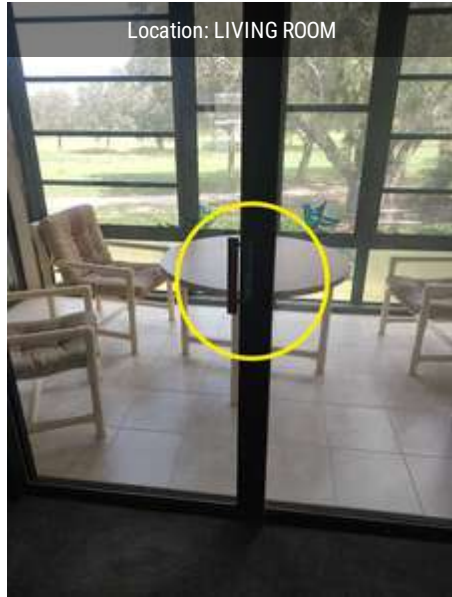
## 1.2.1 SGD - Latch Defective

The latching hardware on the exterior sliding glass door at one or more locations is damaged. Repair or replacement is recommended.

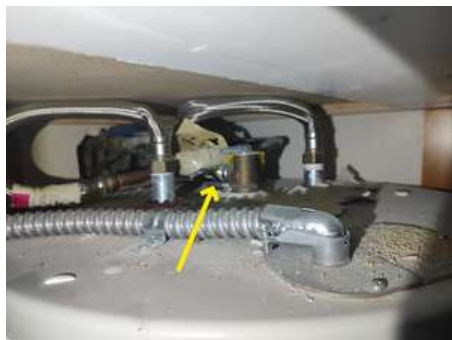
### 3.4.4 TPR pipe, incorrect material and kinked

The TPR discharge pipe on the water heater is comprised of the incorrect material and is kinked. This is a safety concern as it can allow pressure to backup. Recommend repairs by a licensed plumbing contractor.

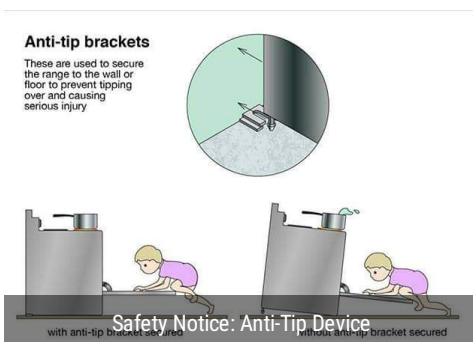
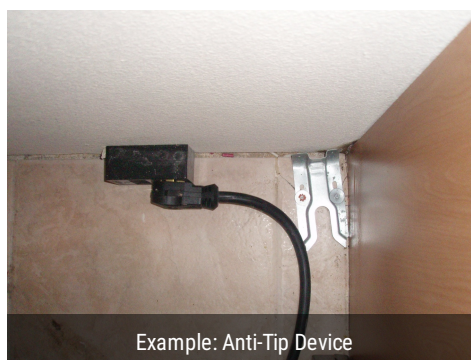
Our inspection does not include moving appliances. However, we strongly recommend verifying that the anti-tip safety device, provided by the range manufacturer and required in installation specifications, is correctly in place. Typically, this device is mounted to the floor or wall behind the unit and placed to catch a leveling bolt to prevent the unit from tipping forward. This safety measure is crucial to prevent injury or fatalities, especially involving children.

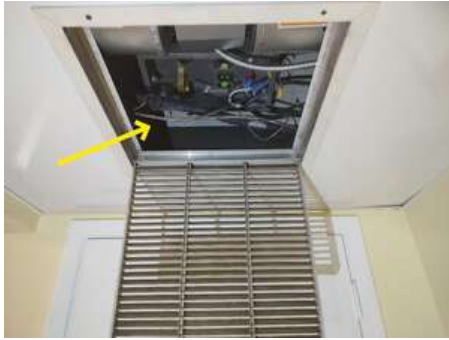
##### 4.1.2 Filter Missing/Not Installed Properly

The filter is missing and or improperly installed for the system. The system is not designed to operate without a filter and can result in a decrease in life. A minimum of monthly filter changes is recommended.

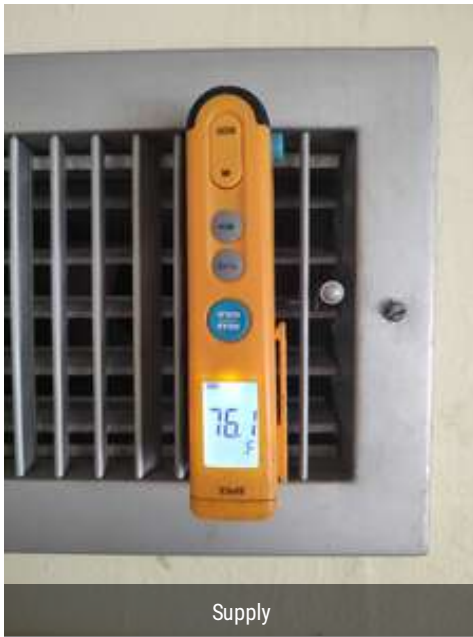
Supply

An ambient air test was performed on the cooling system to determine if the difference in temperatures of the supply and return air are between 15 degrees and 22 degrees, which indicates that the unit is cooling within industry standards. The readings indicate that the unit is NOT cooling within standards and may not be working properly. A licensed Heat/Air contractor should further evaluate the system and advise.

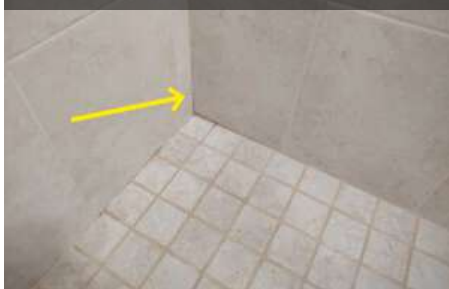
Location: FRONT BATH

Caulk and/or grout is recommended at the tub walls and/or floors in bath. Conditions behind wall or under floor were concealed and not visible or accessible for inspection.

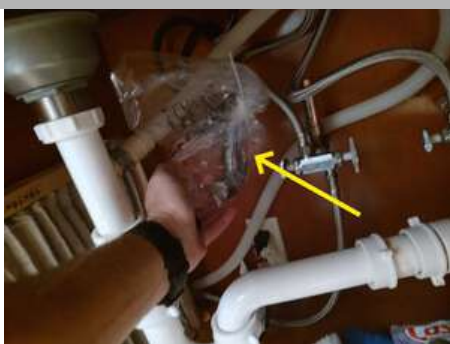
##### 6.2.1 Spray wand, under sink

The spray one for the kitchen sink is stored in a bag under the sink but appears to be connected. We recommend installing this properly on the upper side of the sink or removing it to avoid leaks in the cabinet.

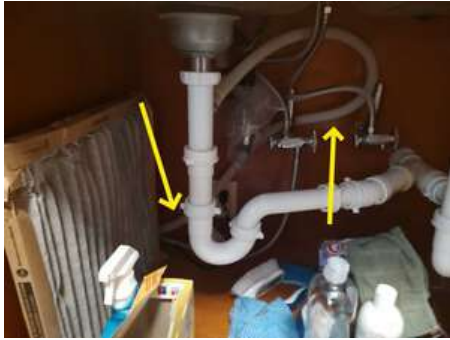
##### 6.7.1 No High Loop

No high loop was evident for the drain hose for the dishwasher. A high loop is required to keep drainage from back flowing into the dishwasher. High loops are generally built into the newer dishwashers however, the manufacturers still recommend an additional high loop under the sink before the drain hose is connected. Recommend routing the hose so a high loop is present. A "Qualified person" can perform the work.

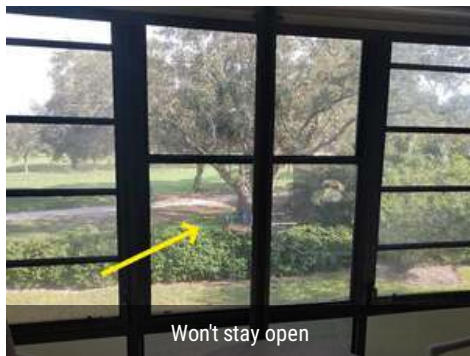
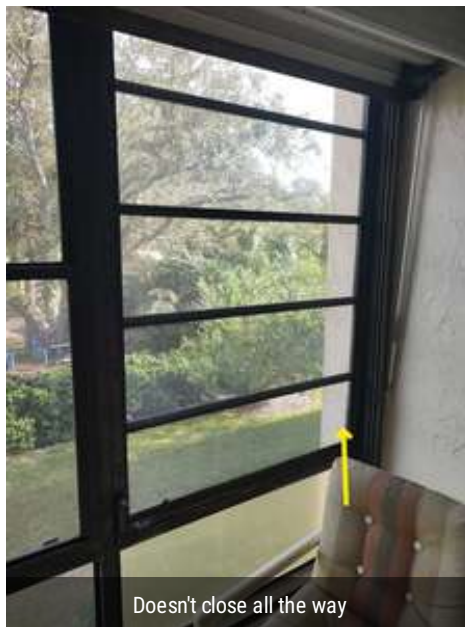
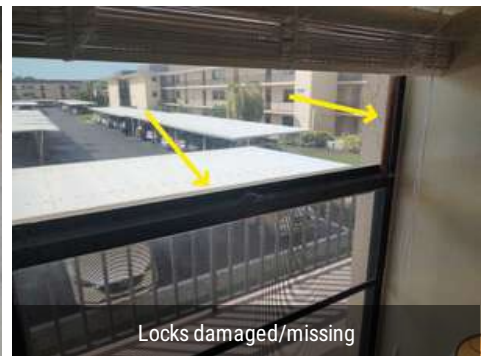
##### 7.4.1 Moderate wear & operation issues

Windows reflected moderate wear and some windows did not operate or were difficult to operate. We recommend repairs and/or replacement as needed.

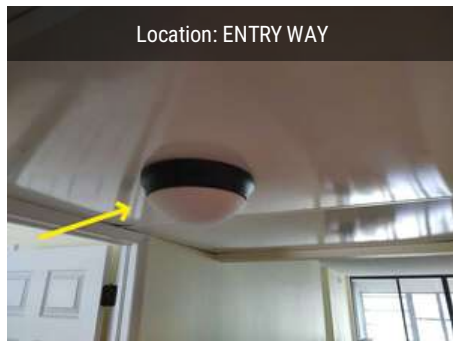
### 2.7.1 Light inoperative - bulb out, no switch

Light(s) were out or inoperative at one or more locations. This may simply be a bulb is out or we were unable to locate the proper switch. Dismantling and testing of light fixtures is not performed as part of this inspection. Note, non-working items noted are based on a random sampling and this condition may exist at other locations. Recommend all lights be operable prior to close.

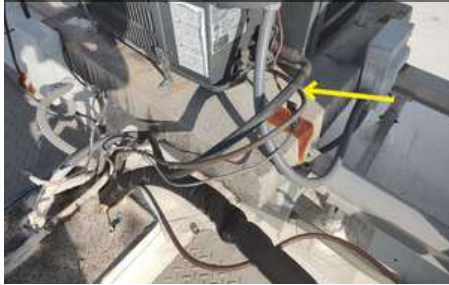
### 4.1.1 Line Insulation Missing/Damaged

The insulation on the refrigerant lines was missing or damaged. Recommend installing this rather inexpensive pipe insulation to improve efficiency. Pipe insulation is available at most hardware stores.

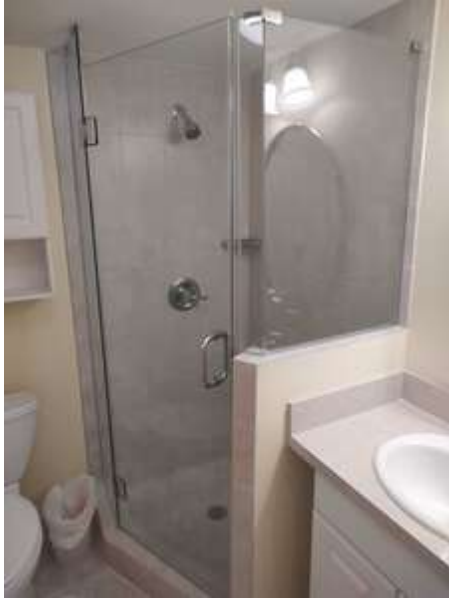
The glass at the shower/tub enclosure has no visible markings indicating that it is safety glass. (A thorough cleaning of the glass may reveal the label indicating its composition). Consider having a qualified technician install safety glazing in accordance with present standards.

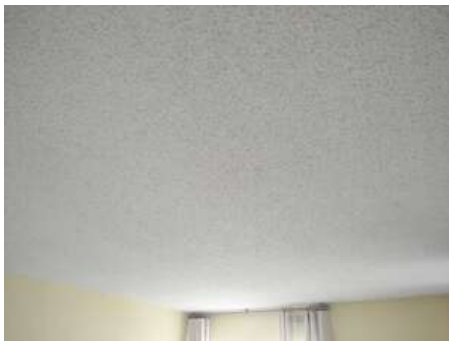
Asbestos was commonly used as a material in popcorn ceilings from the 1950's through the 1980's. In 1978 the Clean Air Act banned spray-on asbestos products, however the law allowed businesses to use existing inventory well into the 1980's. This type of ceiling is found in many homes from that time period. Asbestos material generally does not pose a hazard until particles become airborne. We recommend having it tested by qualified technicians if you have further concerns or prior to starting any construction projects that may disturb it.

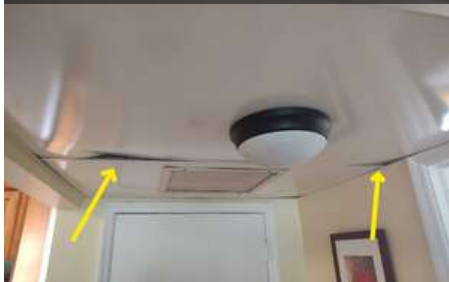
##### 7.2.2 Damage - Ceilings

The ceilings were damaged at one or more locations. Recommend further evaluation and repair as needed by a qualified / licensed contractor.

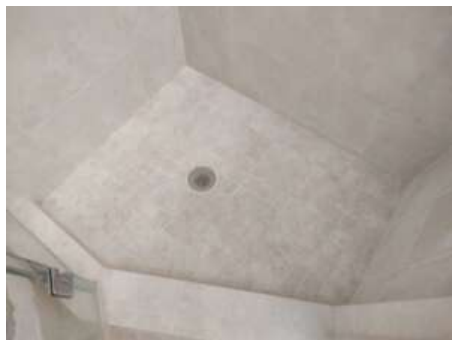
5.5.1 Shower Pan, Not Tested

A definitive test for leaks in a tile shower base requires 2 - 3 inches of water left standing for up to 48 hours. There were no signs of leaks, but this definitive test is beyond the scope of this inspection and was not performed.

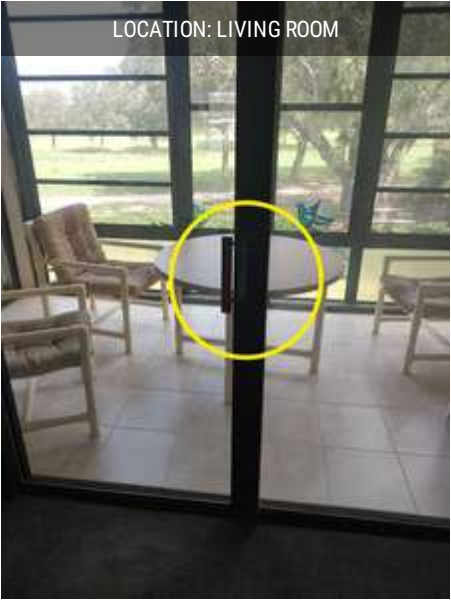
The latching hardware on the exterior sliding glass door at one or more locations is damaged. Repair or replacement is recommended.

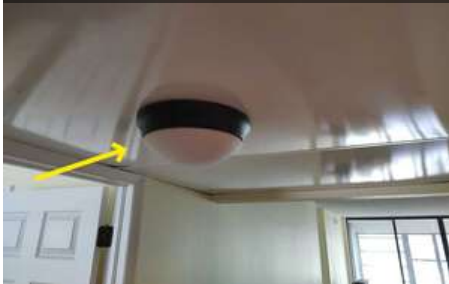
LOCATION: ENTRY WAY

Light(s) were out or inoperative at one or more locations. This may simply be a bulb is out or we were unable to locate the proper switch. Dismantling and testing of light fixtures is not performed as part of this inspection. Note, non-working items noted are based on a random sampling and this condition may exist at other locations. Recommend all lights be operable prior to close.

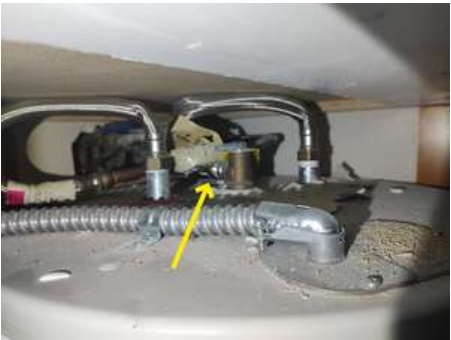
3.4.4 TPR pipe, incorrect material and kinked

The TPR discharge pipe on the water heater is comprised of the incorrect material and is kinked. This is a safety concern as it can allow pressure to backup. Recommend repairs by a licensed plumbing contractor.

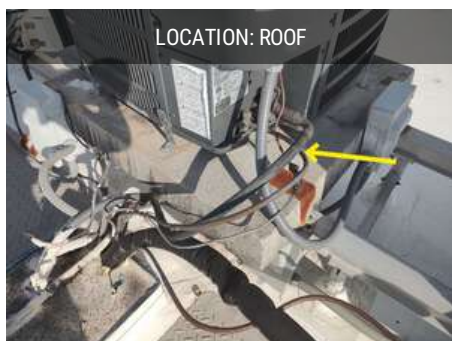
The insulation on the refrigerant lines was missing or damaged. Recommend installing this rather inexpensive pipe insulation to improve efficiency. Pipe insulation is available at most hardware stores.

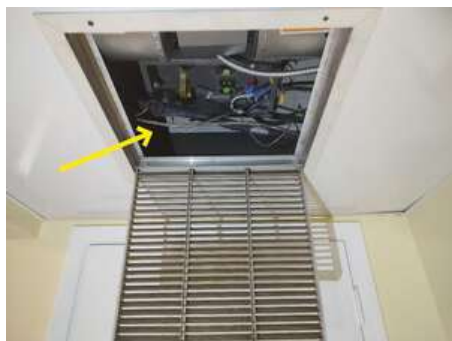
#### 4.1.2 Filter Missing/Not Installed Properly

The filter is missing and or improperly installed for the system. The system is not designed to operate without a filter and can result in a decrease in life. A minimum of monthly filter changes is recommended.

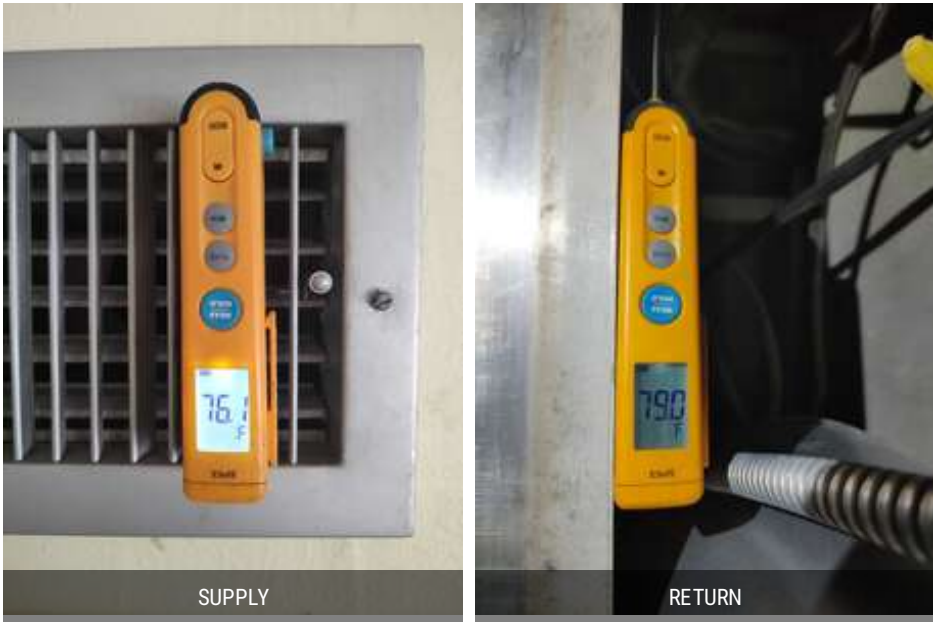
An ambient air test was performed on the cooling system to determine if the difference in temperatures of the supply and return air are between 15 degrees and 22 degrees, which indicates that the unit is cooling within industry standards. The readings indicate that the unit is NOT cooling within standards and may not be working properly. A licensed Heat/Air contractor should further evaluate the system and advise.

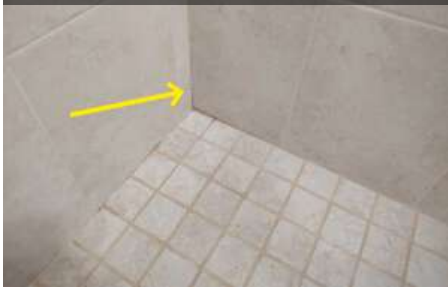
LOCATION: FRONT BATH

Caulk and/or grout is recommended at the tub walls and/or floors in bath. Conditions behind wall or under floor were concealed and not visible or accessible for inspection.

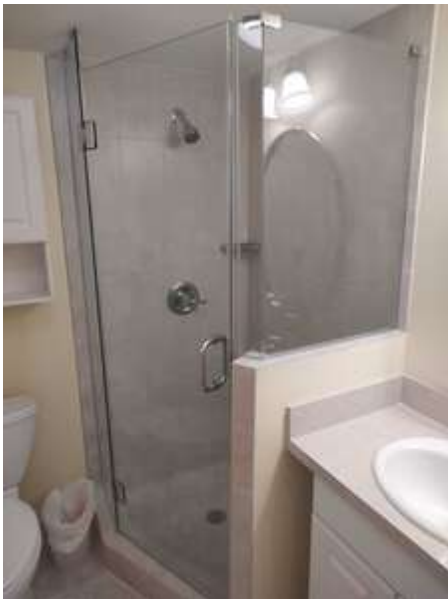
The glass at the shower/tub enclosure has no visible markings indicating that it is safety glass. (A thorough cleaning of the glass may reveal the label indicating its composition). Consider having a qualified technician install safety glazing in accordance with present standards.

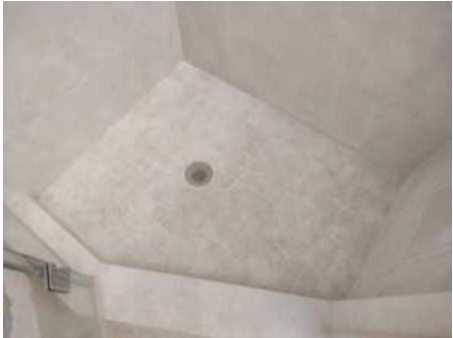
5.5.1 Shower Pan, Not Tested

A definitive test for leaks in a tile shower base requires 2 - 3 inches of water left standing for up to 48 hours. There were no signs of leaks, but this definitive test is beyond the scope of this inspection and was not performed.

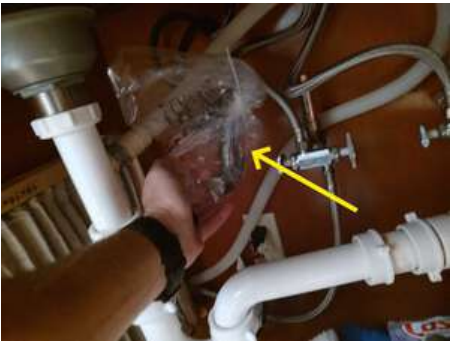
The spray one for the kitchen sink is stored in a bag under the sink but appears to be connected. We recommend installing this properly on the upper side of the sink or removing it to avoid leaks in the cabinet.

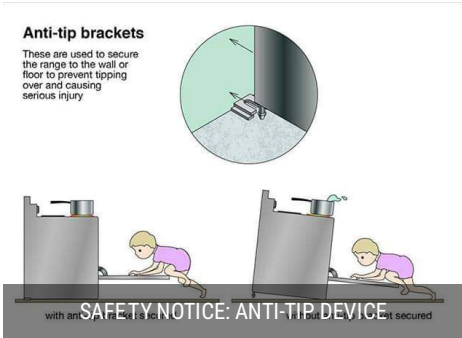
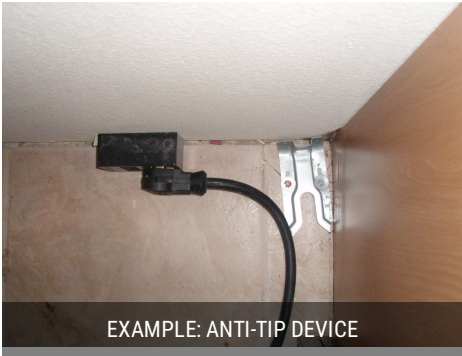
Our inspection does not include moving appliances. However, we strongly recommend verifying that the anti-tip safety device, provided by the range manufacturer and required in installation specifications, is correctly in place. Typically, this device is mounted to the floor or wall behind the unit and placed to catch a leveling bolt to prevent the unit from tipping forward. This safety measure is crucial to prevent injury or fatalities, especially involving children.

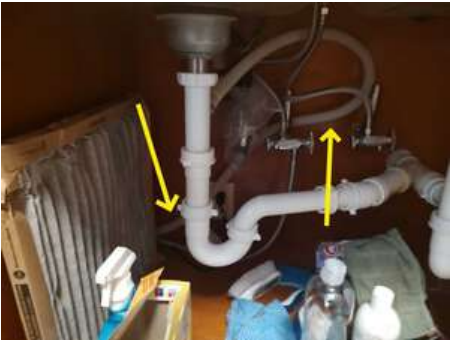
No high loop was evident for the drain hose for the dishwasher. A high loop is required to keep drainage from back flowing into the dishwasher. High loops are generally built into the newer dishwashers however, the manufacturers still recommend an additional high loop under the sink before the drain hose is connected. Recommend routing the hose so a high loop is present. A "Qualified person" can perform the work.

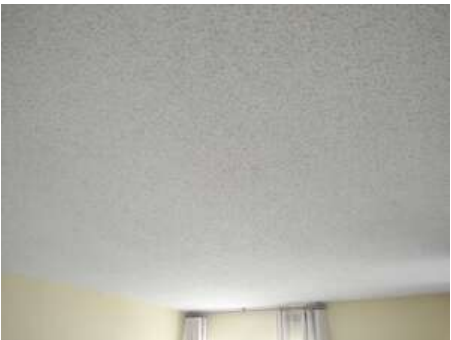
Asbestos was commonly used as a material in popcorn ceilings from the 1950's through the 1980's. In 1978 the Clean Air Act banned spray-on asbestos products, however the law allowed businesses to use existing inventory well into the 1980's. This type of ceiling is found in many homes from that time period. Asbestos material generally does not pose a hazard until particles become airborne. We recommend having it tested by qualified technicians if you have further concerns or prior to starting any construction projects that may disturb it.

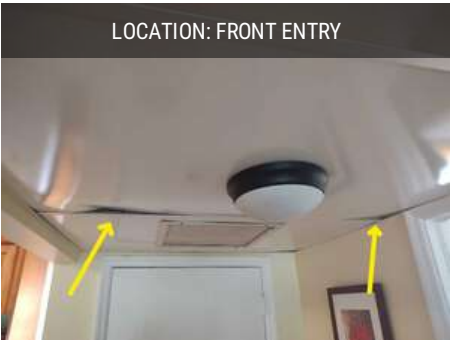
LOCATION: FRONT ENTRY

The ceilings were damaged at one or more locations. Recommend further evaluation and repair as needed by a qualified / licensed contractor.

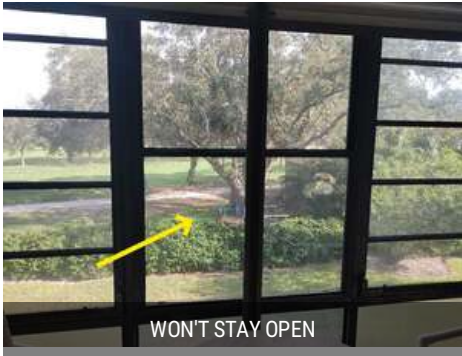
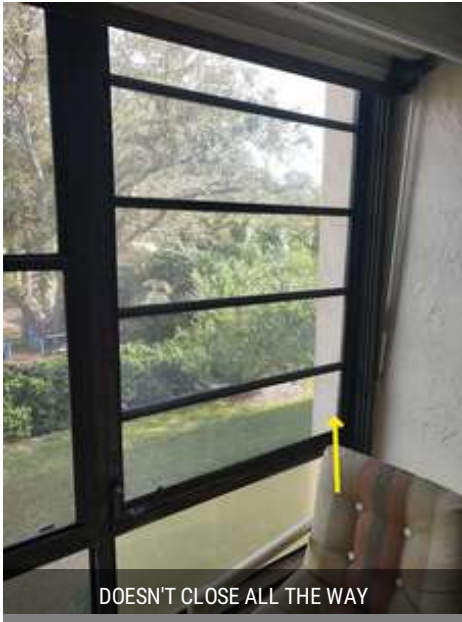
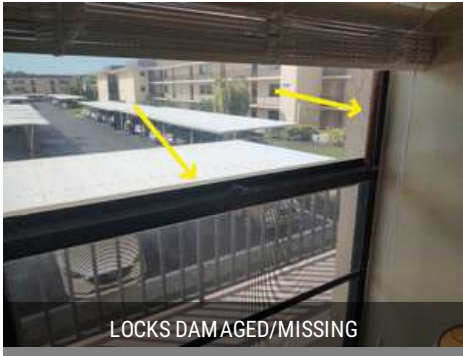
Windows reflected moderate wear and some windows did not operate or were difficult to operate. We recommend repairs and/or replacement as needed.
