**Robbins Services**  
Home Inspections

**3021 Barrow St, North Pole, Alaska 99705**  
**Sample Report - Older Home**  
**Prepared for**  
**Bruce Wayne**  
**Jan 05, 2023 at 06:00 AM**

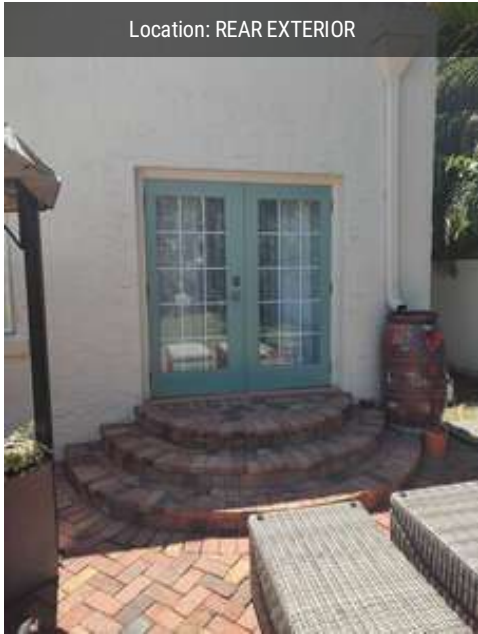
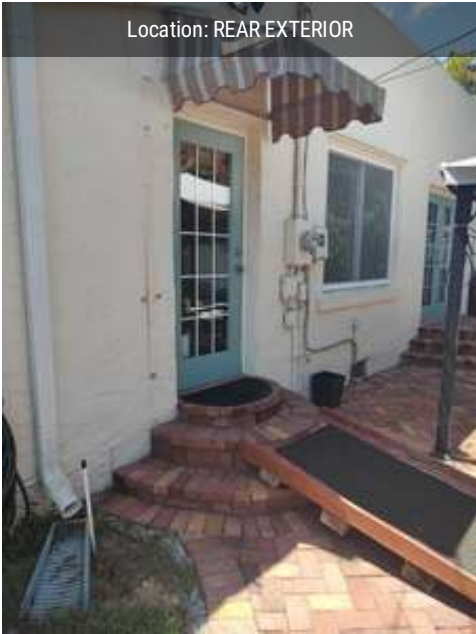
No railings were present. For increased safety, client should consider installation of a railing. Client should consult with a qualified contractor for information on current standards.

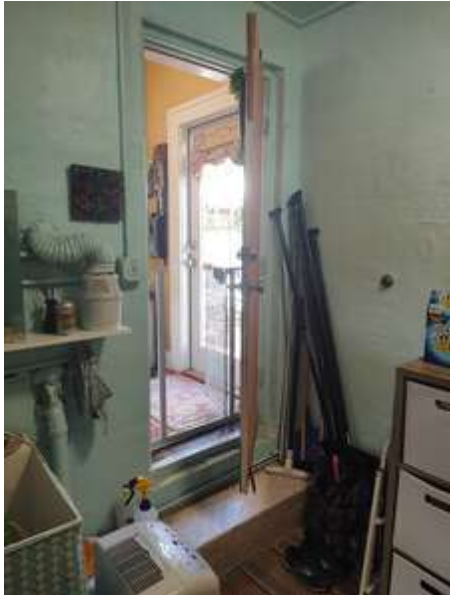
##### 5.5.1 Door - Outswing Over Steps

A passage door swings outward over steps. This is generally considered unsafe as there is no landing step out on. We recommend changing the swing of the door to be in swing for safety. It is suggested that a "Qualified Window & Door Contractor" be contacted for further evaluation and repair.

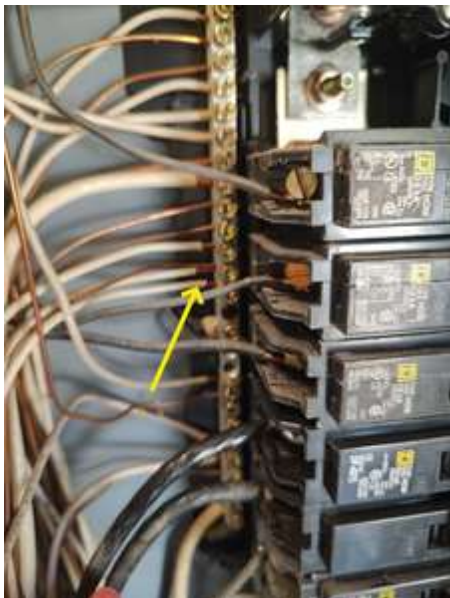
##### 6.4.2 GRD & Neutral, Share Terminal

Ground and neutral wires share the same terminal screw on the bus bar. Per electrical standards, ground and neutral wires should not share the same lug and must connect to separate bus screws. Have an electrician rearrange the wires as needed to meet standards.

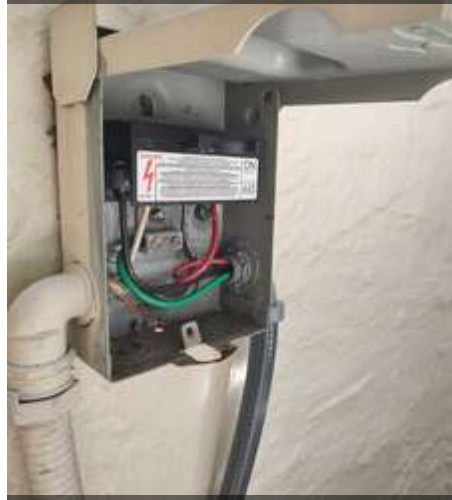
#### 6.5.1 Panel/J-box - HVAC Quk Disc Cover Missing

HVAC condenser unit disconnect

The deadfront cover plate at the HVAC quick disconnect box is missing. Lack of proper covers on junction boxes is a shockhazard. It is suggested that a "Licensed Electrical Contractor" be contacted for further evaluation and repair.

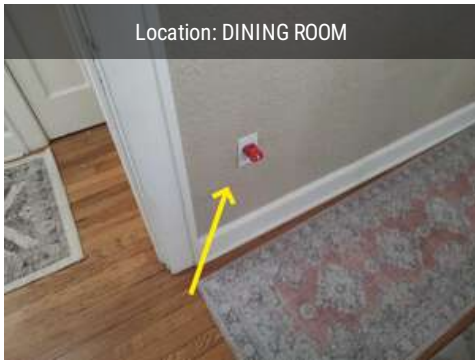
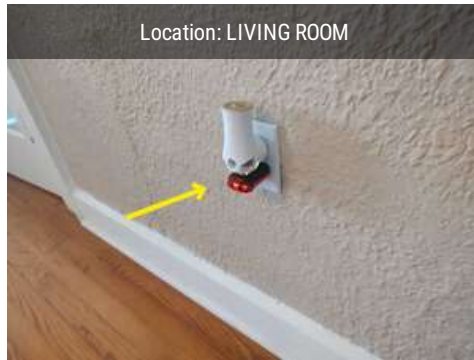
Reverse polarity was noted at one or more outlet(s). Reverse polarity, (hot and ground / neutral reversed) are usually corrected by minor wiring adjustments at the specified item. However, when a number of these conditions are observed, client should consult a licensed electrician.

Note, findings are based on a random sampling. The hired licensed contractor should verify that corrections are not required in other locations.

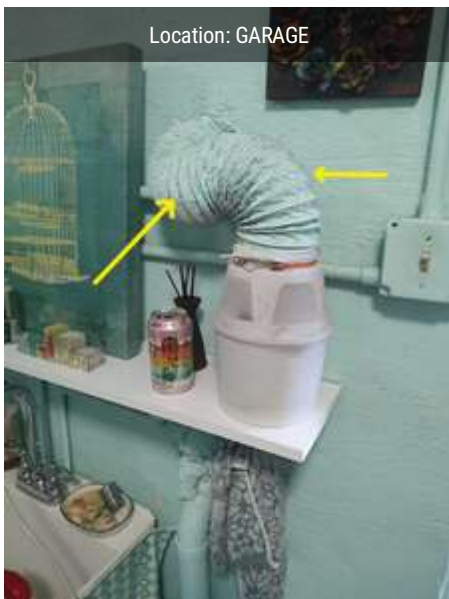
##### 10.3.1 Permanent Dryer Duct, PVC / Vinyl / Foil

The permanent duct in place for the dryer is a fire hazard and should be changed to a smooth surface non-combustible product in accordance with local building code and the manufacturers instructions.

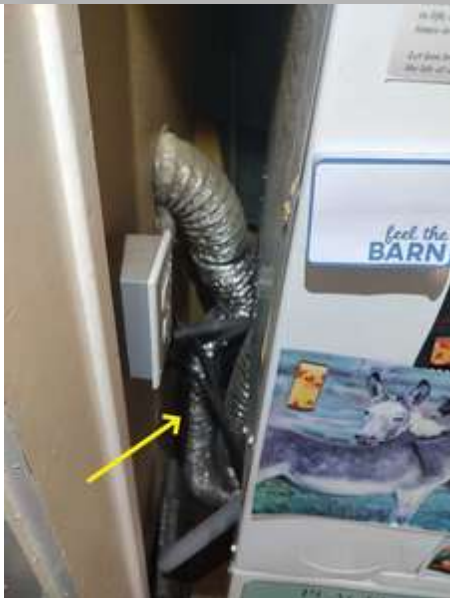
We recommend the transition vent duct in place for the dryer be changed to a fire-retardant product approved by the dryer manufacturer. Generally, semi-rigid or rigid metal duct products are acceptable.

Building codes mandate the use of UL 2158A approved transition vent ducts, but conflicts arise regarding foil transition vent ducts. Many appliance manufacturers explicitly discourage their use with warnings like "Do Not Use Metal Foil Vent" in their instructions. It's not uncommon for manufacturers to establish guidelines that surpass code requirements to guarantee safe and proper installations, and disregarding these instructions can lead to warranty voidance and potential safety risks.

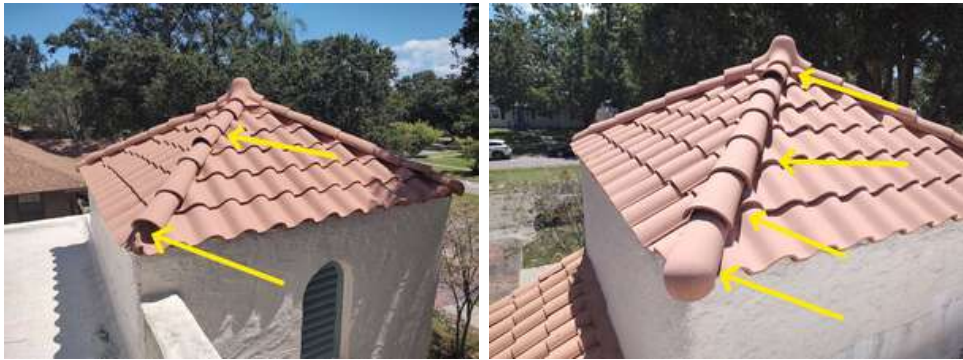
Damaged and/or missing tiles were observed at one or more locations. The inspector can not offer an opinion as to whether the roof leaks today unless it is moderately raining at the time of inspection.

Note: The conditions noted are an indication that repairs are warranted and are not intended to define all areas that may require repairs. It is recommended a professional roofing contractor evaluate the entire system and repair all areas as needed.

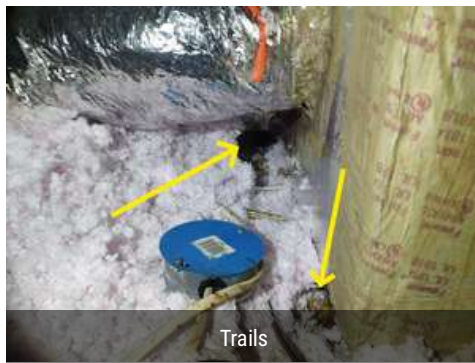
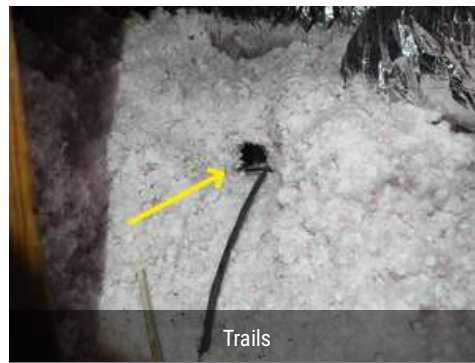
There is evidence of rodent activity in the attic (trails, droppings, carcasses, etc.). Rodent activity is very common but is fixable. These pests can damage wiring, ductwork, etc. All possible openings (cracks, holes, gaps, etc.) should be properly sealed to eliminate rodent entry. A qualified exterminator is recommended.

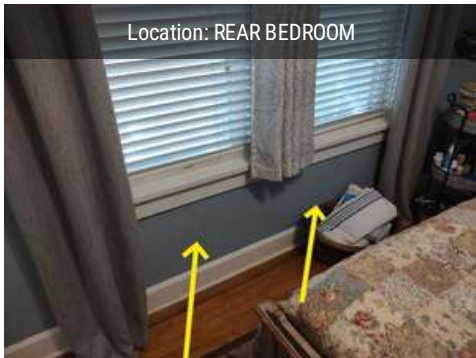
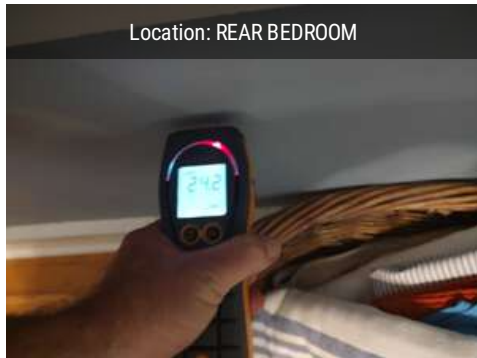
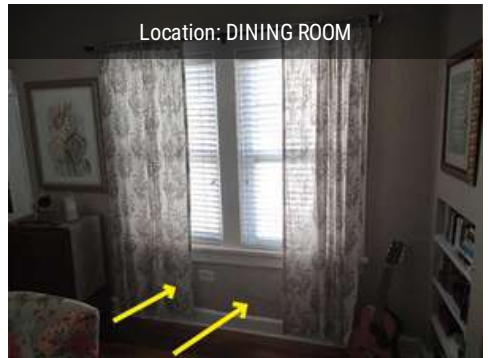
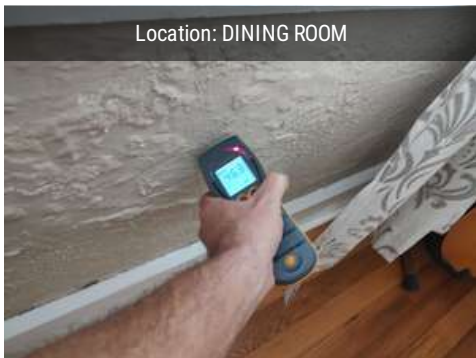
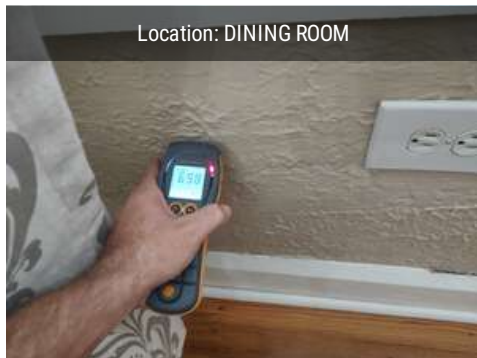
Moisture stains were observed at one or more locations. When checked with a moisture meter the area indicated a wet / active leak condition. Recommend further evaluation and repair as needed by a licensed contractor. Please refer to limitations of inspection regarding mold / moisture related conditions.

Note;We are required to report past or present leak conditionson the 4 point inspection report (if applicable).

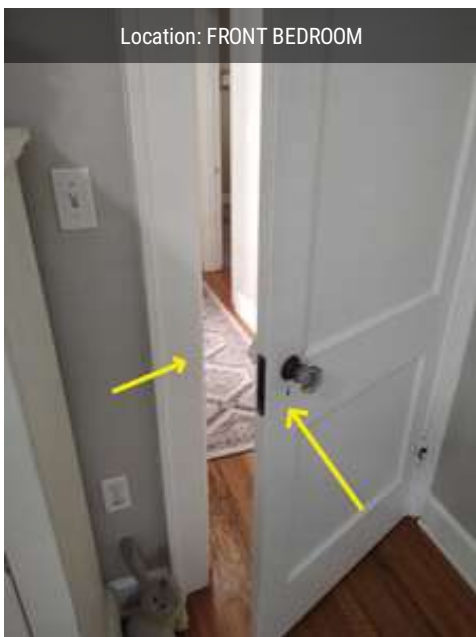
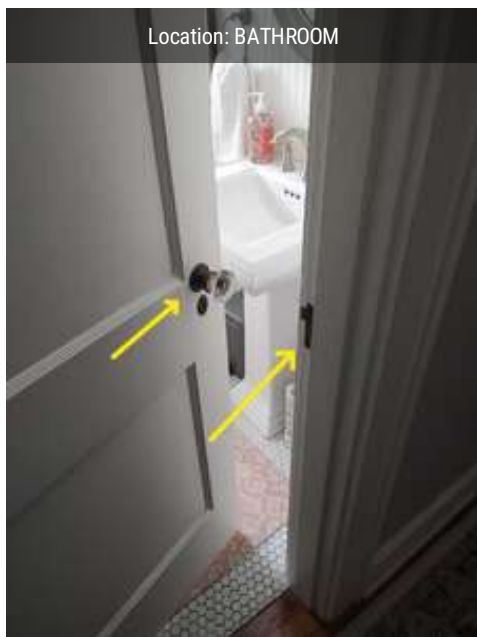
#### 13.5.1 Door - Latching Hardware Problem

The latching hardware on one or more doors did not function properly. Although replacement is sometimes necessary, in most cases this can be repaired with minor adjustments. A qualified person can perform the work.

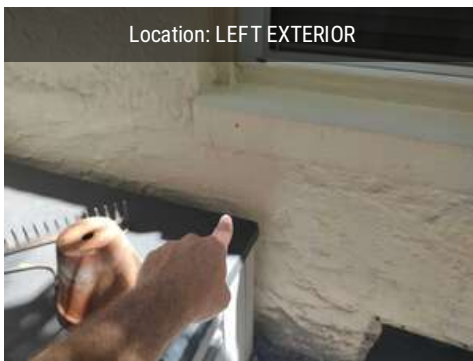
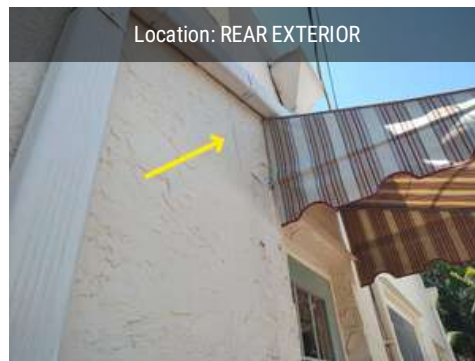
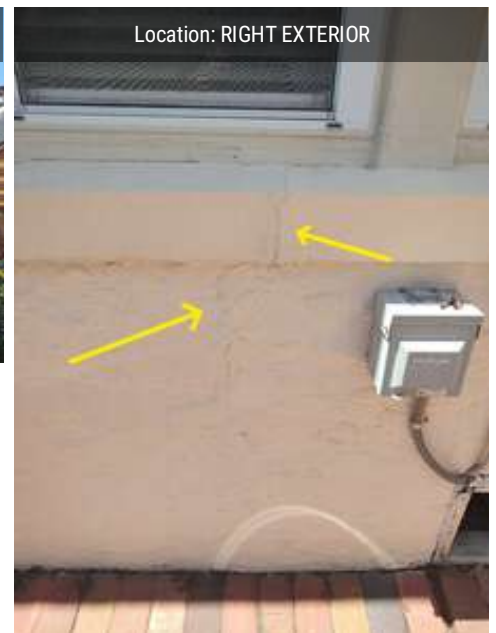
Typical cracks were found in the exterior walls. Minor settlement cracks are very common and occur as the dwelling settles and building materials cure over time. These cracks are not considered serious in nature until they reach a width of 1/8 inches or more. However, they can allow moisture to enter the building components. We recommend sealing and painting to reduce the possibility of water penetration.

Note, this comment may not include all areas requiring attention. The contractor should walk the perimeter of the home and address all areas that require attention.

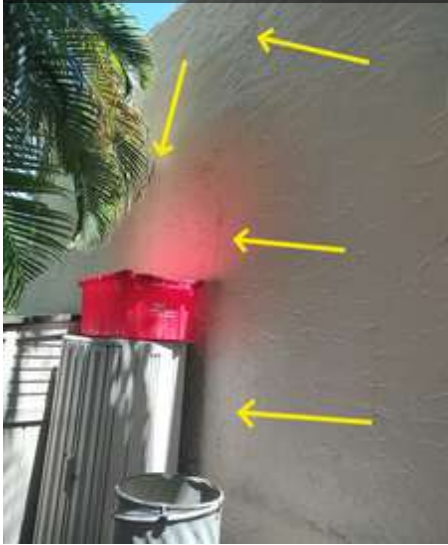
Location: LEFT EXTERIOR

Past repairs were noted at one or more locations on exterior walls. Recommend checking with the current owner for information / documentation.

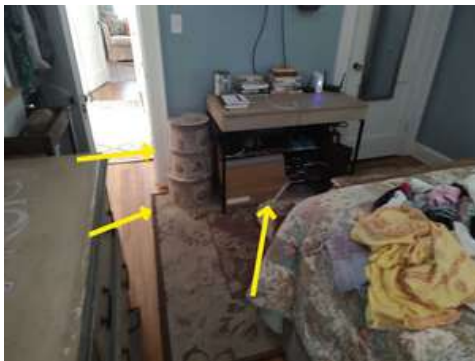
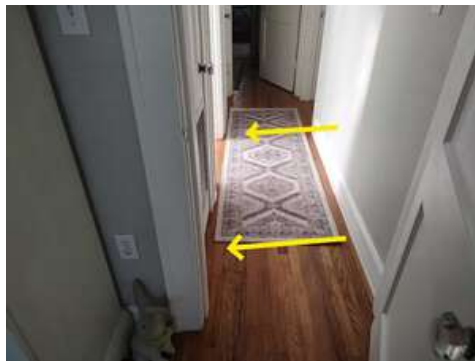
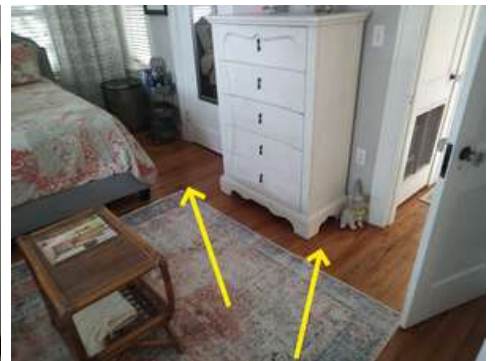
#### 13.3.1 Sloping, Minor

Minor floor sloping was observed at one or more locations. From the visible and accessible areas, no immediate concern was observed. This may not however, be an indication of future conditions.

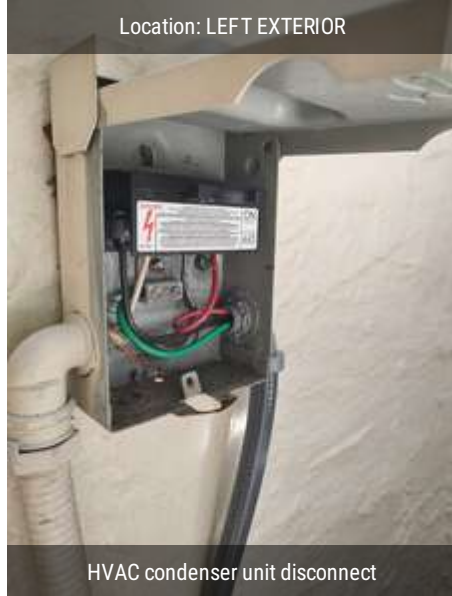
### 6.5.1 Panel/J-box - HVAC Quk Disc Cover Missing

HVAC condenser unit disconnect

The deadfront cover plate at the HVAC quick disconnect box is missing. Lack of proper covers on junction boxes is a shockhazard. It is suggested that a "Licensed Electrical Contractor" be contacted for further evaluation and repair.

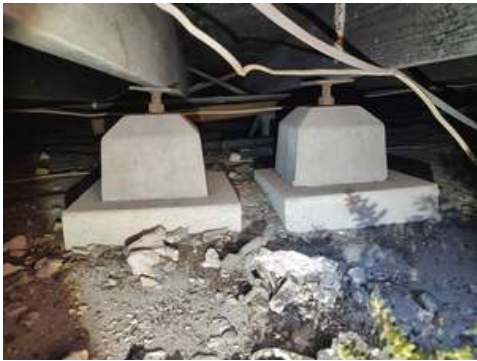
Foundation repairs with added structural support jacks or evident in one or more locations. These appear to be professionally done and we advise obtaining all documentation and warranty information from the current owner prior to close.

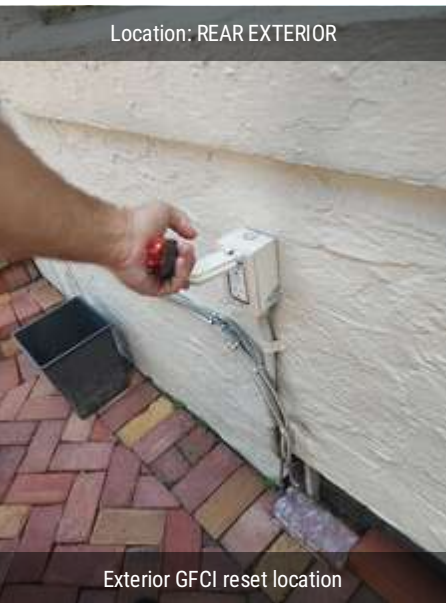
#### 6.8.1 GFCI - Reset Locations (Outlets/Breakers)

When tested, the GFCI devices tripped and shut off power, as designed. Many homes have multiple reset locations to restore power after a fault occurs. To restore power to GFCI protected receptacles or devices after a fault, reset the button on the GFCI outlet or breaker. As a convenience, the GFCI main reset locations identified during our inspection are detailed within the comment images.

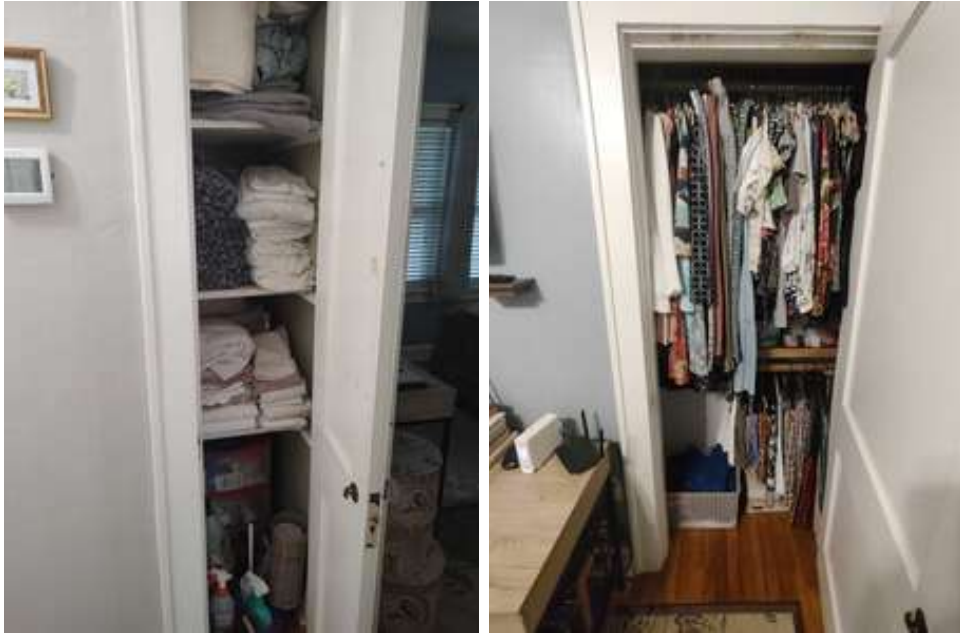
Personal belongings within and/or in front of closets prevented full access for inspection. We suggest further inspection of these areas during your final walk through.

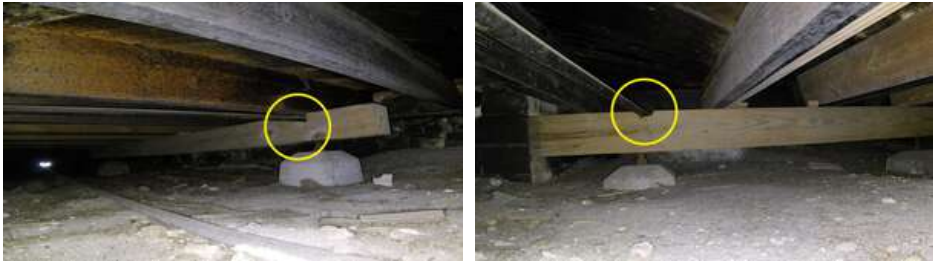
A structural support beam at one or more locations has been notched to allow for plumbing or electrical runs. Generally notching of support beams is not acceptable. We recommend a licensed foundation contractor evaluate and repair as needed.

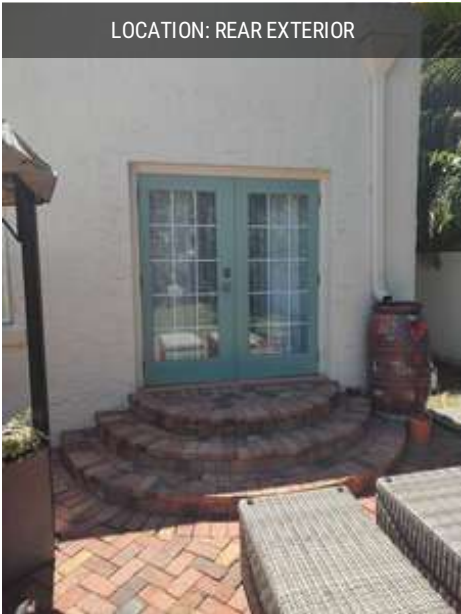
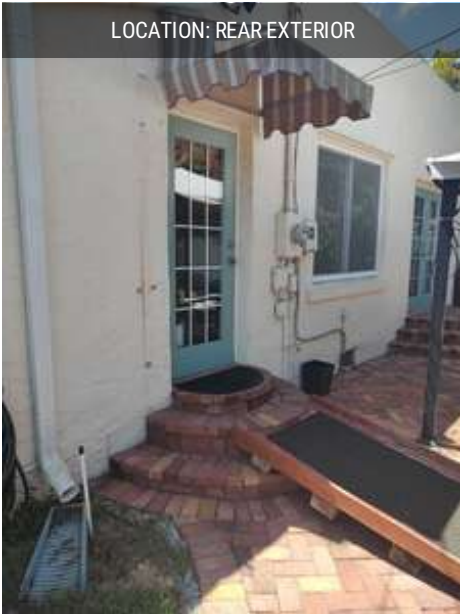
No railings were present. For increased safety, client should consider installation of a railing. Client should consult with a qualified contractor for information on current standards.

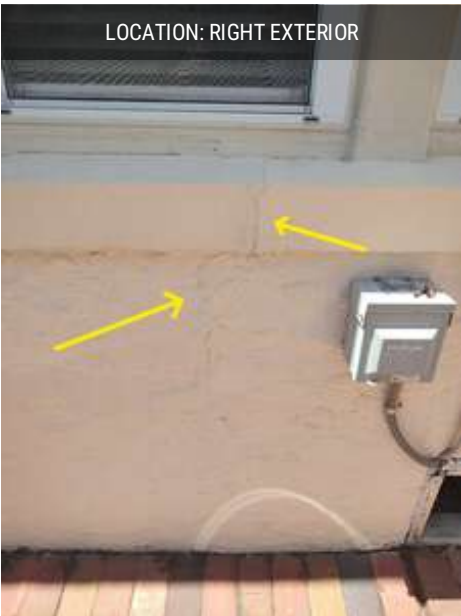
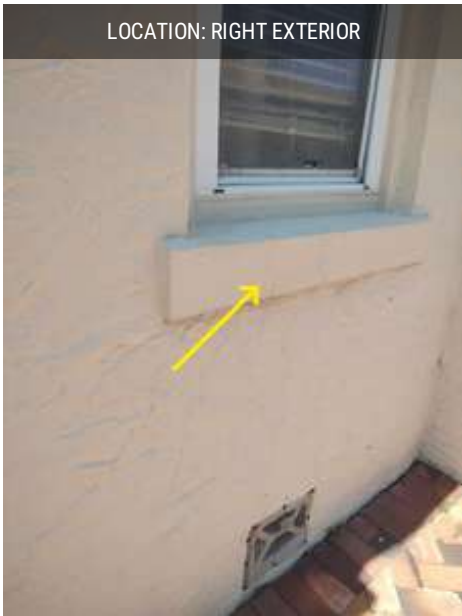
Note, this comment may not include all areas requiring attention. The contractor should walk the perimeter of the home and address all areas that require attention.

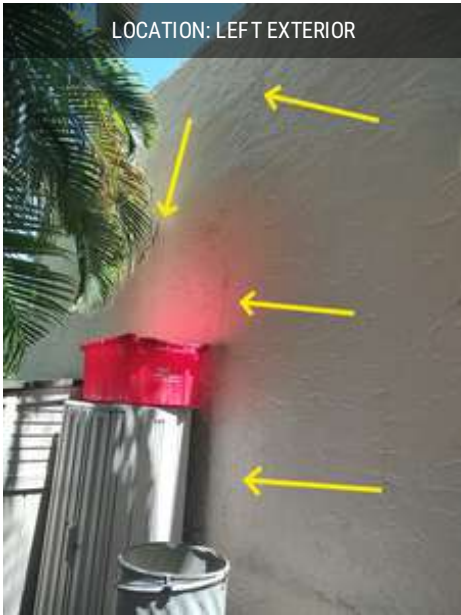
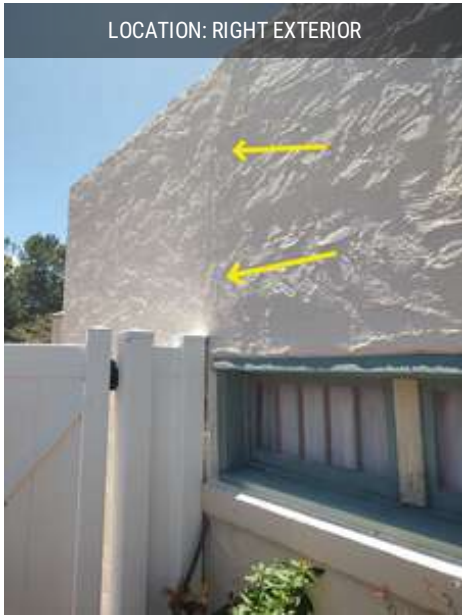
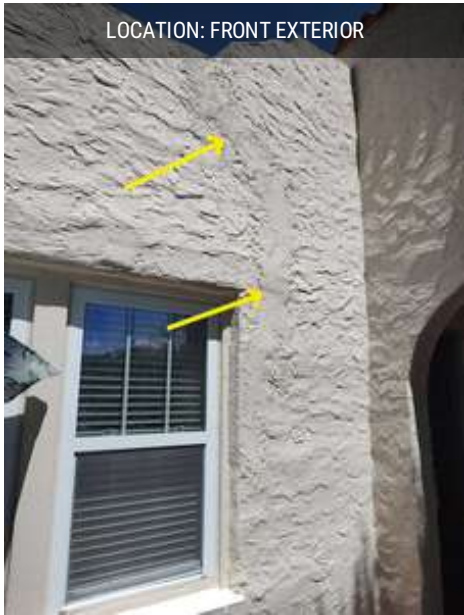
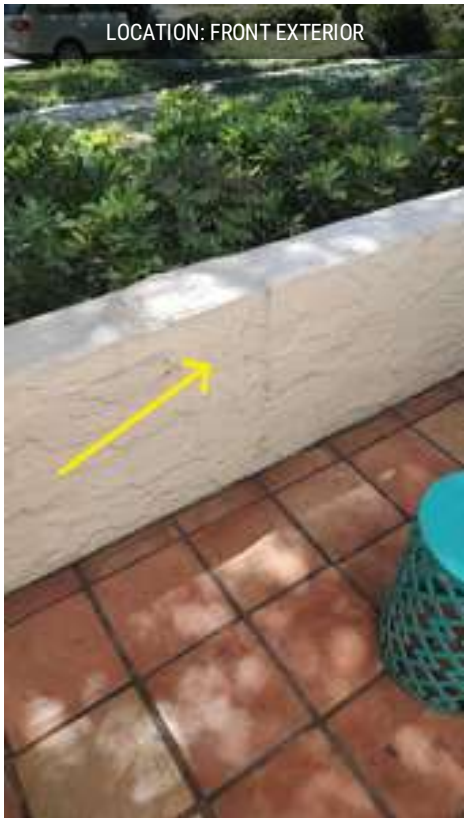
2.8.2 Past Repairs - Exterior Walls

Past repairs were noted at one or more locations on exterior walls. Recommend checking with the current owner for information / documentation.

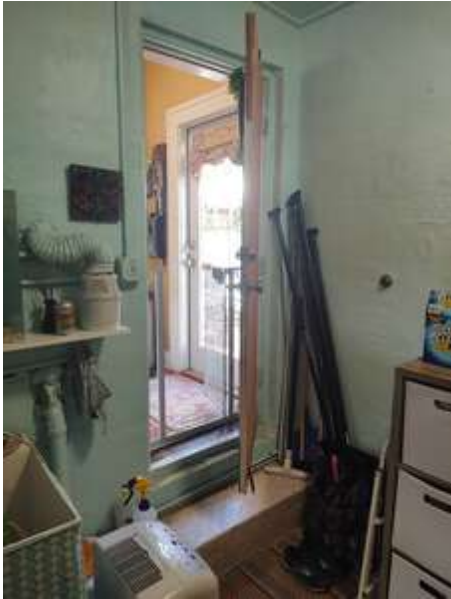
A passage door swings outward over steps. This is generally considered unsafe as there is no landing step out on. Werecommend changing the swing of the door to be in in swing for safety. It is suggested that a "Qualified Window & Door Contractor" be contacted for further evaluation and repair.

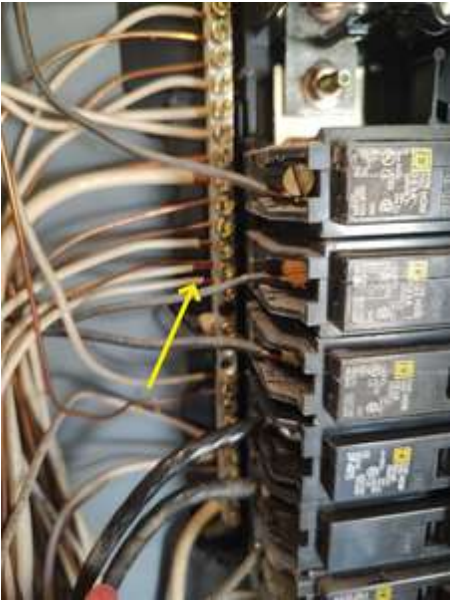
Ground and neutral wires share the same terminal screw on the bus bar. Per electrical standards, ground and neutral wires should not share the same lug and must connect to separate bus screws. Have an electrician rearrange the wires as needed to meet standards.

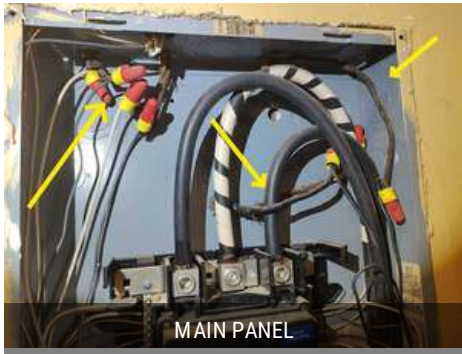
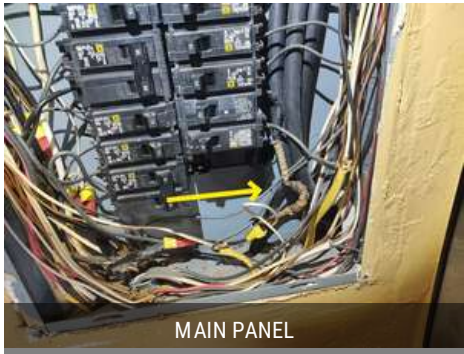
Important Note: This observation requires the inspector to specify the existence of cloth wiring on the separate 4 Point Inspection Report that most insurance companies require - some insurance companies will not insure a house with this type of wiring. We advise you consult with your insurance agent or underwriter regarding insurability.

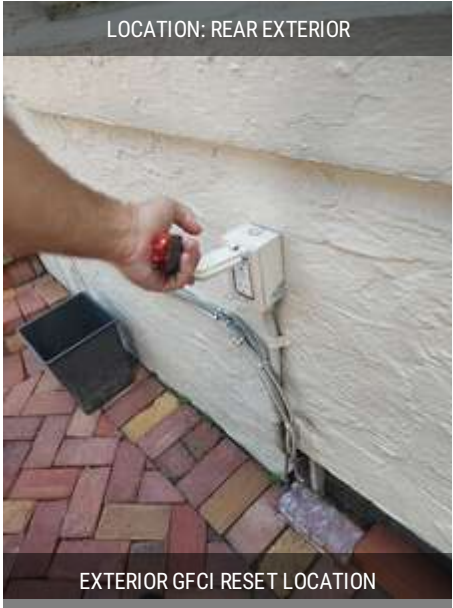
When tested, the GFCI devices tripped and shut off power, as designed. Many homes have multiple reset locations to restore power after a fault occurs. To restore power to GFCI protected receptacles or devices after a fault, reset the button on the GFCI outlet or breaker. As a convenience, the GFCI main reset locations identified during our inspection are detailed within the comment images.

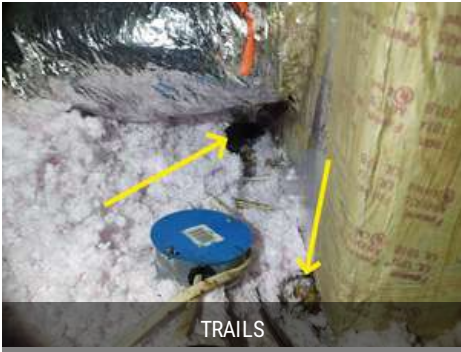
There is evidence of rodent activity in the attic (trails, droppings, carcasses, etc.). Rodent activity is very common but is fixable. These pests can damage wiring, ductwork, etc. All possible openings (cracks, holes, gaps, etc.) should be properly sealed to eliminate rodent entry. A qualified exterminator is recommended.

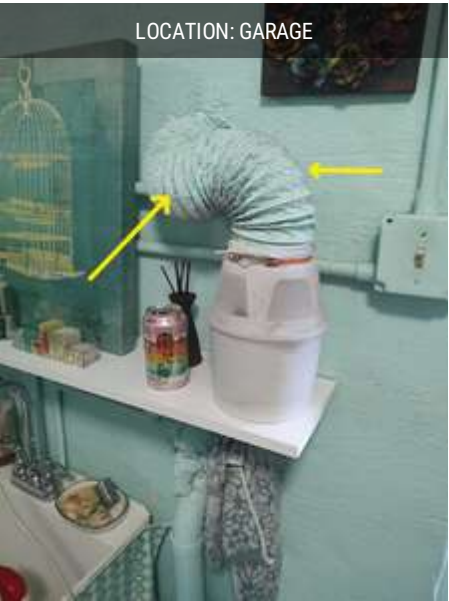
The permanent duct in place for the dryer is a fire hazard and should be changed to a smooth surface non-combustible product in accordance with local building code and the manufacturers instructions.

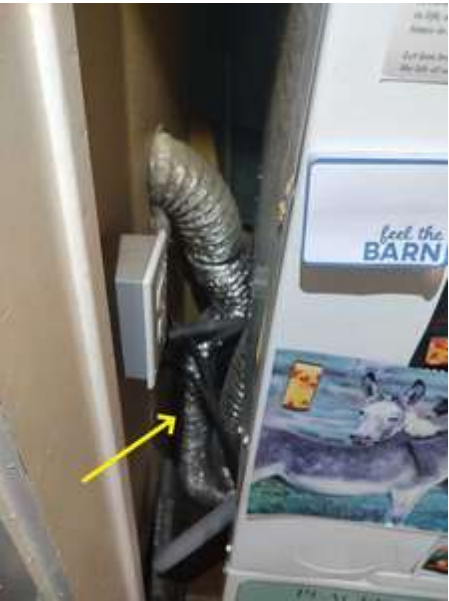
10.3.2 Transition Hose, Foil / Vinyl

We recommend the transition vent duct in place for the dryer be changed to a fire-retardant product approved by the dryer manufacturer. Generally, semi-rigid or rigid metal duct products are acceptable.

Building codes mandate the use of UL 2158A approved transition vent ducts, but conflicts arise regarding foil transition vent ducts. Many appliance manufacturers explicitly discourage their use with warnings like "Do Not Use Metal Foil Vent" in their instructions. It's not uncommon for manufacturers to establish guidelines that surpass code requirements to guarantee safe and proper installations, and disregarding these instructions can lead to warranty voidance and potential safety risks.

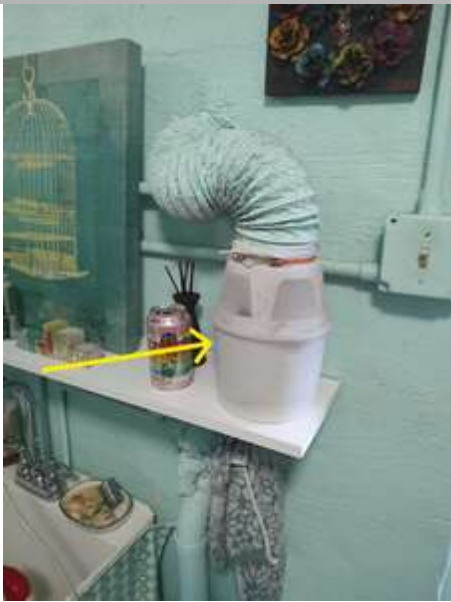
The dryer exhaust vents to an interior venting kit. Although this is considered acceptable, we recommend routing the dryer exhaust to the exterior to reduce lint and humidity inside the structure.

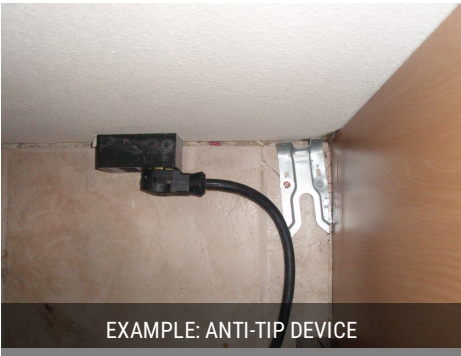
Our inspection does not include moving appliances. However, we strongly recommend verifying that the anti-tip safety device, provided by the range manufacturer and required in installation specifications, is correctly in place. Typically, this device is mounted to the floor or wall behind the unit and placed to catch a leveling bolt to prevent the unit from tipping forward. This safety measure is crucial to prevent injury or fatalities, especially involving children.

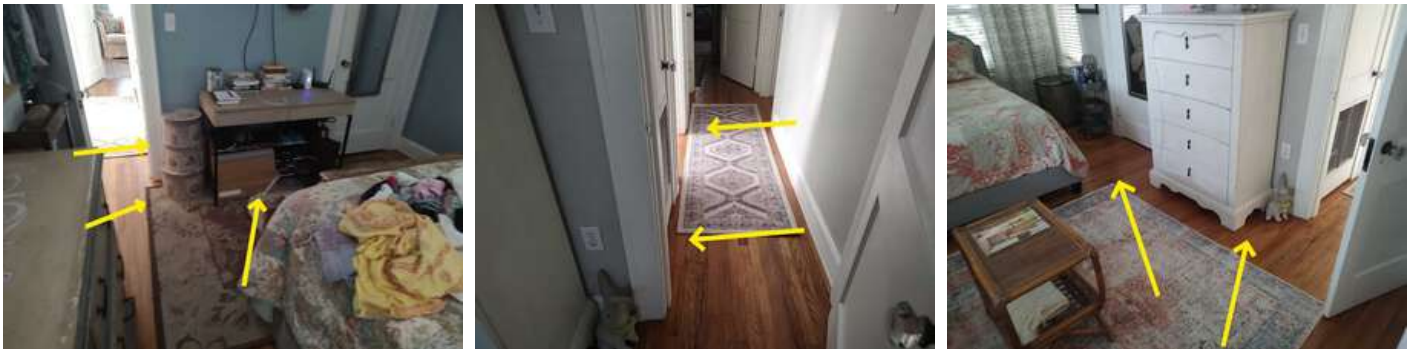
Minor floor sloping was observed at one or more locations. From the visible and accessible areas, no immediate concern was observed. This may not however, be an indication of future conditions.

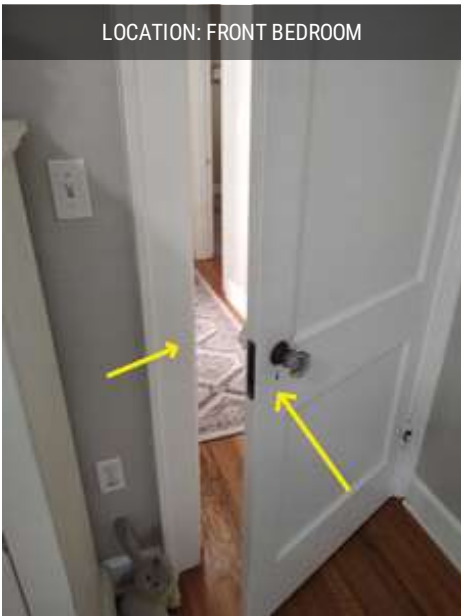
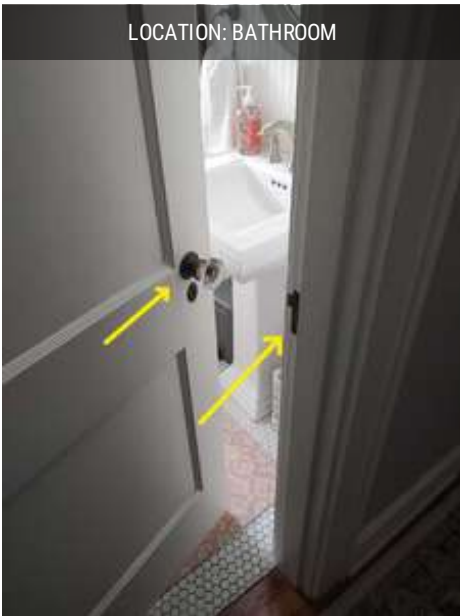
The latching hardware on one or more doors did not function properly. Although replacement is sometimes necessary, in most cases this can be repaired with minor adjustments. A qualified person can perform the work.
