**Robbins Services, Inc.**  
<http://RobbinsHomeInspections.com>  
(727) 475-5252  
[Support@RobbinsHomeInspections.com](mailto:Support@RobbinsHomeInspections.com)

**3021 Barrow St, North Pole, Alaska 99705**  
**Sample Report - Manufactured Home**  
**Prepared for**  
**Bruce Wayne**  
**Jan 05, 2023 at 06:00 AM**

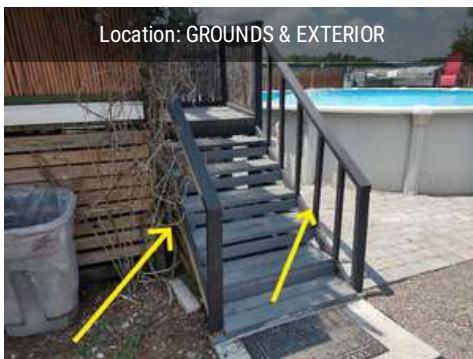
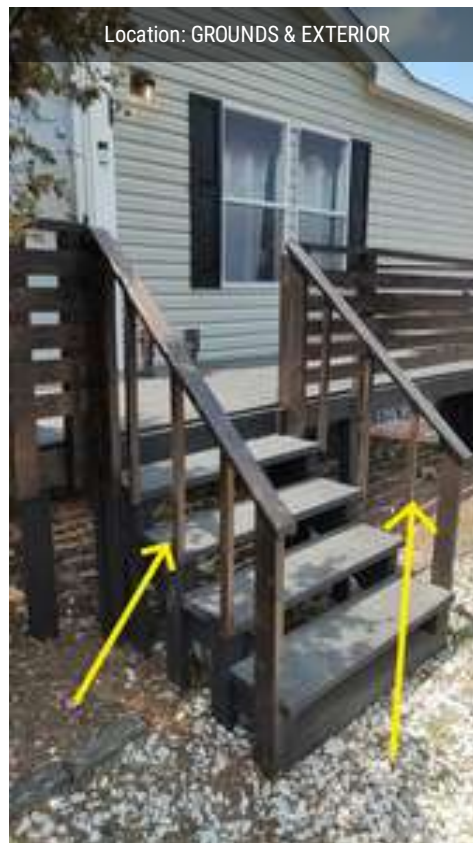
The openings in the railings are too wide. Openings in railings should not exceed a 4 inches width. We recommend decreasing the opening length between the balusters to reduce the possibility of child injury. Client should consult with a licensed contractor for repairs and/or information on current standards. Other forms of add-on netting protection devices may be available online.

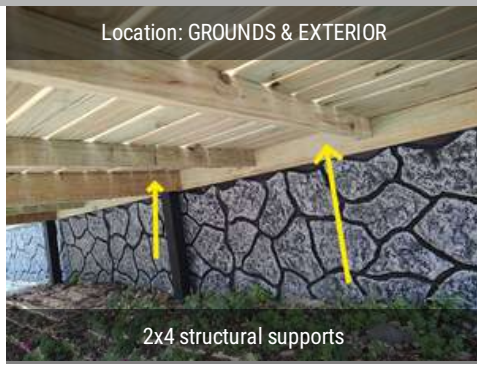
##### 3. NO JOIST HANGERS

The joists were toe nailed into framing. Ideally, joist hangers would offer proper support. Client is advised to consult a licensed deck contractor for further information and repairs.

2x4 structural supports

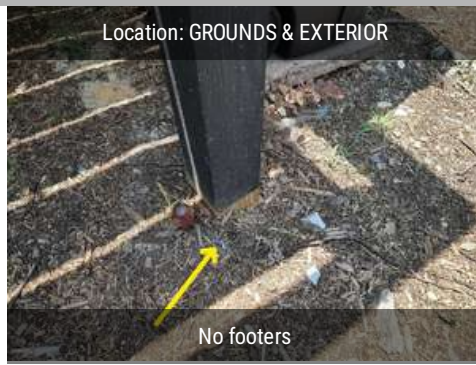
No footers

##### 2. IMPROPER FOOTINGS - 2021 IRC R507.3

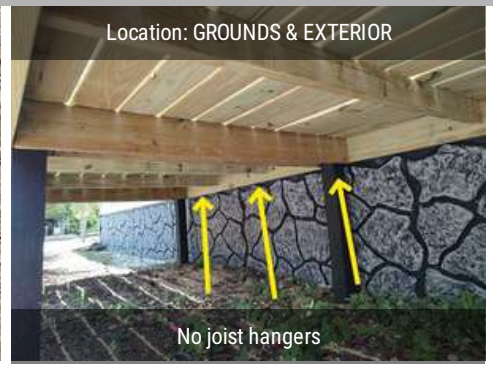
No joist hangers

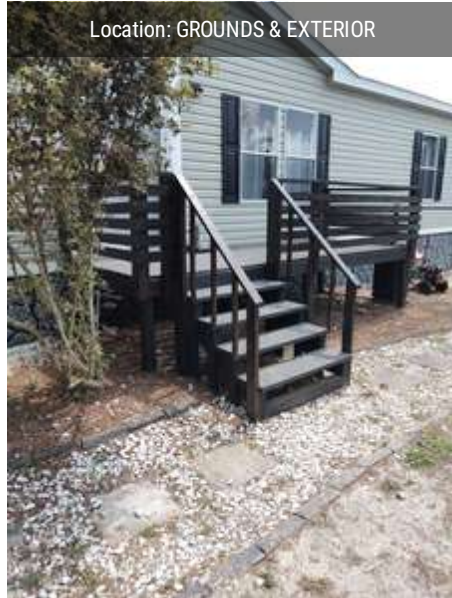
### 2.6.1 Staircase - Riser Heights Bad

The heights of the various risers at one or more of the staircases are not uniform. This creates a potential trip hazard. Generally, industry standard dictates that "step risers" (the vertical distance from one step up to the next) not exceed 7-3/4" high and all be within 3/8" of the smallest riser. A "Licensed Carpenter or General Contractor" should repair or modify the stairs to ensure they are safe.

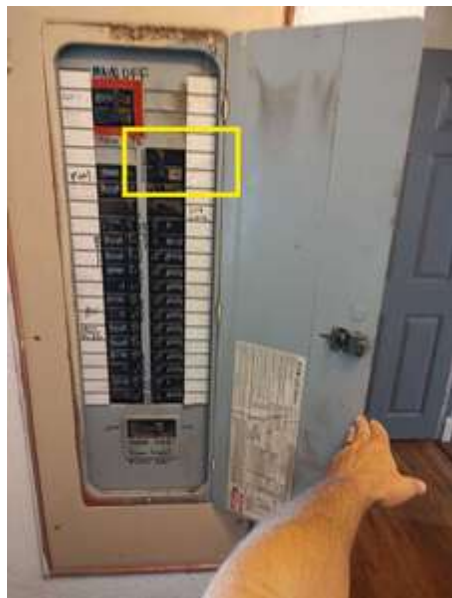
### 4.4.4 Off / Disconnected, Breaker

One or more breakers in the panel were in the off position, or not in use at the time of this inspection. We did not activate the breaker, or energize the circuit because doing so could create a hazard. In addition, components connected to these breakers were not tested. The owner may have information as to why the breaker is disconnected. If it is not functional, a licensed electrician should make appropriate repairs.

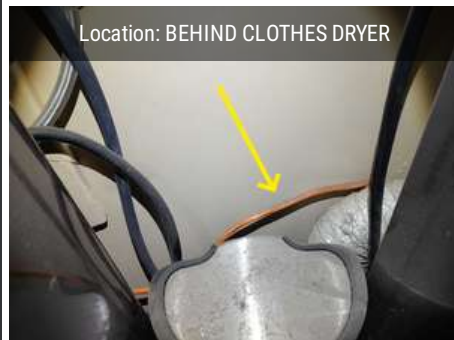
### 4.5.1 Exposed Wiring

There is exposed wiring at one or more locations. Industry standards indicate that wiring installed below 7 feet be protected from physical damage. The wiring needs to be installed in properly rated conduit to meet electrical safety standards. A qualified electrician should do the work.

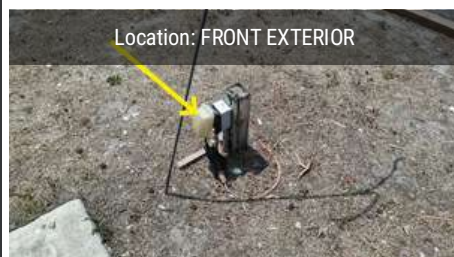
#### 4.6.2 Loose dmgd outlet

Loose / damaged outlet was observed at one or more locations. Recommend further evaluation and repairs by a licensed electrician prior to close.

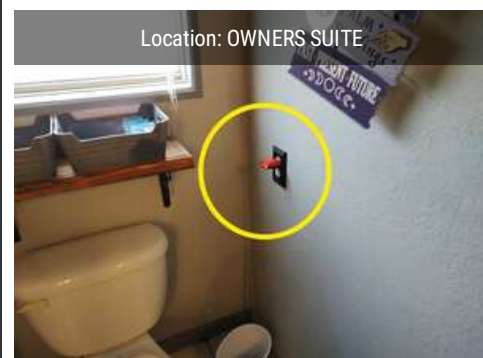
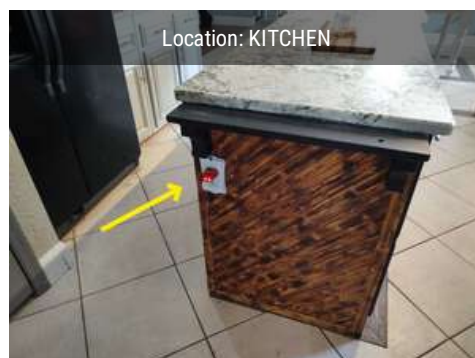
#### 4.8.1 Receptacle - GFCI - Should Be

There is no Ground Fault Circuit Interrupted (GFCI) protection for the receptacle(s) at one or more locations. Industry standards would have dictated installation of GFCI protection at the time of construction or when the outlet(s) were updated for the exterior, baths, kitchen, laundry and/ or garage. A licensed electrician should install GFCI protection for all locations necessary to meet current electrical safety standards.

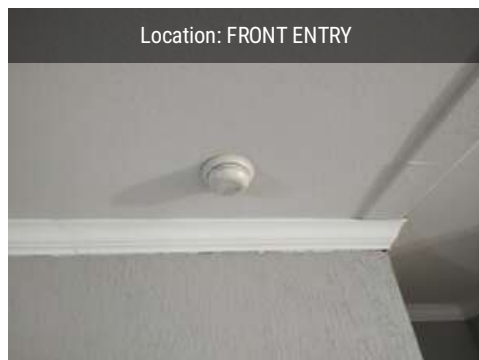
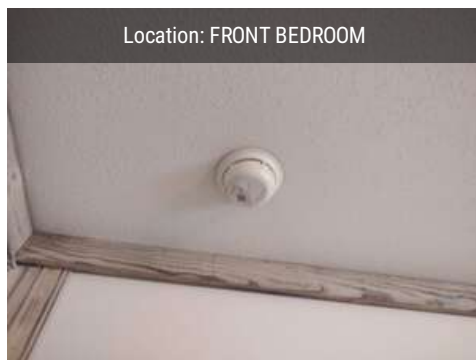
One or more detectors did not respond to the test button. New batteries or replacement is recommend. Smoke detectors have a life expectancy of about 10 years, while carbon monoxide detectors have a useful lifespan of about 5-6 years, replacement is recommended after these time periods.

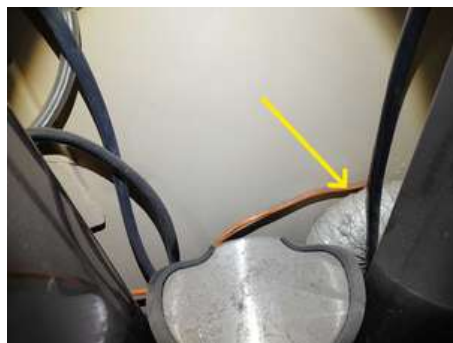
### 7.3.2 Transition Hose, Foil / Vinyl

We recommend the transition vent duct in place for the dryer be changed to a fire-retardant product approved by the dryer manufacturer. Generally, semi-rigid or rigid metal duct products are acceptable.

Building codes mandate the use of UL 2158A approved transition vent ducts, but conflicts arise regarding foil transition vent ducts. Many appliance manufacturers explicitly discourage their use with warnings like "Do Not Use Metal Foil Vent" in their instructions. It's not uncommon for manufacturers to establish guidelines that surpass code requirements to guarantee safe and proper installations, and disregarding these instructions can lead to warranty voidance and potential safety risks.

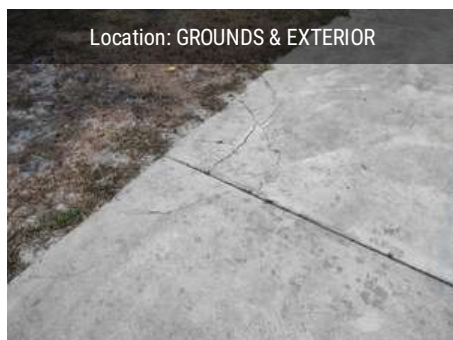
### 2.4.1 Cracks and settlement - Possible Trip Hazards

Cracks and settlement was observed. Trip hazards may be present or occur overtime. Correction is recommended by a qualified masonry contractor to deter further settlement and cracking.

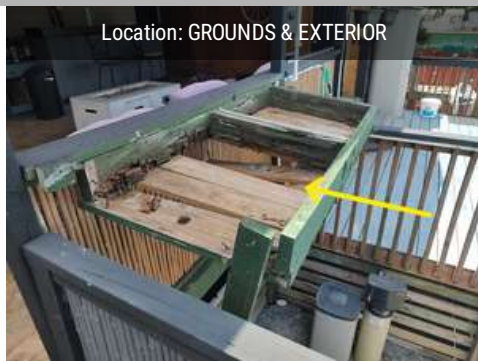
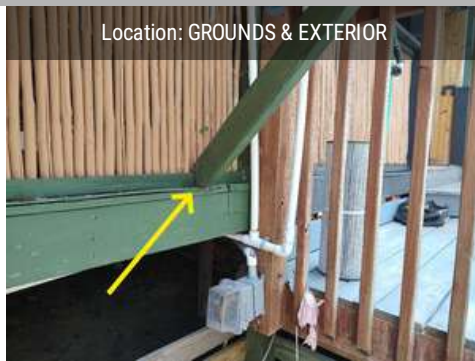
Moisture damage and/or wood rot was observed. Replacement of affected materials is recommended. A "Licensed Decking Contractor" can make repairs.

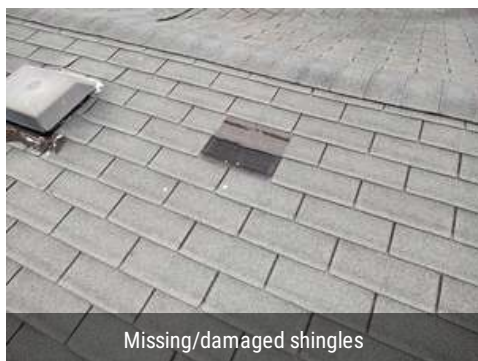
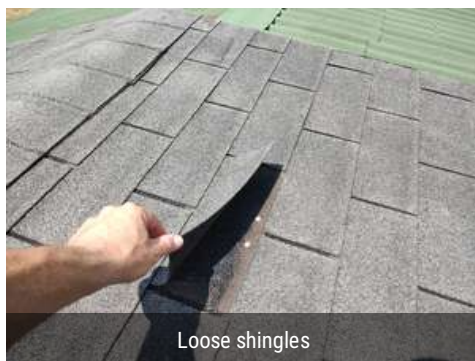
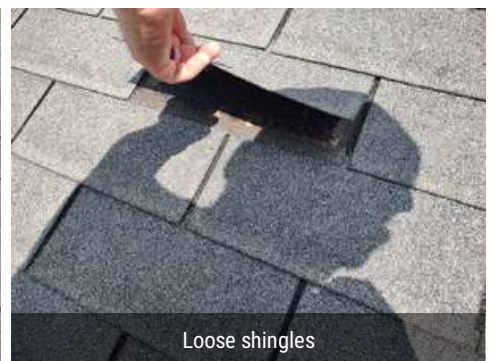
### 3.1.1 Loose/Damaged/Missing Shingles

Loose, damaged or missing shingles were observed at one or more locations. The inspector can not offer an opinion as to whether the roof leaks today unless it is moderately raining at the time of inspection. A licensed roofing contractor should evaluate the roof and repair all damaged areas.

Note, when applicable we are required to note roof concerns on the 4 Point Inspection report. Insurance companies may request repairs prior to providing insurance.

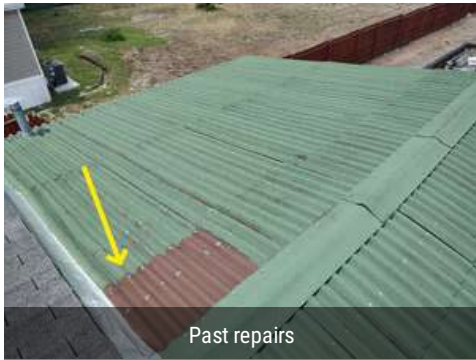
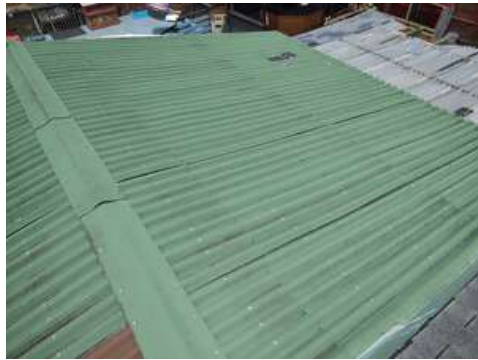
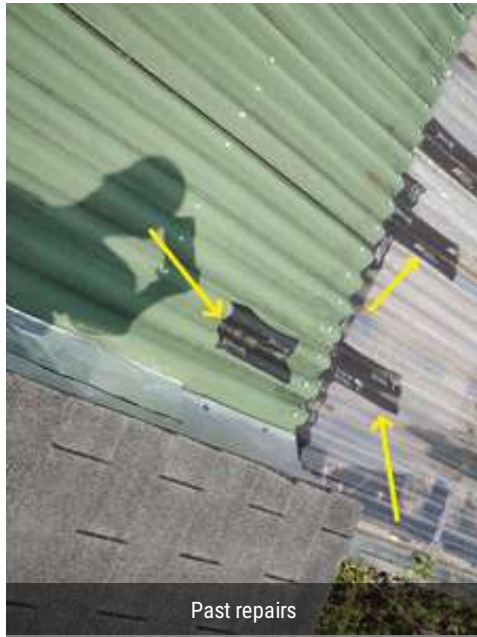
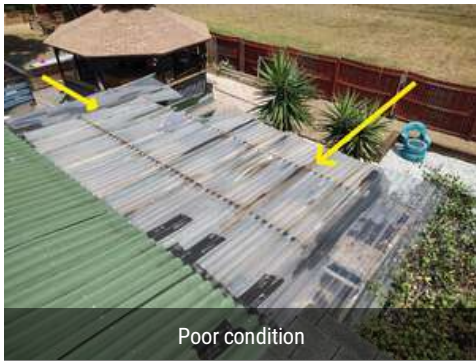
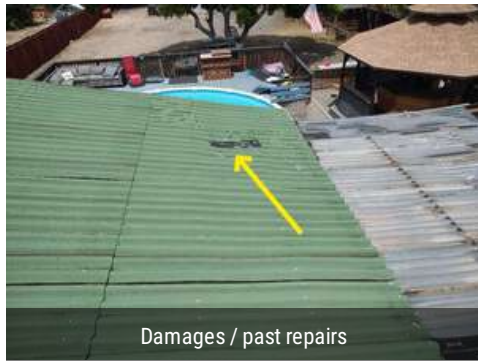
### 3.1.2 Unprofessional roofing materials

Unprofessional roofing materials were utilized over the back porch area. Areas with this type of material are generally not permitted and replacement is recommended with a qualified roofing product. Holes and damages were present. Recommend farther evaluation by a licensed roofing contractor.

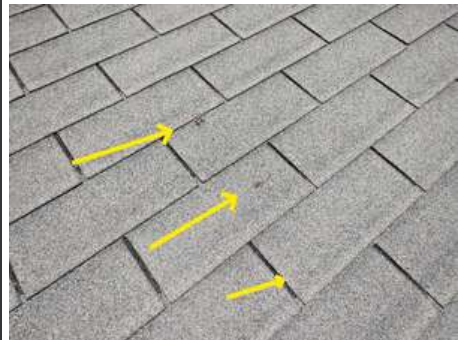
Punctures were noted in roofing materials at one or more locations. We recommend unapproved fasteners be removed and punctures be properly sealed to deter leaks.

Note, conditions noted are based on a random sampling or visible areas. This condition may exist in other locations. The roof should be reviewed by a licensed roofing contractor and repairs should be made as needed.

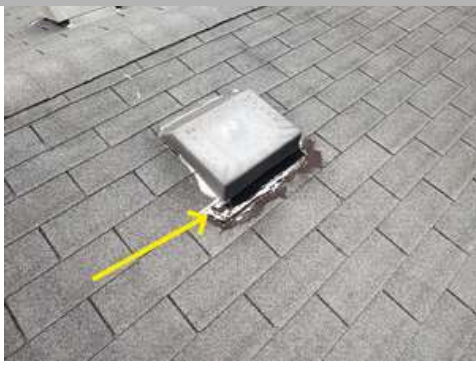
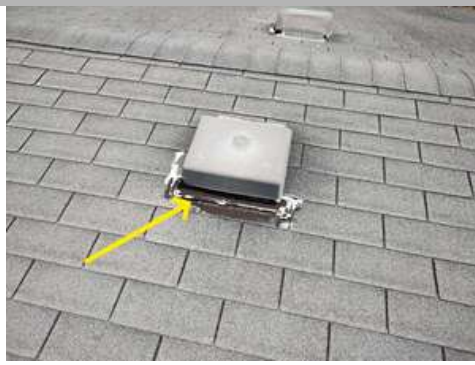
Damaged/deteriorated sealant was noted at numerous locations. Sealantis recommend at all vent pipes, chimney, wall and valley seams, and any other through roof projections (including skylights if present) to reduce the possibility of water penetration. Recommend repair as needed by a qualified / licensed contractor.

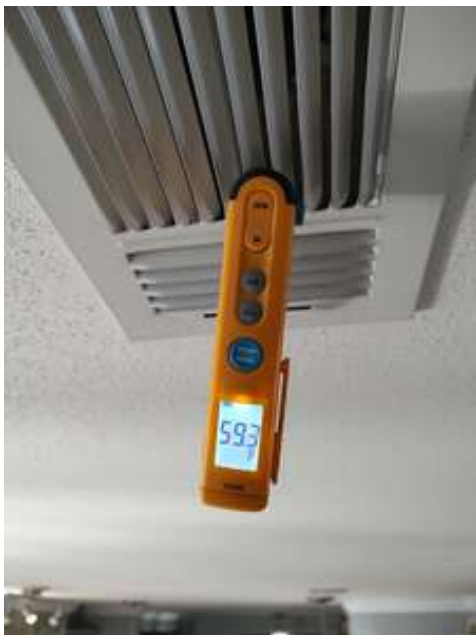
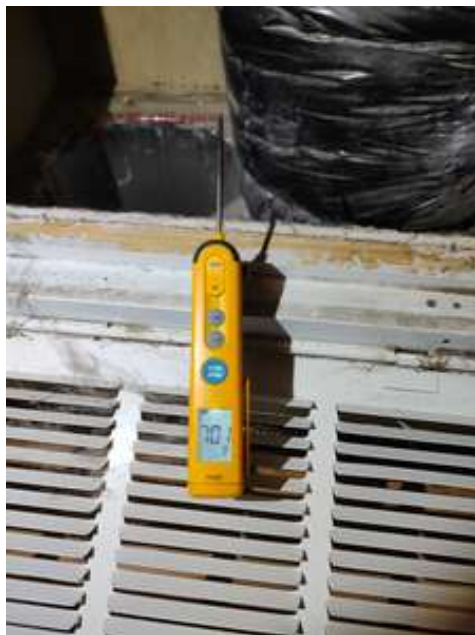
### 6.2.1 \*Improper Cooling Differential

An ambient air test was performed on the cooling system to determine if the difference in temperatures of the supply and return air are between 15 degrees and 22 degrees, which indicates that the unit is cooling within industry standards. The readings indicate that the unit is NOT cooling within standards and may not be working properly. A licensed Heat/Air contractor should further evaluate the system and advise.

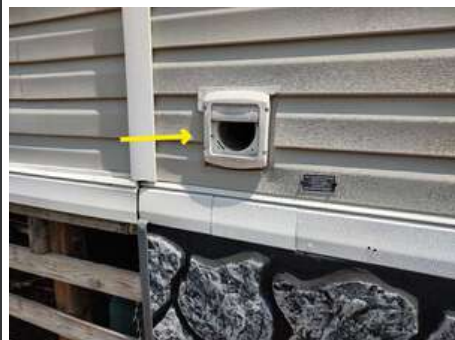
The dryer hood vent is missing/damaged. A qualified technician should repair/replace.

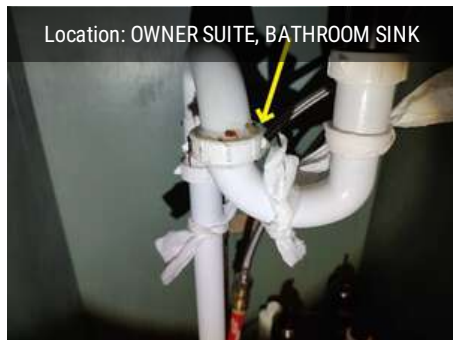
Location: OWNER SUITE, BATHROOM SINK

### 8.2.2 Unprofessional Repairs

Unprofessional plumbing repairs were observed (tape, caulking, etc.). No active leaks were noted. A licensed plumber can make repairs.

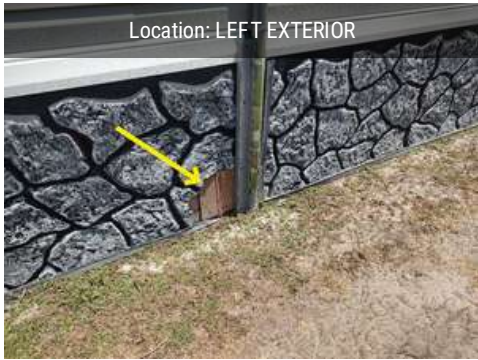
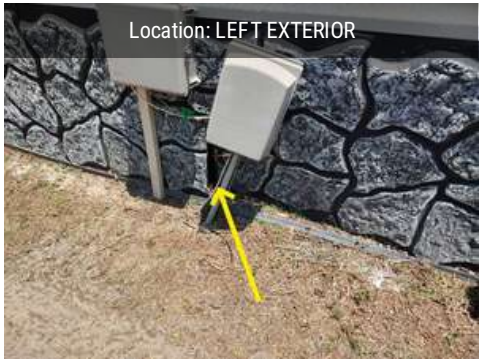
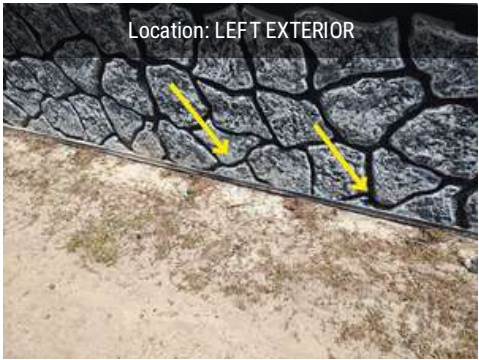
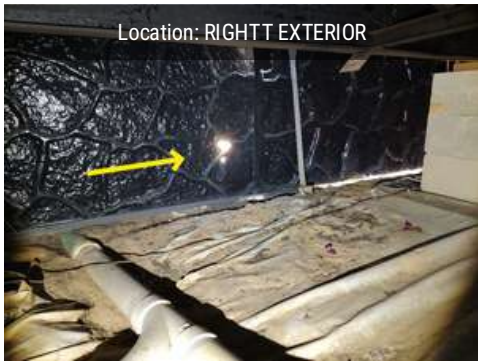
Skirting around the crawl space was damaged at one or more locations. We recommend repairs be made to deter rodents and other pest from entering the crawl space area.

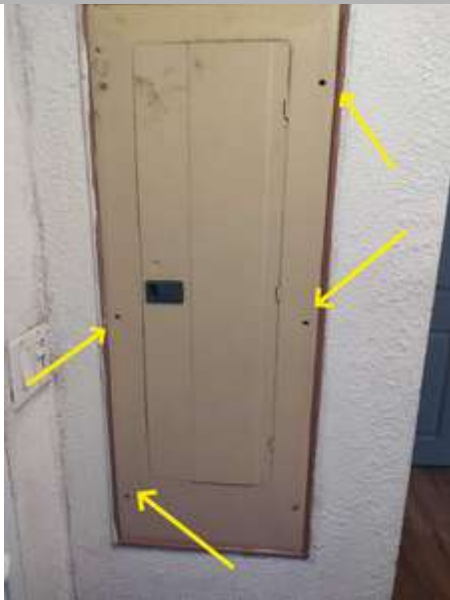
Screws were missing, stripped, or damaged at the electric panel cover at the time of inspection. In many cases, these screws can simply be replaced and are available at most local hardware stores. In cases where the screws require repairs for proper operation we recommend repairs be performed by a licensed electrician.

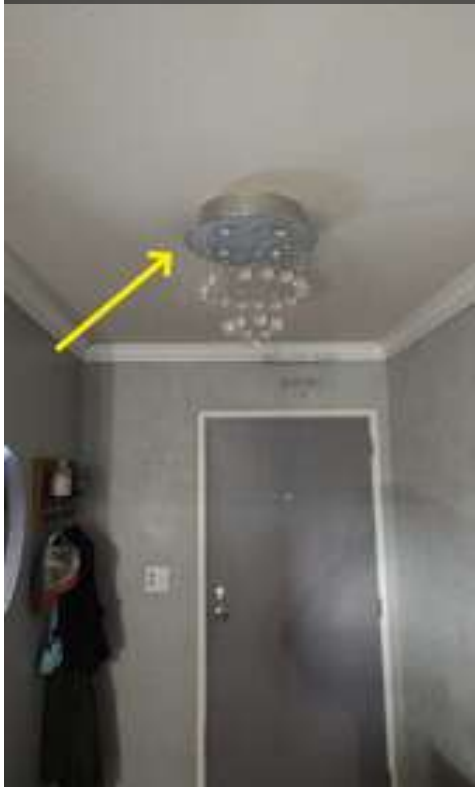
Location: FRONT ENTRY

Light(s) were out or inoperative at one or more locations. This may simply be a bulb is out or we were unable to locate the proper switch. Dismantling and testing of light fixtures is not performed as part of this inspection. Note, non-working items noted are based on a random sampling and this condition may exist at other locations. Recommend all lights be operable prior to close.

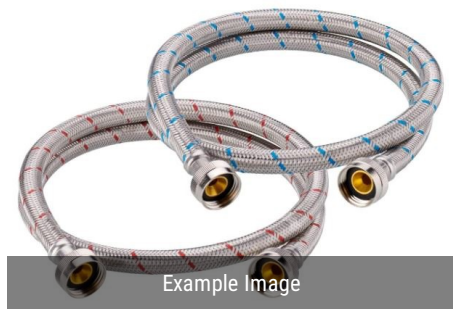
### 5.3.1 Anti-Burst Hoses, Recommendation (If Not Installed)

If not currently installed, as a preventive measure we recommend installing anti-burst water supply hoses at interior plumbing connections, such as clothes washers, toilets, sinks, and refrigerators. These hoses reduce the risk of excessive water damage due to burst connections.

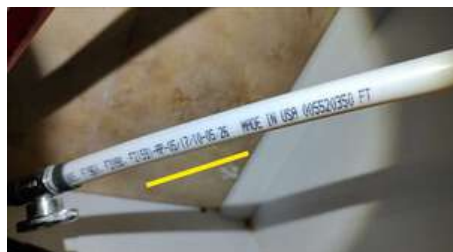
### 5.3.3 PEX, Insurance Notice

Some insurance companies will not insure properties with Pre-2010 PEX water supply lines due to leak statistics. We advise checking with your insurance provider as to their stance on this type of piping.

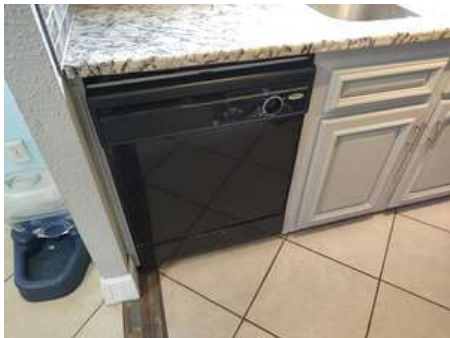
##### 9.7.1 EOL

The unit was examined. It appears to be functioning normally. However, it appears to be at or near the end of its useful life. Client may consider replacement with a more current model.

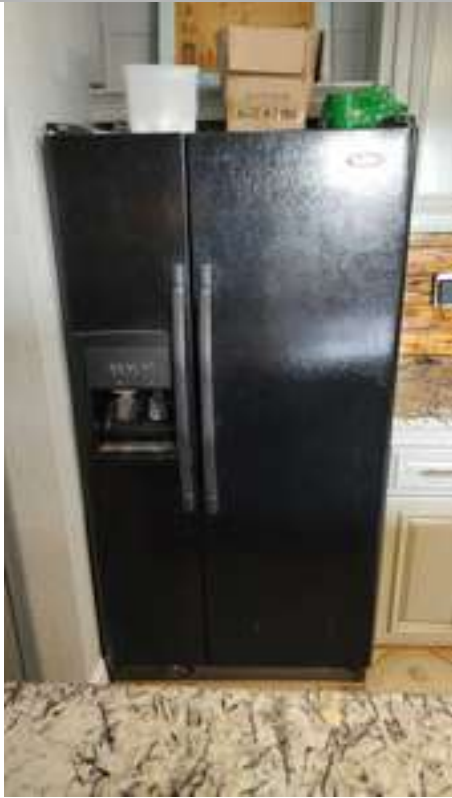
##### 9.8.1 EOL

The unit was examined. It appears to be functioning normally. However, it appears to be near the end of its useful life. Client may consider replacement with a more current model.

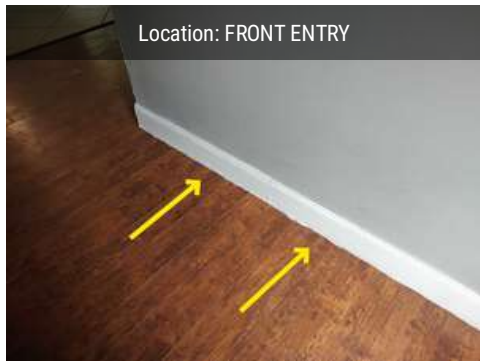
10.1.1 Moisture Stains - Not Active

Moisture stains and/or damage was observed at one or more locations. A moisture meter indicated the area(s) are currently within normal moisture levels and considered dry. However, if the leak source has not been identified and properly repaired, the leak may return. Contact the current owner to verify this condition has been addressed -or- contact a licensed contractor for repairs.

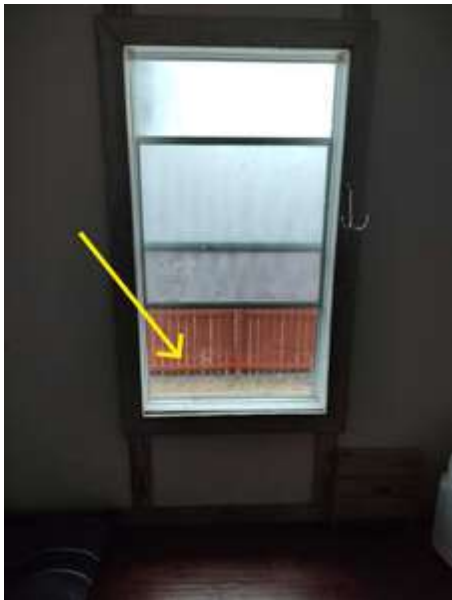
#### 10.5.1 Screens - Damaged / Missing

One or more screens are missing or damaged. A "Qualified Window & Door Contractor" can be contacted for further evaluation and repairs. It is suggested you contact the "Current Owner" to verify if missing items are in storage.

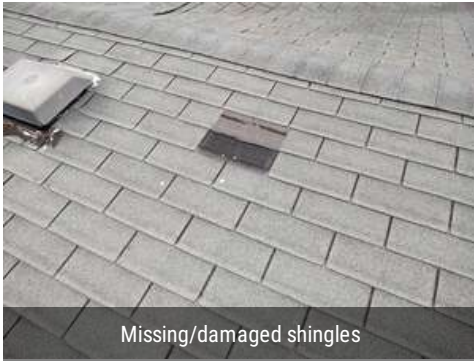
Loose, damaged or missing shingles were observed at one or more locations. The inspector can not offer an opinion as to whether the roof leaks today unless it is moderately raining at the time of inspection. A license roofing contractor should evaluate the roof and repair all damaged areas.

Missing/damaged shingles

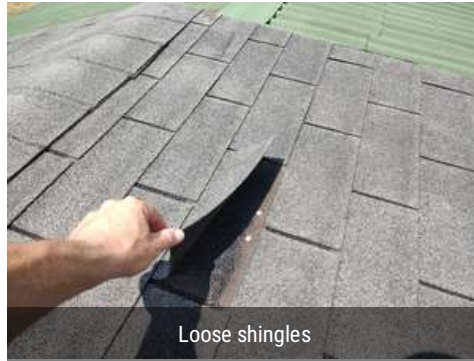
Loose shingles

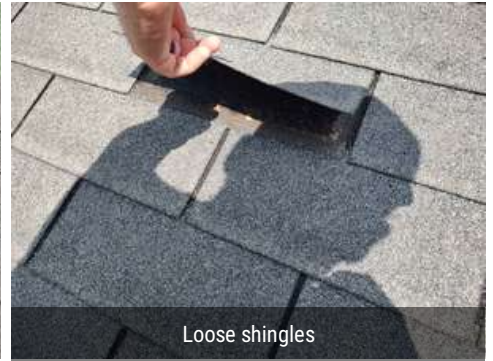
Loose shingles

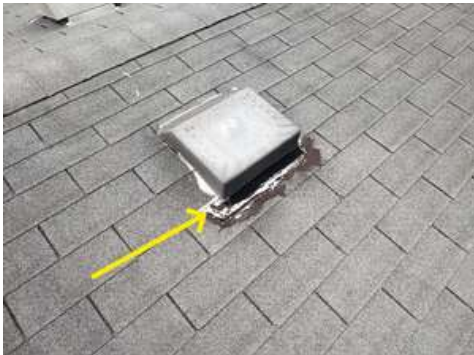
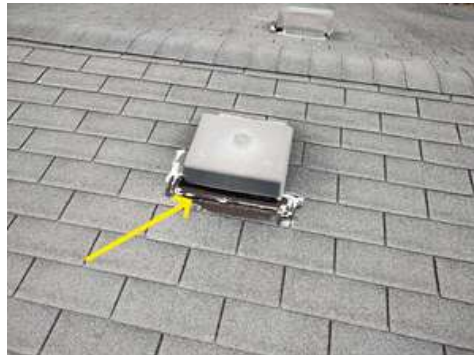
Damaged/deteriorated sealant was noted at numerous locations. Sealantis recommend at all vent pipes, chimney, wall and valley seams, and any other through roof projections (including skylights if present) to reduce the possibility of water penetration. Recommendrepair as needed by a qualified / licensed contractor.

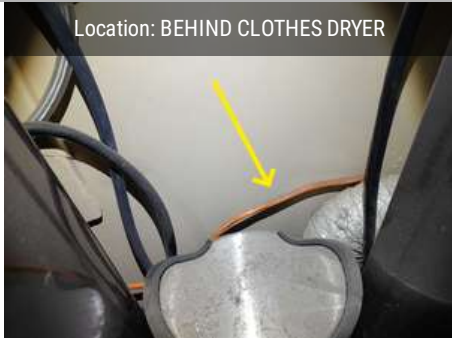
#### 4.5.1 Exposed Wiring

There is exposed wiring at one or more locations. Industry standards indicate that wiring installed below 7 feet be protected from physical damage. The wiring needs to be installed in properly rated conduit to meet electrical safety standards. A qualified electrician should do the work.

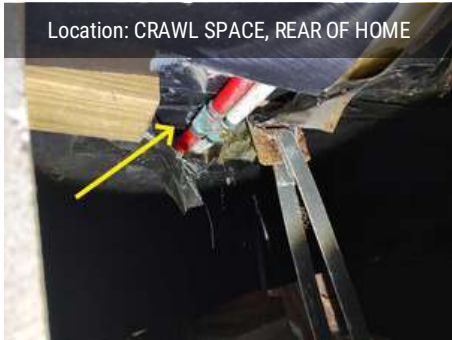
5.3.2 Active Leak

Active leaks were observed at one or more locations. Recommend further evaluation and repair by a licensed plumber.

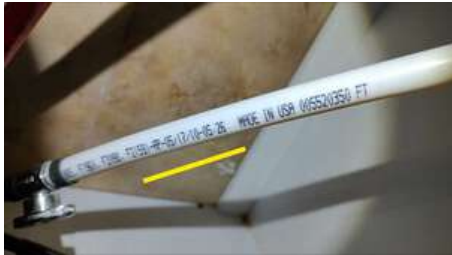
5.3.3 PEX, Insurance Notice

Some insurance companies will not insure properties with Pre-2010PEX water supply lines due to leak statistics. We advise checking with your insurance provider as to their stance on this type of piping.

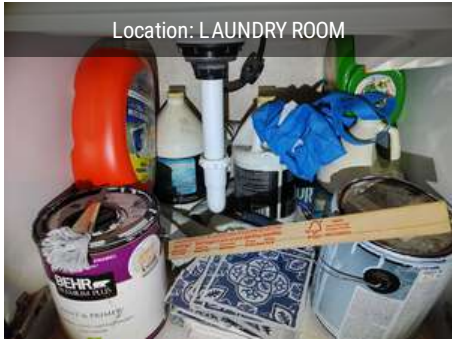
7.4.2 No Shut Off Valves, Sink

No shut off valves were present for the sink at the time of inspection. Recommended a licensed plumber install.

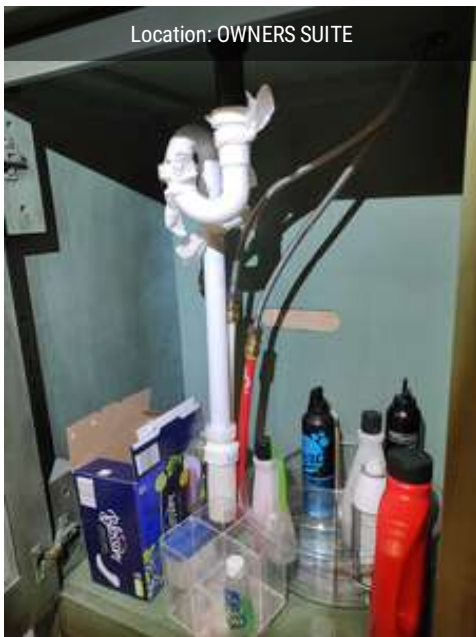
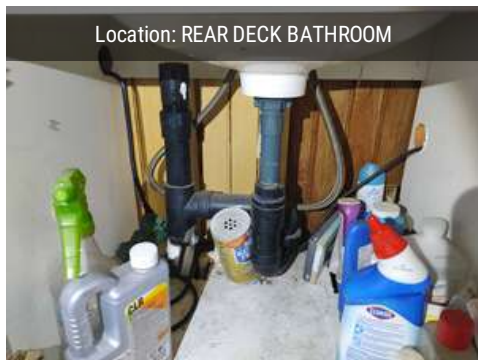
No shut off valves were present for the sink at the time of inspection. Recommended a licensed plumber install.

Note, Images of all plumbing valves are required for the 4-Point Inspection report (if applicable). Many insurance companies require shut-off valves at fixtures in order to obtain insurance.

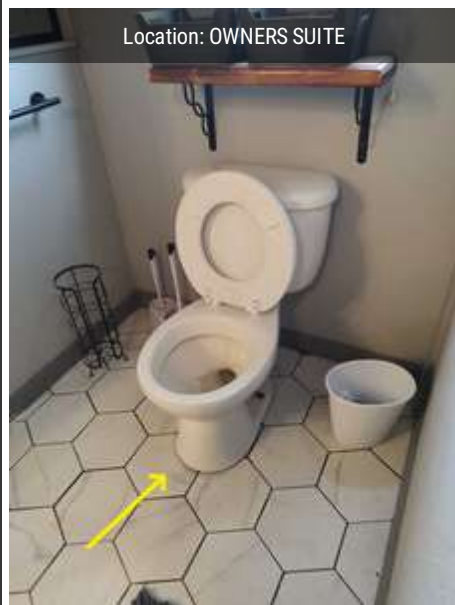
### 8.6.1 Toilet Base Loose

The toilet was loose at the floor. While this condition is somewhat common, it can increase the likelihood of leaks from the base wax seal area. It is suggested that a "Licensed Plumbing Contractor" be contacted for further evaluation and repair.

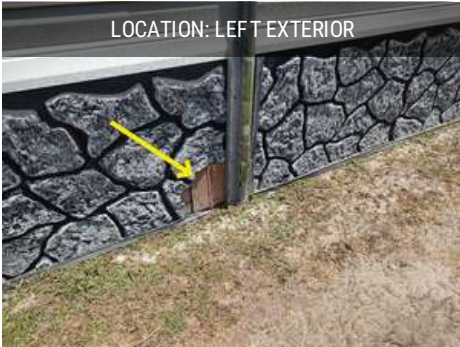
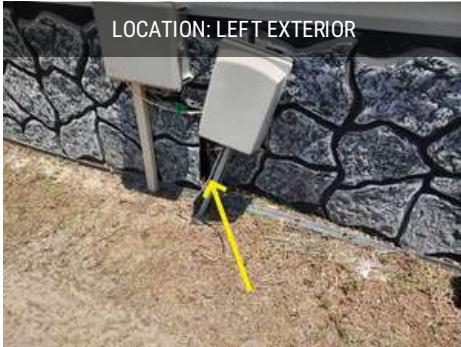
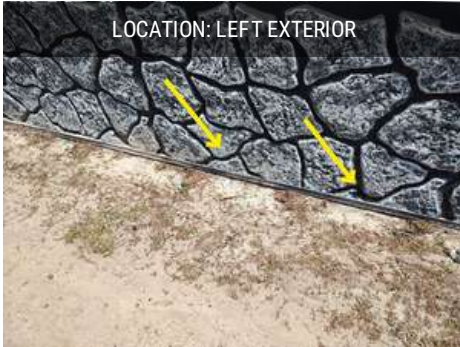
| 1.1.1 Skirting Damaged | Qualified Contractor | Consideration / Recommendation |
| Skirting around the crawl space was damaged at one or more locations. We recommend repairs be made to deter rodents and other pest from entering the crawl space area. | | |

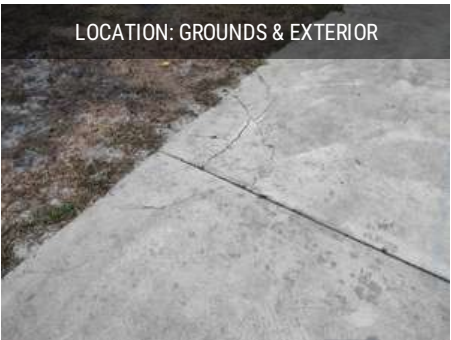
2.4.1 Cracks and settlement - Possible Trip Hazards

Cracks and settlement was observed. Trip hazards may be present or occur overtime. Correction is recommended by a qualified masonry contractor to deter further settlement and cracking.

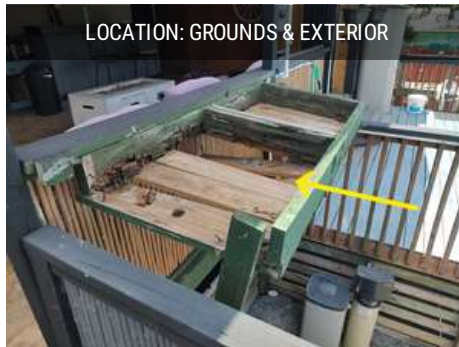
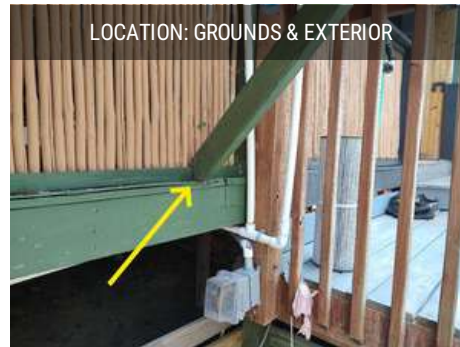
## 2.5.1 Moisture damage / wood rot

Moisture damage and/or wood rot was observed. Replacement of affected materials is recommended. A "Licensed Decking Contractor" can make repairs.

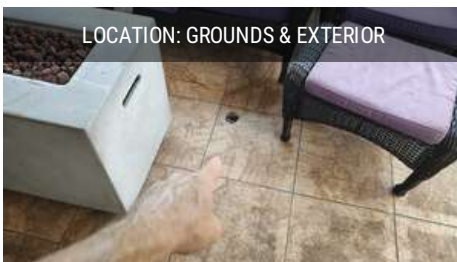
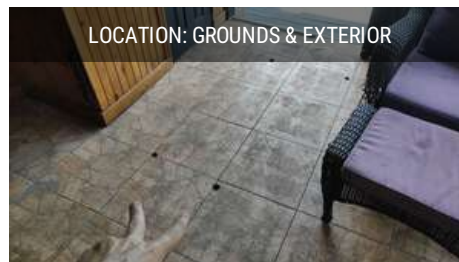
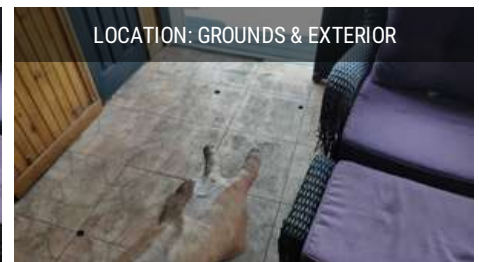
## 2.5.2 Flooring damaged

Flooring was damaged at one or more locations. Recommend repairs as desired.

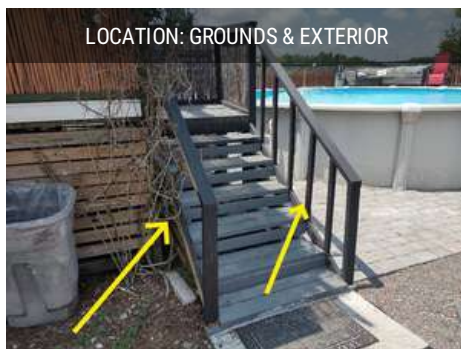
## 2.5.3 Railing balusters (&gt;4")

The openings in the railings are too wide. Openings in railings should not exceed a 4 inches width. We recommend decreasing the opening length between the balusters to reduce the possibility of child injury. Client should consult with a licensed contractor for repairs and/or information on current standards. Other forms of add-on netting protection devices may be available online.

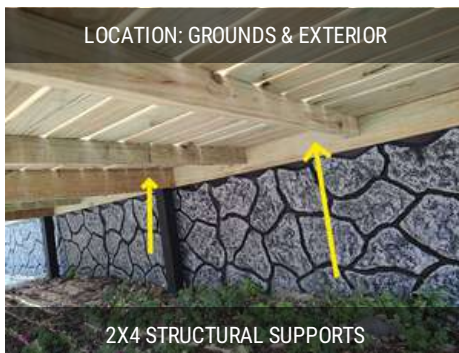
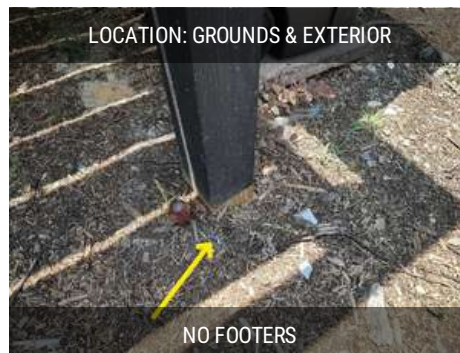
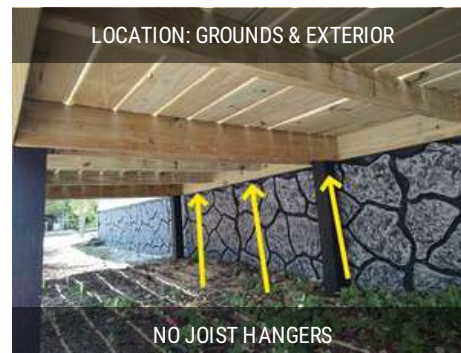
#### 2.5.4 Deck

Limited and/or unprofessional framing support was observed. Today's construction would require larger / additional framing. Client should consider further evaluation by a licensed decking contractor.

The joists were toe nailed into framing. Ideally, joist hangers would offer proper support. Client is advised to consult a licensed deck contractor for further information and repairs.

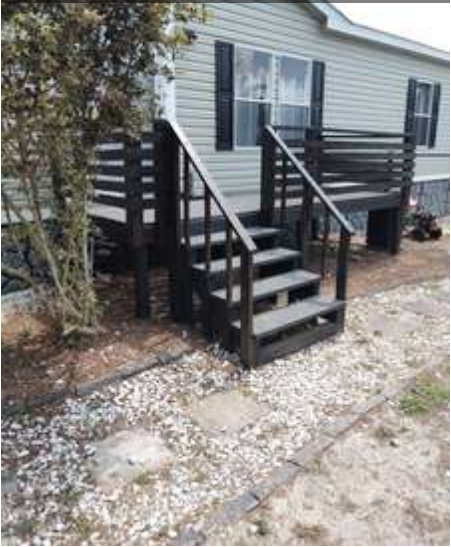
LOCATION: GROUNDS & EXTERIOR

The heights of the various risers at one or more of the staircases are not uniform. This creates a potential trip hazard. Generally, industry standard dictates that "step risers" (the vertical distance from one step up to the next) not exceed 7-3/4" high and all be within 3/8" of the smallest riser. A "Licensed Carpenter or General Contractor" should repair or modify the stairs to ensure they are safe.

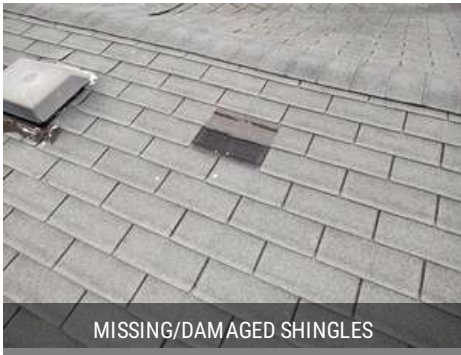
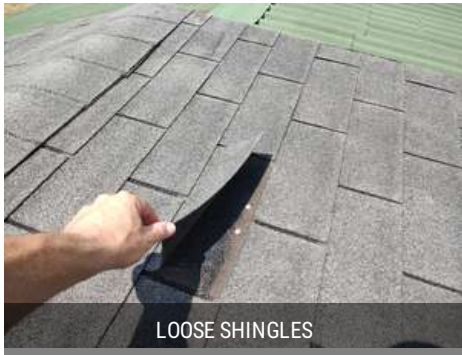
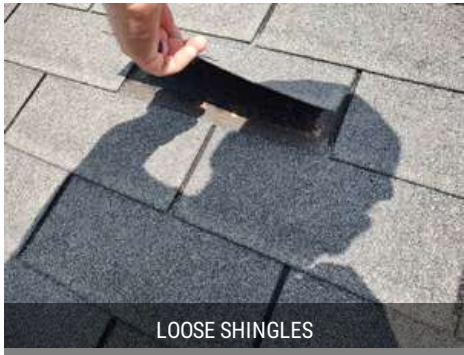
Loose, damaged or missing shingles were observed at one or more locations. The inspector can not offer an opinion as to whether the roof leaks today unless it is moderately raining at the time of inspection. A license roofing contractor should evaluate the roof and repair all damaged areas.

Note, when applicable we are required to note roof concernson the 4 Point Inspectionreport. Insurance companies may request repairs prior to providing insurance.

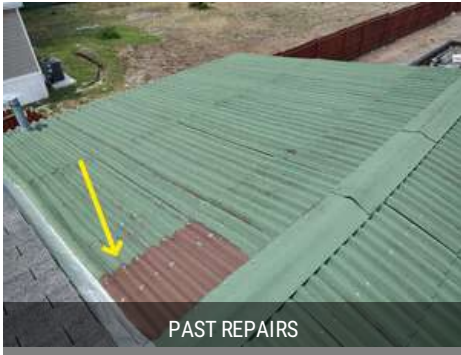
Unprofessional roofing materials were utilized over the back porch area. Areas with this type of material are generally not permitted and replacement is recommended with a qualified roofing product. Holes and damages were present. Recommend farther evaluation by a licensed roofing contractor.

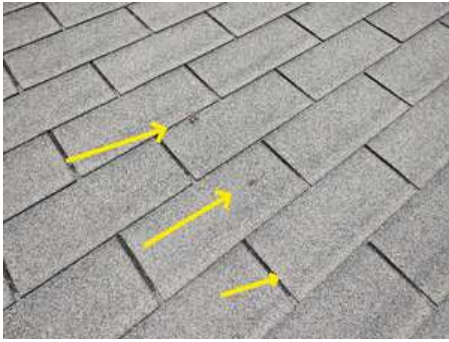
### 3.1.3 Fasteners/Punctures in Roofing Materials

Punctures were noted in roofing materials at one or more locations. We recommend unapproved fasteners be removed and punctures be properly sealed to deter leaks.

Note, conditions noted are based on a random sampling or visible areas. This condition may exist in other locations. The roof should be reviewed by a licensed roofing contractor and repairs should be made as needed.

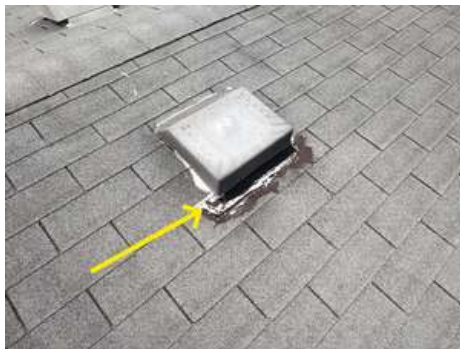
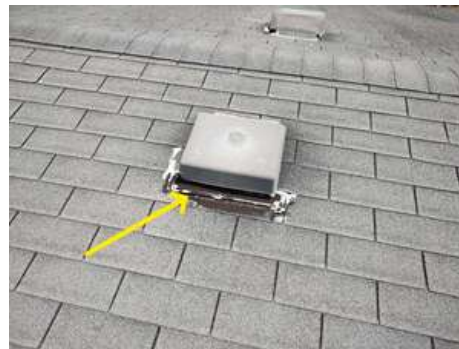
Damaged/deteriorated sealant was noted at numerous locations. Sealantis recommend at all vent pipes, chimney, wall and valley seams, and any other through roof projections (including skylights if present) to reduce the possibility of water penetration.Recommendrepair as needed by a qualified / licensed contractor.

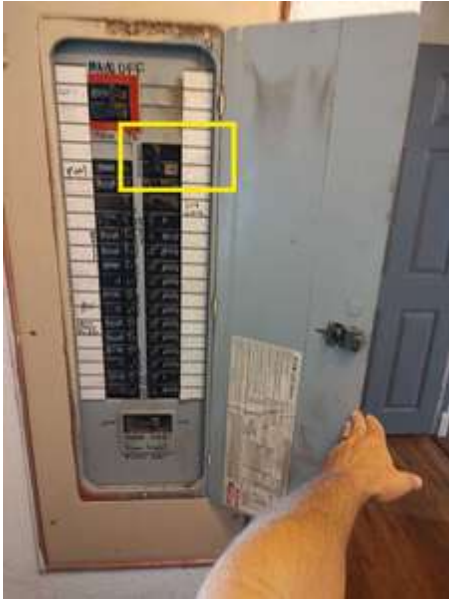
One or more breakers in the panel were in the off position, or not in use at the time of this inspection. We did not activate the breaker, or energize the circuit because doing so could create a hazard. In addition, components connected to these breakers were not tested. The owner may have information as to why the breaker is disconnected. If it is not functional, a licensed electrician should make appropriate repairs.

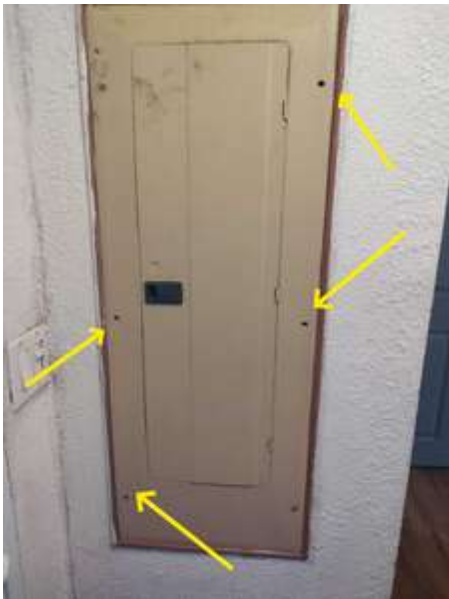
#### 4.4.5 Screws, Missing/Stripped/Damaged

Screws were missing, stripped, or damaged at the electric panel cover at the time of inspection. In many cases, these screws can simply be replaced and are available at most local hardware stores. In cases where the screws require repairs for proper operation we recommend repairs be performed by a licensed electrician.

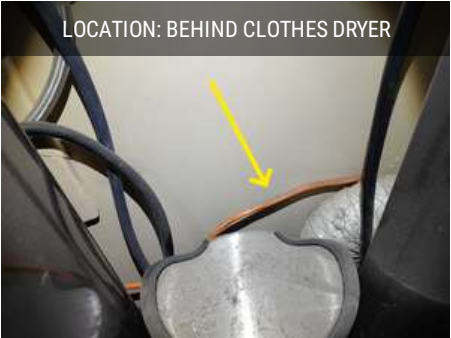
There is exposed wiring at one or more locations. Industry standards indicate that wiring installed below 7 feet be protected from physical damage. The wiring needs to be installed in properly rated conduit to meet electrical safety standards. A qualified electrician should do the work.

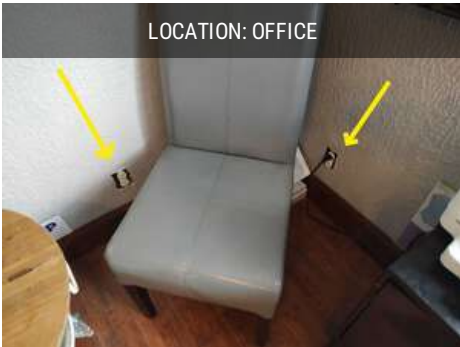
4.6.1 Missing/Damaged Cover

Missing / damaged receptacle or switch covers were observed at one or more locations. Recommend covers be installed for safety.

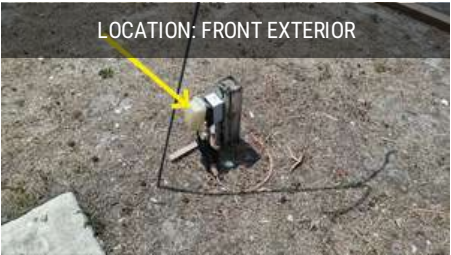
4.6.2 Loose dmgd outlet

Loose / damaged outlet was observed at one or more locations. Recommend further evaluation and repairs by a licensed electrician prior to close.

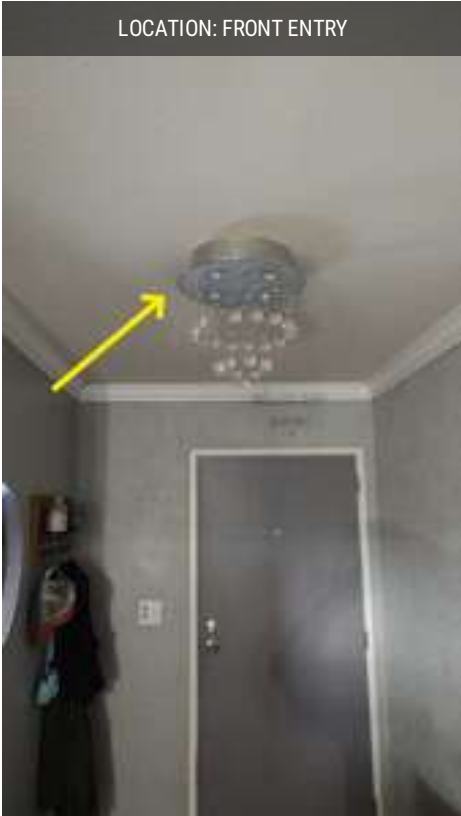
Light(s) were out or inoperative at one or more locations. This may simply be a bulb is out or we were unable to locate the proper switch. Dismantling and testing of light fixtures is not performed as part of this inspection. Note, non-working items noted are based on a random sampling and this condition may exist at other locations. Recommend all lights be operable prior to close.

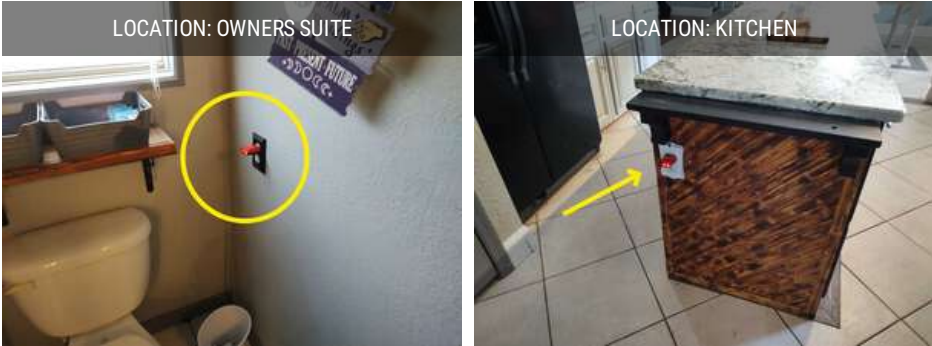
There is no Ground Fault Circuit Interrupted (GFCI) protection for the receptacle(s) at one or more locations. Industry standards would have dictated installation of GFCI protection at the time of construction or when the outlet(s) were updated for the exterior, baths, kitchen, laundry and/ or garage. A licensed electrician should install GFCI protection for all locations necessary to meet current electrical safety standards.

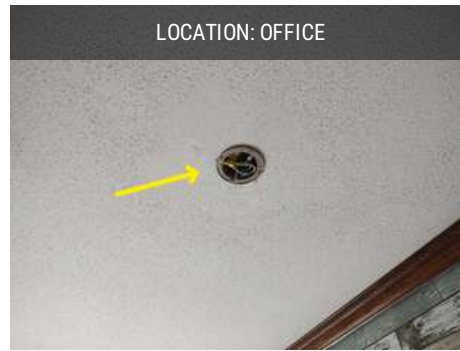
4.9.2 Detector, Missing/Damaged

Detectors were missing or damaged at one or more locations. Replacement is recommended.

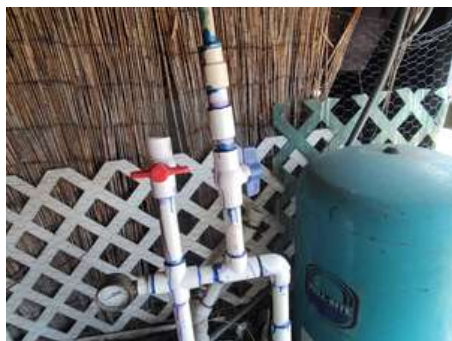
##### 5.1.1 PVC Supply Line, Paint Recommended

PVC pipes are susceptible to UV rays which can cause them to breakdown over time. As part of normal maintenance we recommend exterior PVC water lines be kept painted for best performance. A qualified person can perform the work.

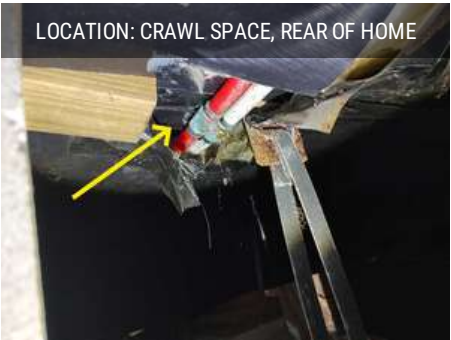
5.3.2 Active Leak

Active leaks were observed at one or more locations. Recommend further evaluation and repair by a licensed plumber.

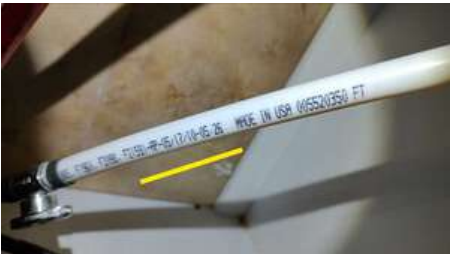
5.3.3 PEX, Insurance Notice

Some insurance companies will not insure properties with Pre-2010PEX water supply lines due to leak statistics. We advise checking with your insurance provider as to their stance on this type of piping.

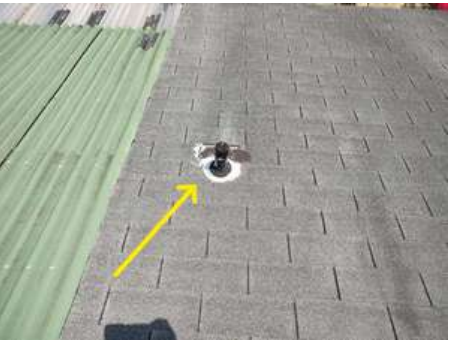
A plumbing vent stack at one or more locations with plugged and did not appear to be in use. We recommend checking with the current owner to determine the reason. Repairs can be made by a license plumbing contractor.

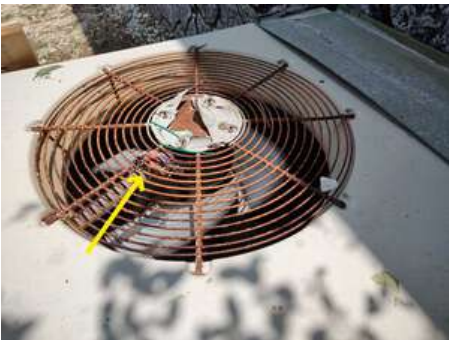
Past repairs were evident at the unit. We recommend requesting all repair documentation from the current owner.

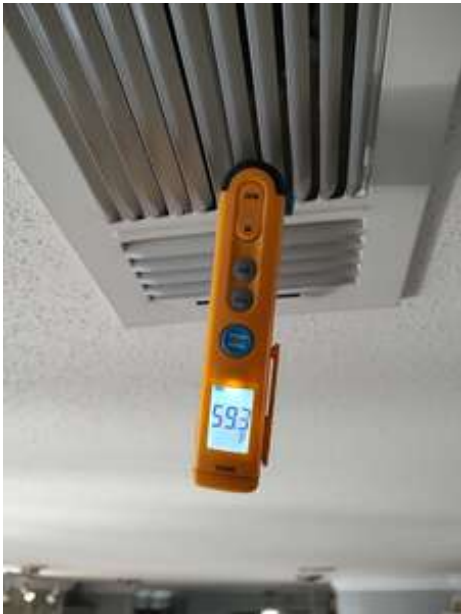
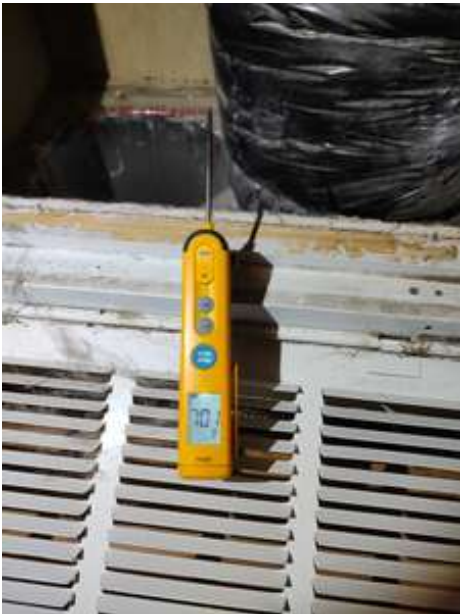
An ambient air test was performed on the cooling system to determine if the difference in temperatures of the supply and return air are between 15 degrees and 22 degrees, which indicates that the unit is cooling within industry standards. The readings indicate that the unit is NOT cooling within standards and may not be working properly. A licensed Heat/Air contractor should further evaluate the system and advise.
