**Robbins Services, Inc.**  
<http://RobbinsHomeInspections.com>  
(727) 475-5252  
[Support@RobbinsHomeInspections.com](mailto:Support@RobbinsHomeInspections.com)

**3021 Barrow St, North Pole, Alaska 99705**  
**Sample Report - Manufactured Home**  
**Prepared for**  
**Bruce Wayne**  
**Jan 05, 2023 at 06:00 AM**

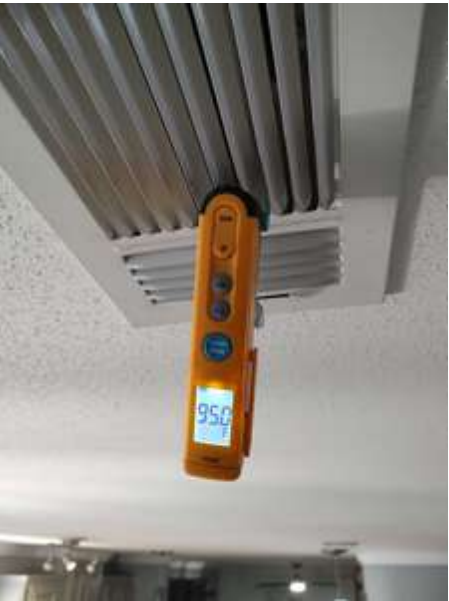
6.3.1 Heat okay

The heat responded when tested and no defects were noted. We suggest periodic review and servicing by a qualified HVAC contractor for continued safe and efficient operation.

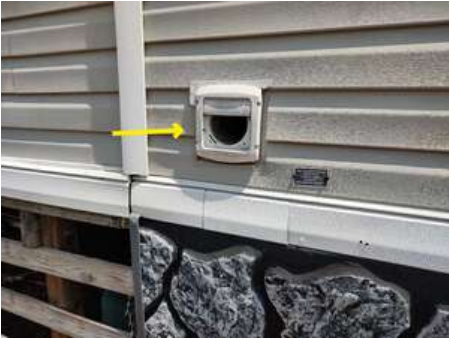
The dryer hood vent is missing/damaged. A qualified technician should repair/replace.

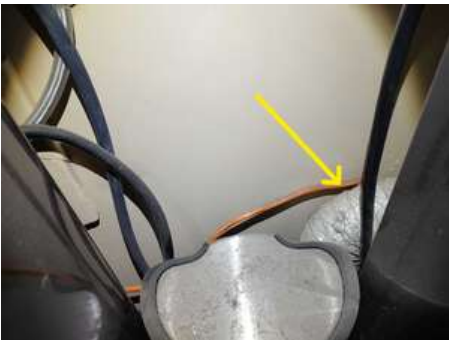
7.3.2 Transition Hose, Foil / Vinyl

We recommend the transition vent duct in place for the dryer be changed to a fire-retardant product approved by the dryer manufacturer. Generally, semi-rigid or rigid metal duct products are acceptable.

Building codes mandate the use of UL 2158A approved transition vent ducts, but conflicts arise regarding foil transition vent ducts. Many appliance manufacturers explicitly discourage their use with warnings like "Do Not Use Metal Foil Vent" in their instructions. It's not uncommon for manufacturers to establish guidelines that surpass code requirements to guarantee safe and proper installations, and disregarding these instructions can lead to warranty voidance and potential safety risks.

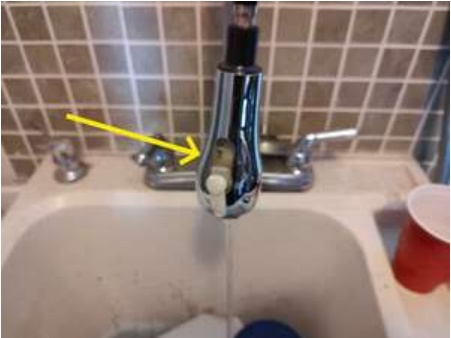
The sink faucet was damaged and did not fully function. Replacement is recommended by a licensed plumbing contractor.

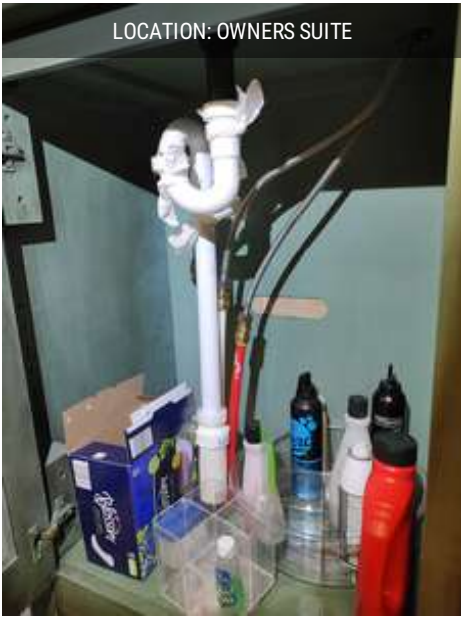
No shut off valves were present for the sink at the time of inspection. Recommended a licensed plumber install.

Note, Images of all plumbing valves are required for the 4-Point Inspection report (if applicable). Many insurance companies require shut-off valves at fixtures in order to obtain insurance.

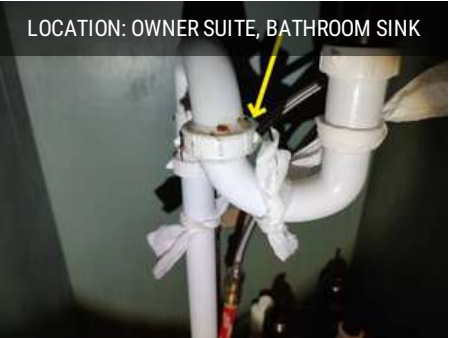
8.2.2 Unprofessional Repairs

Unprofessional plumbing repairs were observed (tape, caulking, etc.). No active leaks were noted. A licensed plumber can make repairs.

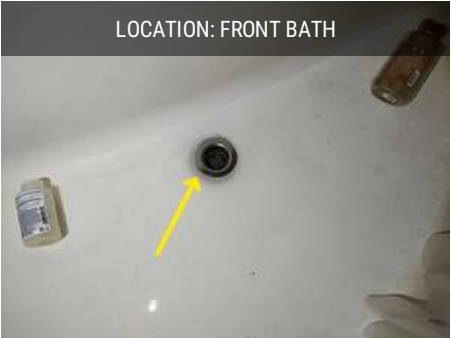
The drain stopper was missing, damaged or not operational. A qualified plumber should make repairs.

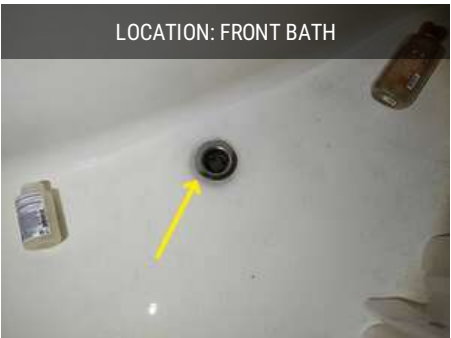
8.3.2 Slow Drain, Tub/Shower

The bathtub/shower drained slowly. This may require simple cleaning or could be an indication of a plumbing problem.

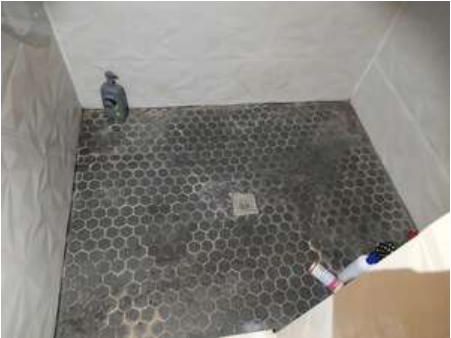
8.5.1 Shower Pan, Not Tested

A definitive test for leaks in a tile shower base requires 2 - 3 inches of water left standing for up to 48 hours. There were no signs of leaks, but this definitive test is beyond the scope of this inspection and was not performed.

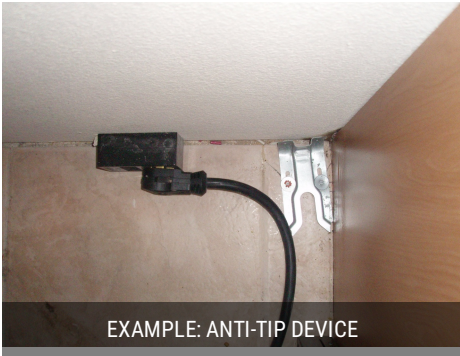
Our inspection does not include moving appliances. However, we strongly recommend verifying that the anti-tip safety device, provided by the range manufacturer and required in installation specifications, is correctly in place. Typically, this device is mounted to the floor or wall behind the unit and placed to catch a leveling bolt to prevent the unit from tipping forward. This safety measure is crucial to prevent injury or fatalities, especially involving children.

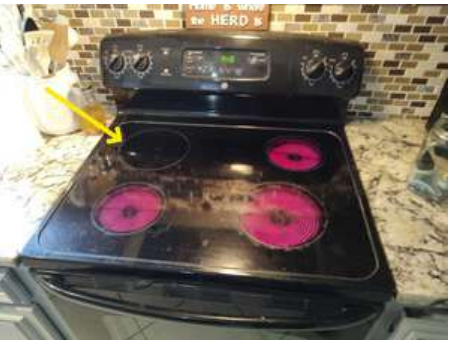
One or more burners on the cook top did not operate. Repair is needed.

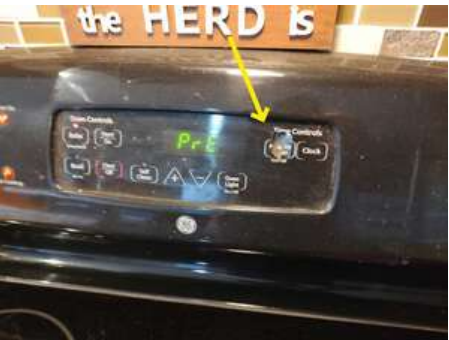
9.4.3 Control Knob, Missing/Damaged

One or more control knobs and or displays were missing or damaged. Recommend repair.

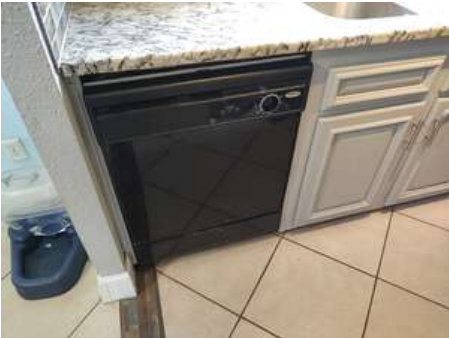
The unit was examined. It appears to be functioning normally. However, it appears to be near the end of its useful life. Client may consider replacement with a more current model.

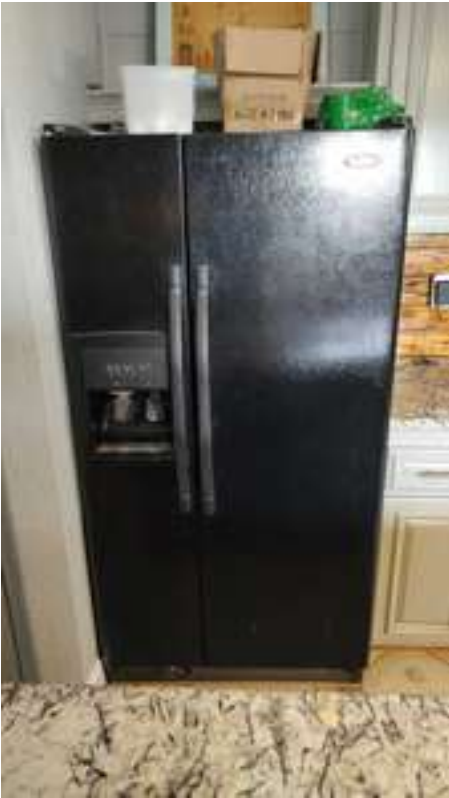
9.8.1 EOL

The unit was examined. It appears to be functioning normally. However, it appears to be near the end of its useful life. Client may consider replacement with a more current model.

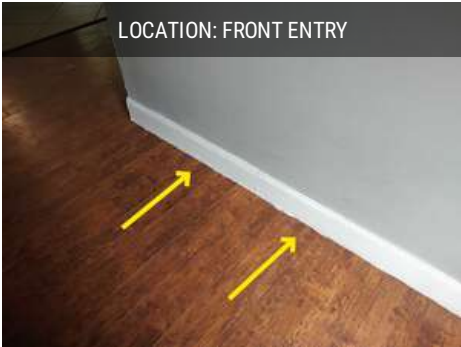
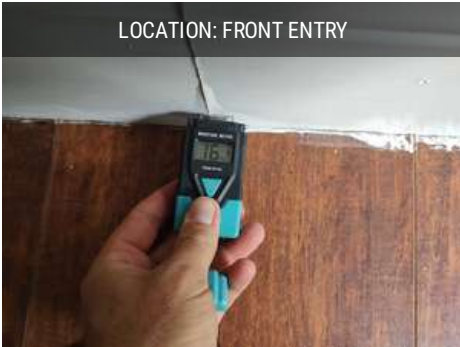
10.1.1 Moisture Stains - Not Active

Moisture stains and/or damage was observed at one or more locations. A moisture meter indicated the area(s) are currently within normal moisture levels and considered dry. However, if the leak source has not been identified and properly repaired, the leak may return. Contact the current owner to verify this condition has been addressed -or- contact a licensed contractor for repairs.

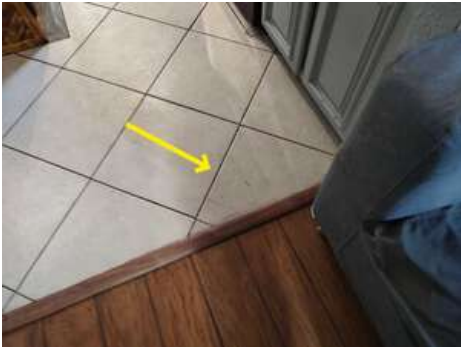
10.3.1 Tiles, Missing/Damaged

Missing or damaged floor tiles were observed at one or more locations. Recommend repair as needed.

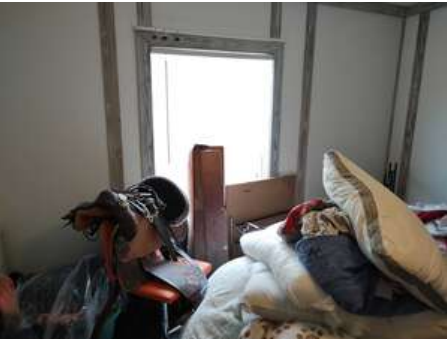
Furnishings, personal item storage, and window treatments prevented a full visual inspection of all windows and window areas. Conditions can change between the time of inspection and closing. Please do a careful check of all windows during your final walk through.

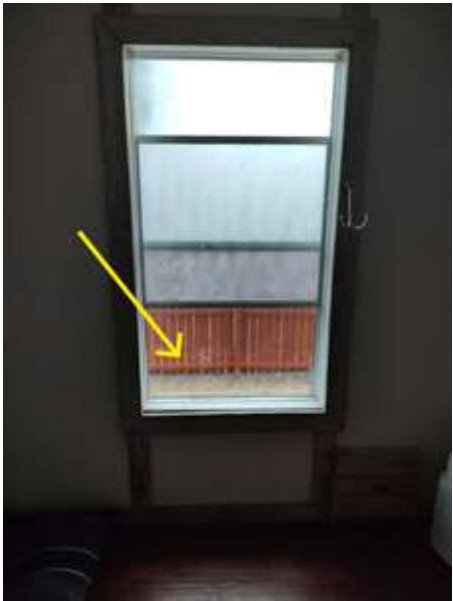
One or more screens are missing or damaged. A "Qualified Window & Door Contractor" can be contacted for further evaluation and repairs. It is suggested you contact the "Current Owner" to verify if missing items are in storage.

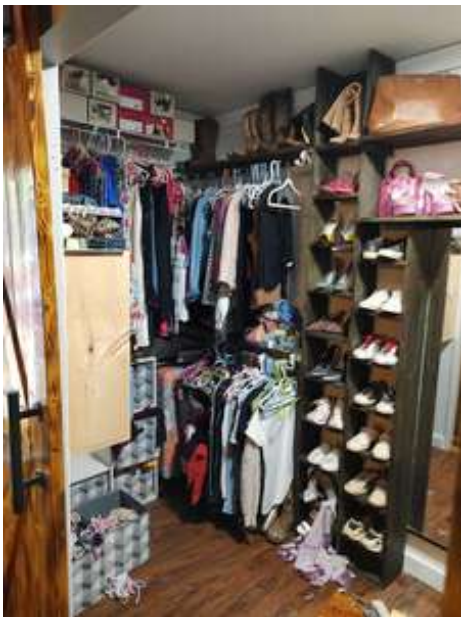
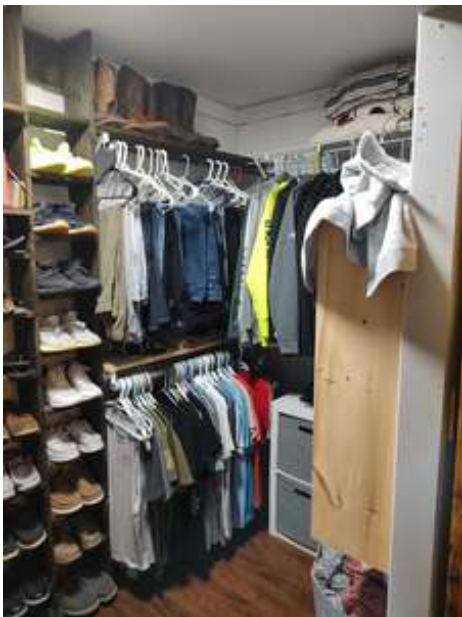
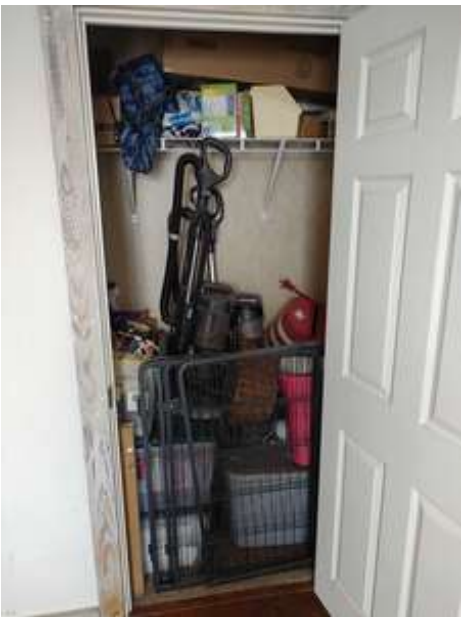
Personal belongings within and/or in front of closets prevented full access for inspection. We suggest further inspection of these areas during your final walk through.
