**Robbins Services**  
Home Inspections

**3021 Barrow St, North Pole, Alaska 99705**  
**Sample Report - New Construction**  
**Prepared for**  
**Bruce Wayne**  
**Jan 05, 2023 at 06:00 AM**

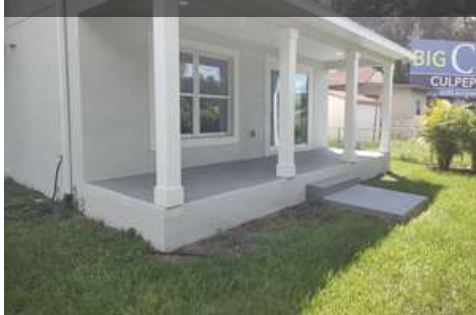
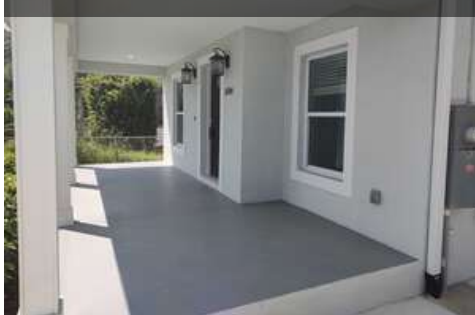
Location: GROUNDS &amp; EXTERIOR

No railings were present. For increased safety, client should consider installation of a railing. Client should consult with a qualified contractor for information on current standards.

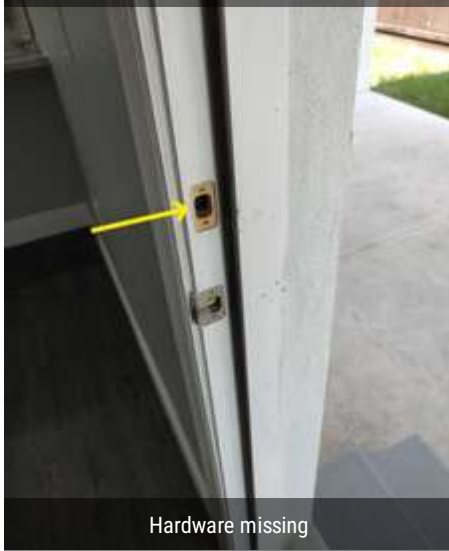
## 2.9 Door Conditions

The latching hardware on one or more doors did not function properly. Although replacement is sometimes necessary, in most cases this can be repaired with minor adjustments. A qualified person can perform the work.

Hardware missing

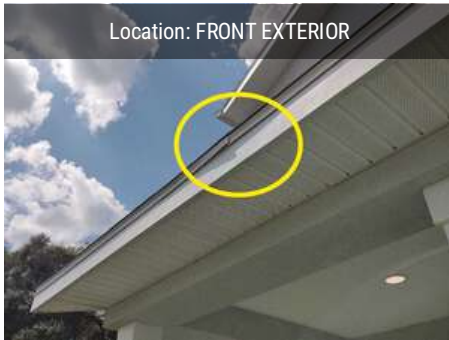
### 3.3 Flashing Conditions

The drip edge is separated at one or more locations around the home. We recommend properly securing and connecting the drip edge at all locations to deter moisture intrusion.

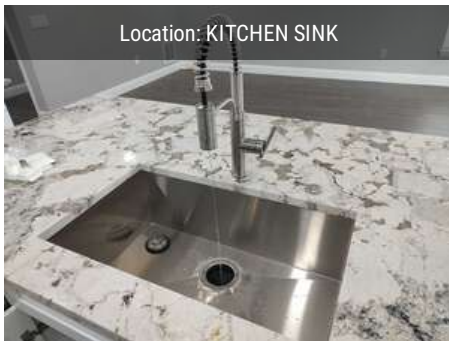
#### 6.3.2 Low Pressure - 1+ Locations

There was visible evidence of low water pressure at one or more locations. A licensed plumber can evaluate and repair as needed.

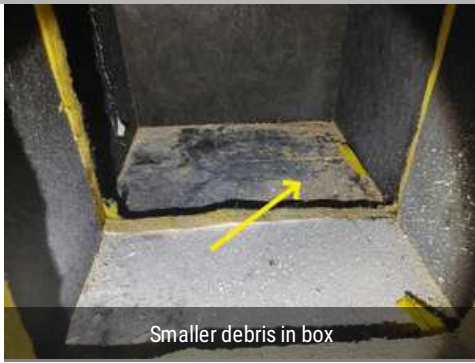
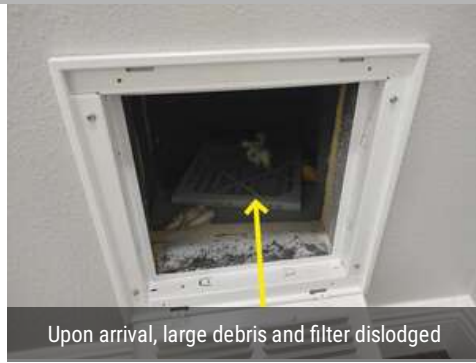
#### 7.1.1 Return Box, filter dislodged and debris present

The breeze are present in the return box in the living room. In addition the filter was dislodged upon arrival. We reinstalled the filter and it is extremely noisy. It is recommended that all debris be cleared from the return box to keep these items from being sucked into the coil and becoming lodged.

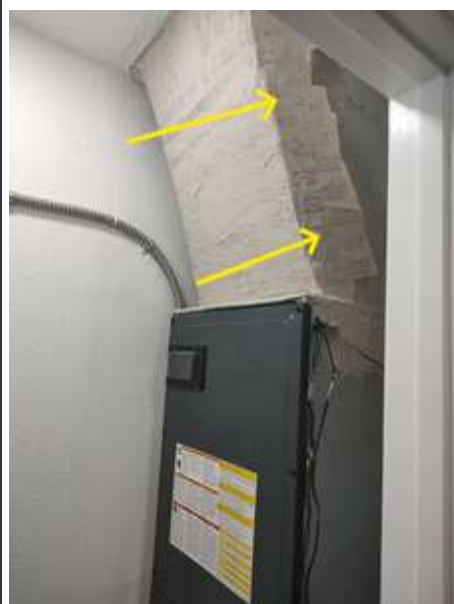
##### 7.5.1 Ductwork - Leak

One or more leaks are evident in the ductwork in allowing conditioned air to escape. It is recommended a qualified HVAC contractor make repairs as needed.

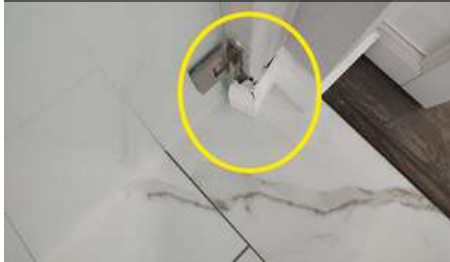
#### 13.1.1 Damage - Interior Walls

The interior walls were damaged at one or more locations. Recommend further evaluation and repair as needed by a qualified / licensed contractor.

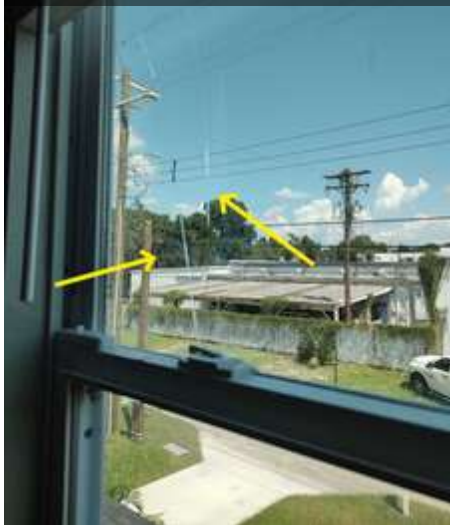
#### 13.4.1 Broken/Cracked Panes

Broken glass pane(s) were observed at one or more locations. Recommend repair as needed by a licensed window and door specialist.

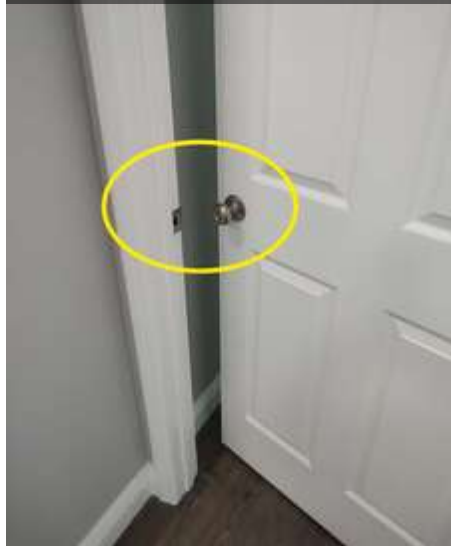
#### 13.5.1 Door - Latching Hardware Problem

The latching hardware on one or more doors did not function properly. Although replacement is sometimes necessary, in most cases this can be repaired with minor adjustments. A qualified person can perform the work.

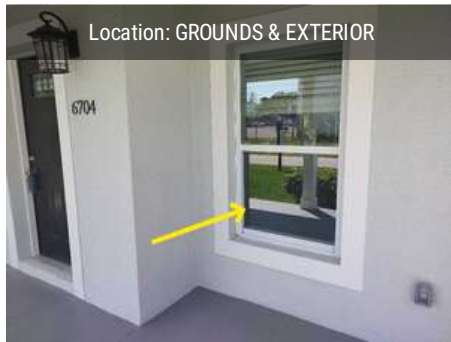
## 2.8.1 Screens - Damaged / Missing

One or more screens are missing or damaged. We suggest contacting the "Current Owner" to verify if missing items are in storage.

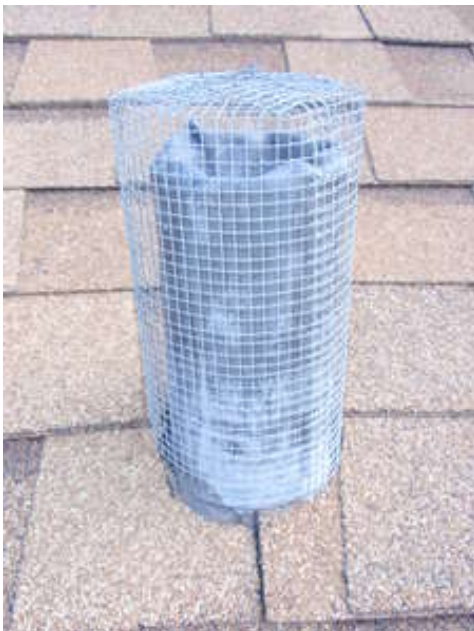
Rodents such as squirrels and rats like to chew on lead flashing materials. If not currently installed, we recommend adding rodent protection to plumbing vents to deter future damage.

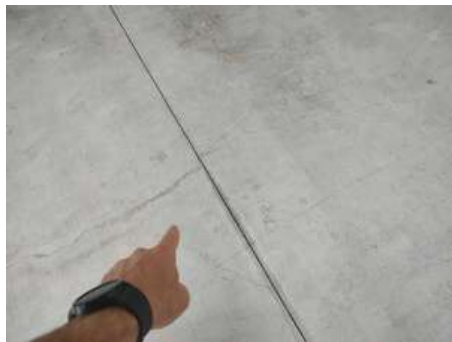
#### 4.1.1 Typical shrinkage cracks

Typical shrinkage cracks were observed in the floor slab with no noticeable vertical displacement. The cracks appear to be typical for this type of construction. These cracks are very common and generally take place as the concrete cures. Sealing of these cracks is recommended to deter moisture penetration and further deterioration. A qualified contractor can perform the work.

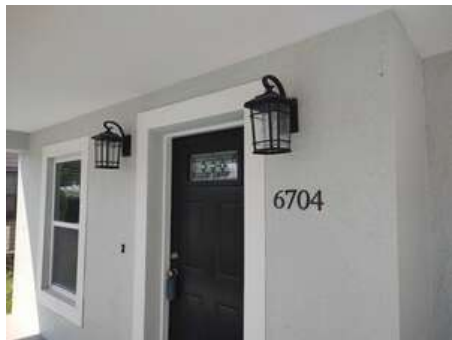
##### 5.8.1 Light inoperative - timer/sensor, bulb out, no switch

Light(s) were out or inoperative at one or more locations. This may simply indicate the fixture is on a timer/sensor, the bulb may be out or we were unable to locate the proper switch. Dismantling and testing of light fixtures is not performed as part of this inspection.

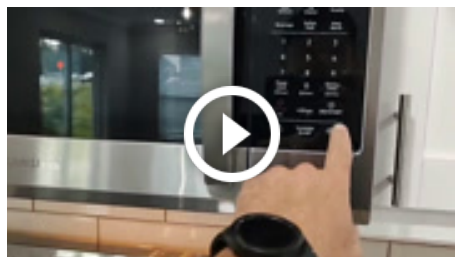
### 12.5.1 Cooking fan reduces speed during microwave operation

The cooking fan reduces its speed when the microwave is operating. This may be a defect in the manufacturing of the microwave. We recommend checking the manual or with the manufacturer to determine if repairs or replacement are needed.

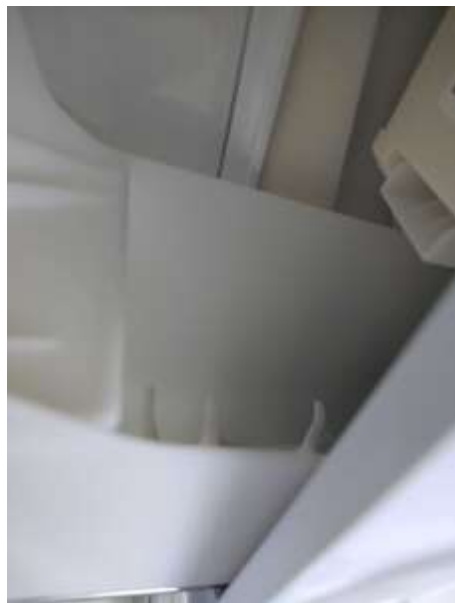
### 12.7.1 No Ice Fridge

No ice was present in the ice machine at the time of inspection, therefore the ice maker could not be tested. We recommend ensuring the ice maker is turned on and the water supply for the refrigerator is available and properly installed.

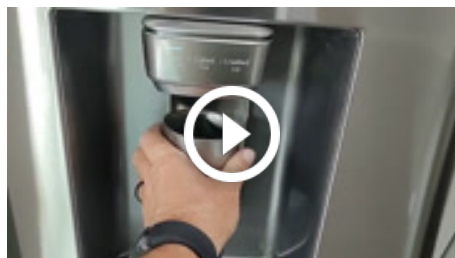
### 12.7.2 No Water Flow, Dispenser

No water flow was evident at the dispenser. This may indicate that the water supply is not connected, has been turned off, a filter change is needed and/or the unit is in need of repairs. Due to safety concerns and/or risk of property damage, operation of valves is not performed. Recommend having the owner demonstrate operation or a licensed plumber or appliance technician evaluate and repair as needed.

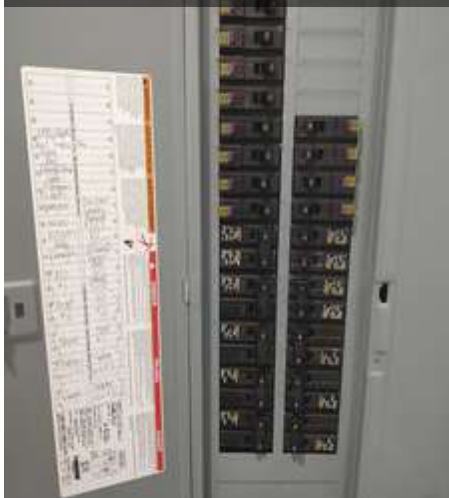
### 5.9.1 GFCI - Reset Locations (Outlets/Breakers)

Reset for all GFCI circuits throughout the home

When tested, the GFCI devices tripped and shut off power, as designed. Many homes have multiple reset locations to restore power after a fault occurs. To restore power to GFCI protected receptacles or devices after a fault, reset the button on the GFCI outlet or breaker. As a convenience, the GFCI main reset locations identified during our inspection are detailed within the comment images.

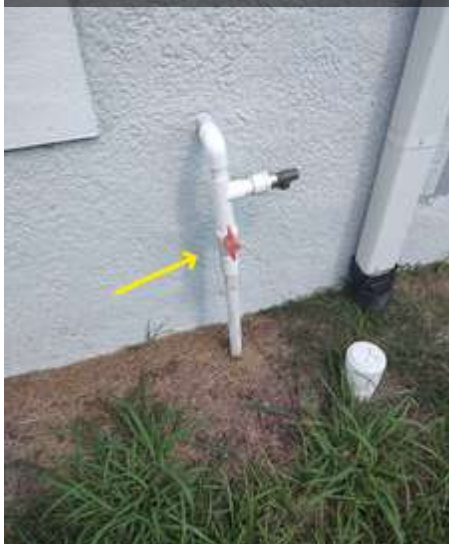
### 6.1.1 PVC Supply Line, Paint Recommended

PVC pipes are susceptible to UV rays which can cause them to breakdown over time. As part of normal maintenance we recommend exterior PVC water lines be kept painted for best performance. A qualified person can perform the work.

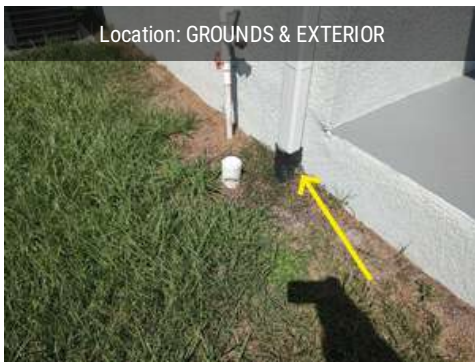
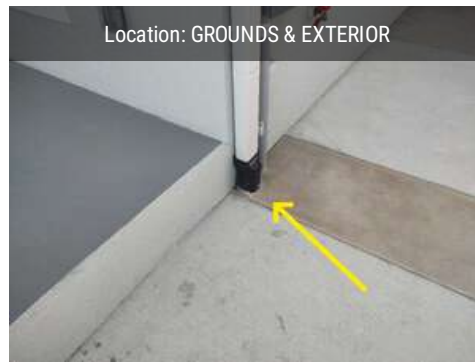
## 2.1.2 Subsurface Drains - Not Inspected

Subsurface drains were observed, but evaluation of the condition, performance, and termination points of underground pipes are beyond the scope of this inspection. These systems generally require regular maintenance, including periodic flushing, for optimal performance.

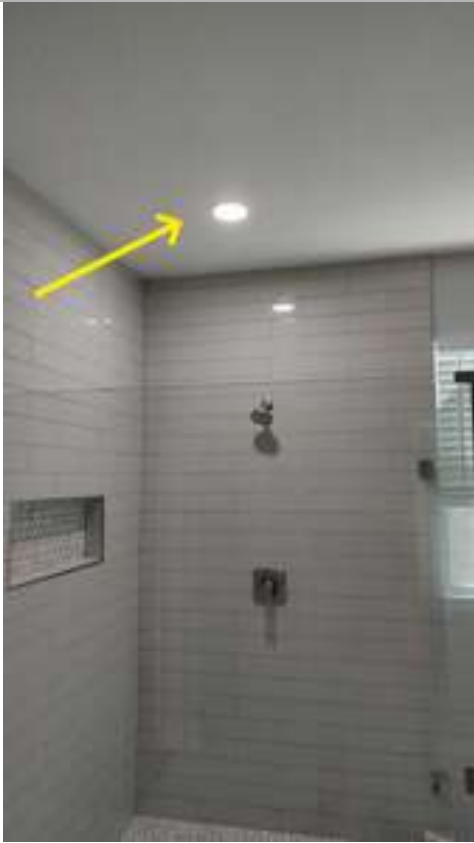
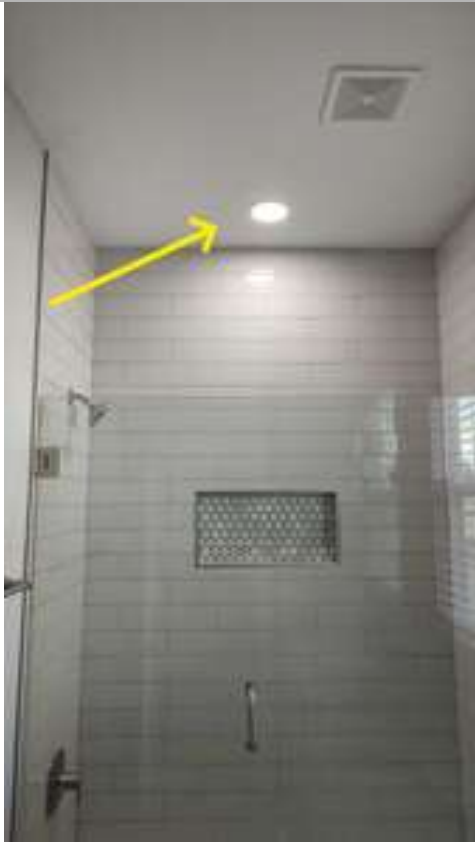
A light was present in the shower area. It is beyond the scope of this inspection to determine whether light fixtures are water or moisture proof. Client is advised to contact a licensed electrician for further information.

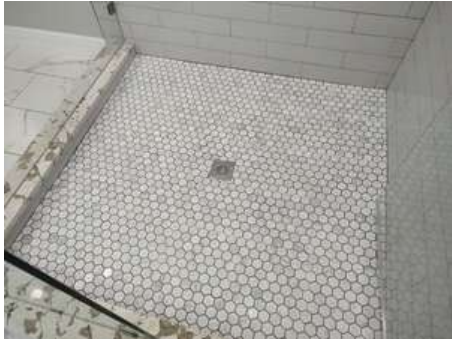
11.6.1 Shower Pan, Not Tested

A definitive test for leaks in a tile shower base requires 2 - 3 inches of water left standing for up to 48 hours. There were no signs of leaks, but this definitive test is beyond the scope of this inspection and was not performed.

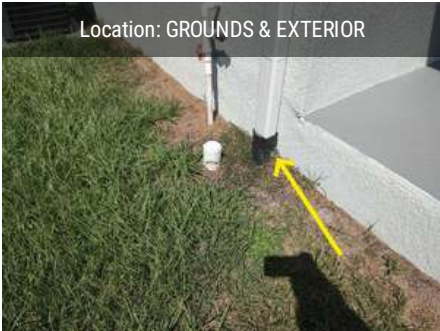
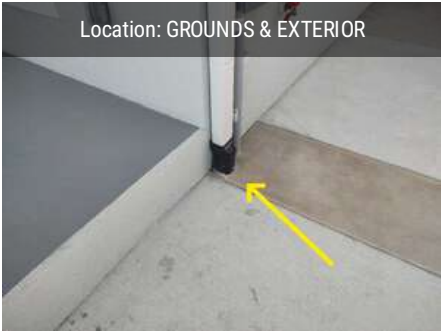
## Subsurface Drains - Not Inspected

Subsurface drains were observed, but evaluation of the condition, performance, and termination points of underground pipes are beyond the scope of this inspection. These systems generally require regular maintenance, including periodic flushing, for optimal performance.

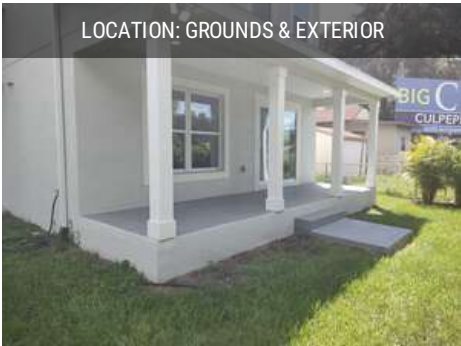
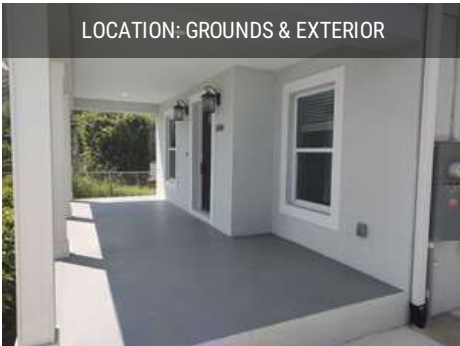
No railings were present. For increased safety, client should consider installation of a railing. Client should consult with a qualified contractor for information on current standards.

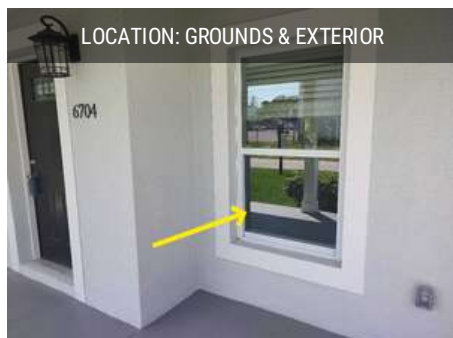
One or more screens are missing or damaged. We suggest contacting the "Current Owner" to verify if missing items are in storage.

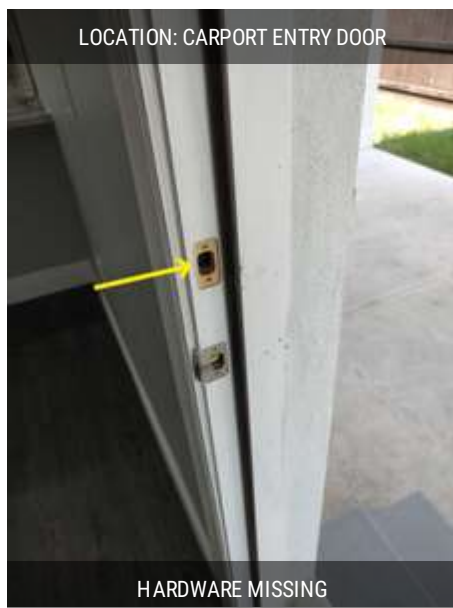
The latching hardware on one or more doors did not function properly. Although replacement is sometimes necessary, in most cases this can be repaired with minor adjustments. A qualified person can perform the work.

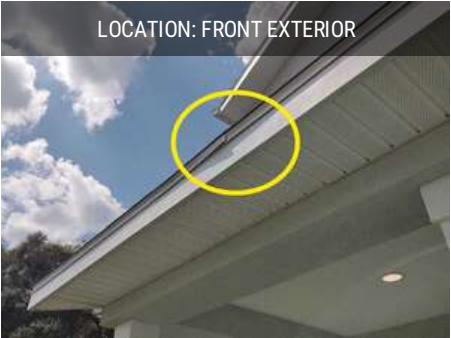
The drip edge is separated at one or more locations around the home. We recommend properly securing and connecting the drip edge at all locations to deter moisture intrusion.

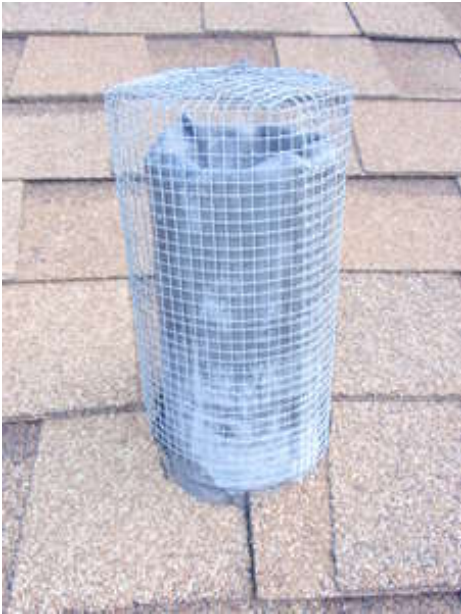
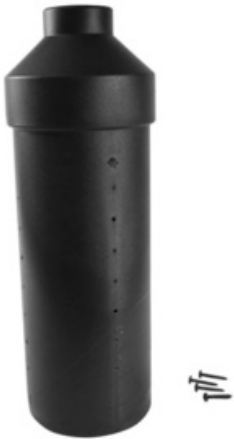
Rodents such as squirrels and rats like to chew on lead flashing materials. If not currently installed, we recommend adding rodent protection to plumbing vents to deter future damage.

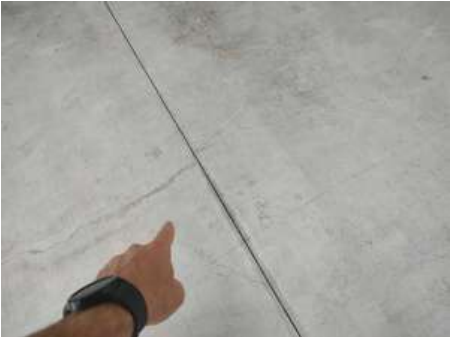
Typical shrinkage cracks were observed in the floor slab with no noticeable vertical displacement. The cracks appear to be typical for this type of construction. These cracks are very common and generally take place as the concrete cures. Sealing of these cracks is recommended to deter moisture penetration and further deterioration. A qualified contractor can perform the work.

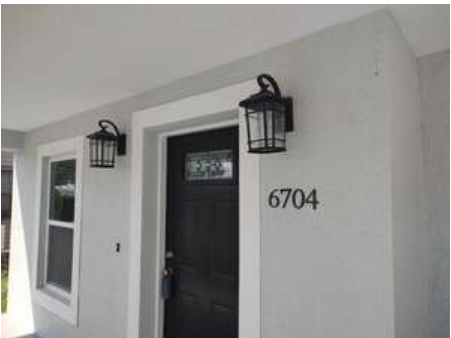
Light(s) were out or inoperative at one or more locations. This may simply indicate the fixture is on a timer/sensor, the bulb may be out or we were unable to locate the proper switch. Dismantling and testing of light fixtures is not performed as part of this inspection.

Note, non-working items noted are based on a random sampling and this condition may exist at other locations. Recommend all lights be operable prior to close.

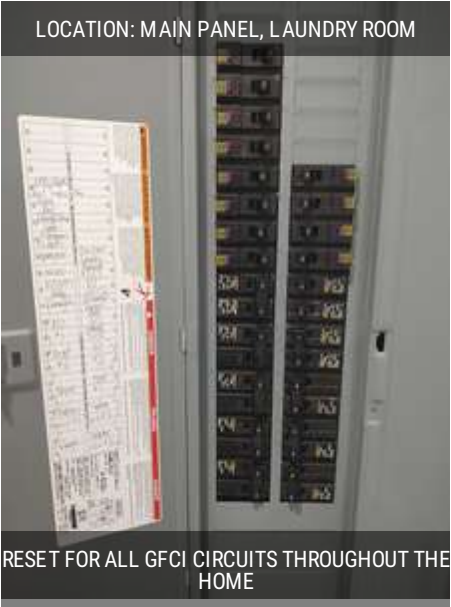
When tested, the GFCI devices tripped and shut off power, as designed. Many homes have multiple reset locations to restore power after a fault occurs. To restore power to GFCI protected receptacles or devices after a fault, reset the button on the GFCI outlet or breaker. As a convenience, the GFCI main reset locations identified during our inspection are detailed within the comment images.

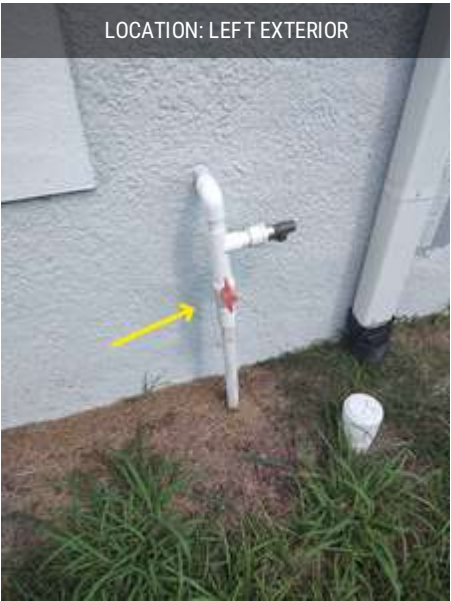
PVC pipes are susceptible to UV rays which can cause them to breakdown over time. As part of normal maintenance we recommend exterior PVC water lines be kept painted for best performance. A qualified person can perform the work.

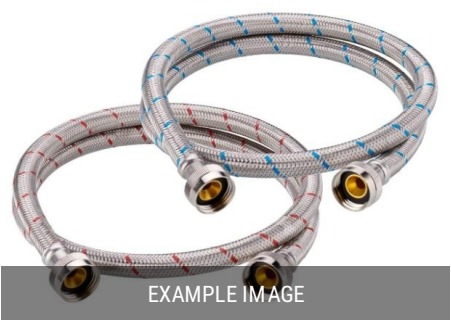
6.3.1 Anti-Burst Hoses, Recommendation (If Not Installed)

If not currently installed, as a preventive measure we recommend installing anti-burst water supply hoses at interior plumbing connections, such as clothes washers, toilets, sinks, and refrigerators. These hoses reduce the risk of excessive water damage due to burst connections.

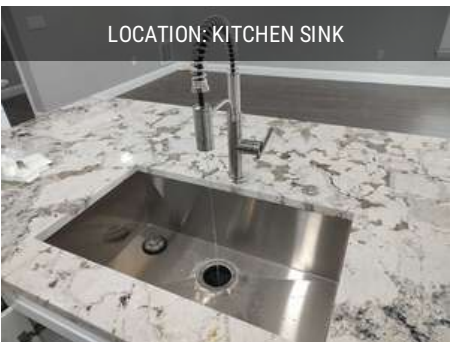
6.3.2 Low Pressure - 1+ Locations

There was visible evidence of low water pressure at one or more locations. A licensed plumber can evaluate and repair as needed.

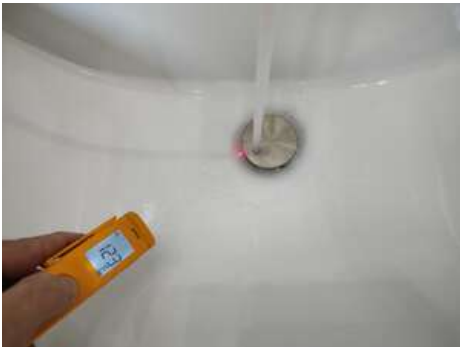
WATER TEMPERATURE CHART

| Water Scalding Chart | |
|---|---|
| Temperature | Time to Produce Serious Burn |
| 160 degrees (very hot) | About 1/2 second |

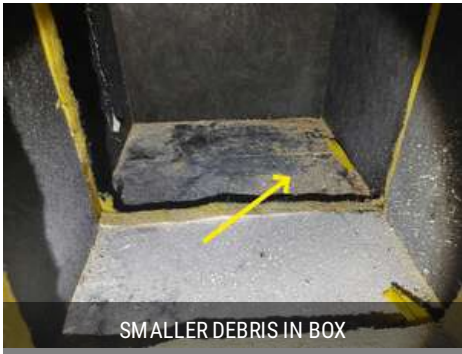
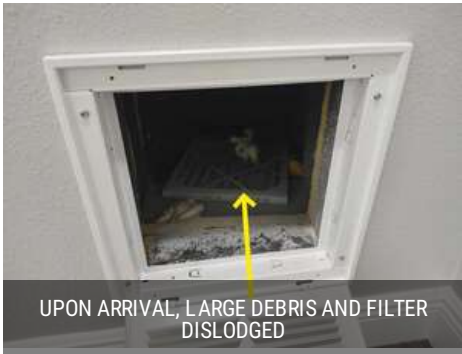
The breeze are present in the return box in the living room. In addition the filter was dislodged upon arrival. We reinstalled the filter and it is extremely noisy. It is recommended that all debris be cleared from the return box to keep these items from being sucked into the coil and becoming lodged.

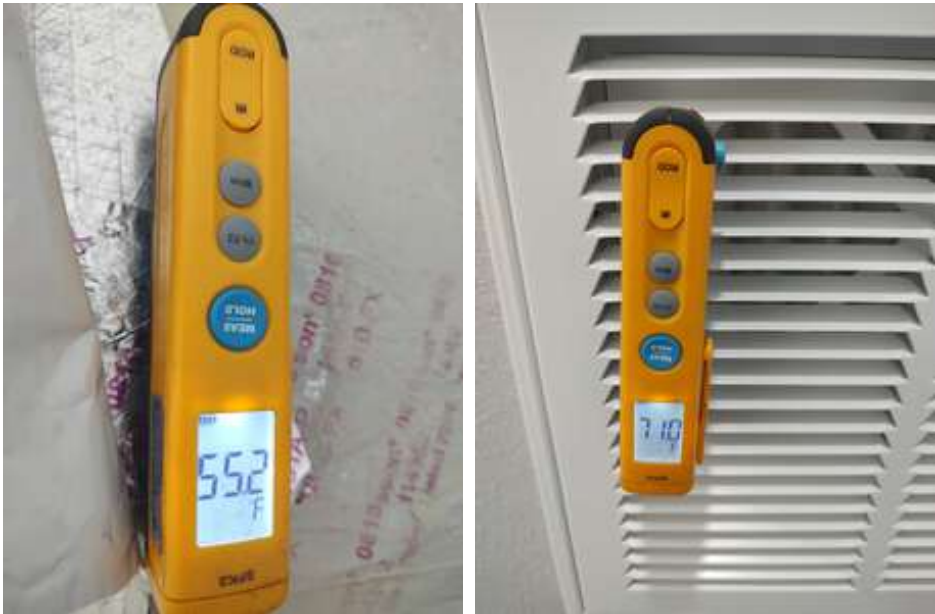
7.2.1 \*Proper Cooling Differential

An ambient air test was performed on the cooling system to determine if the difference in temperatures of the supply and return air are between 15 degrees and 22 degrees, which indicates that the unit is cooling within industry standards. The readings indicatethat the unit is cooling within industry standards.

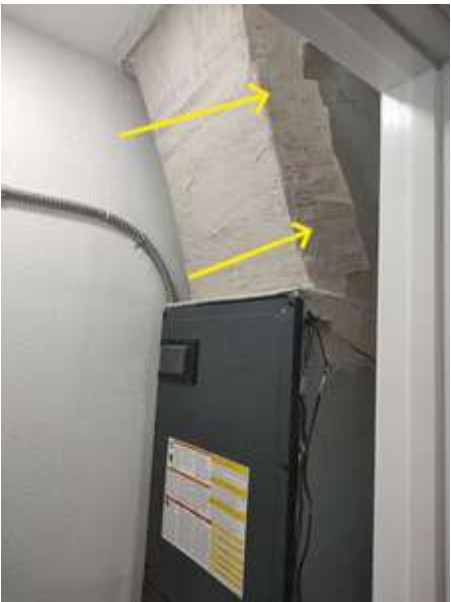
One or more leaks are evident in the ductwork in allowing conditioned air to escape. It is recommended a qualified HVAC contractor make repairs as needed.

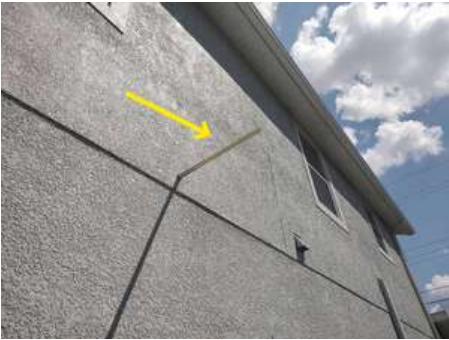
The secondary drain line does not appear to be aesthetically cut and trimmed properly. An end fitting that deters cust intrusion is also recommended.

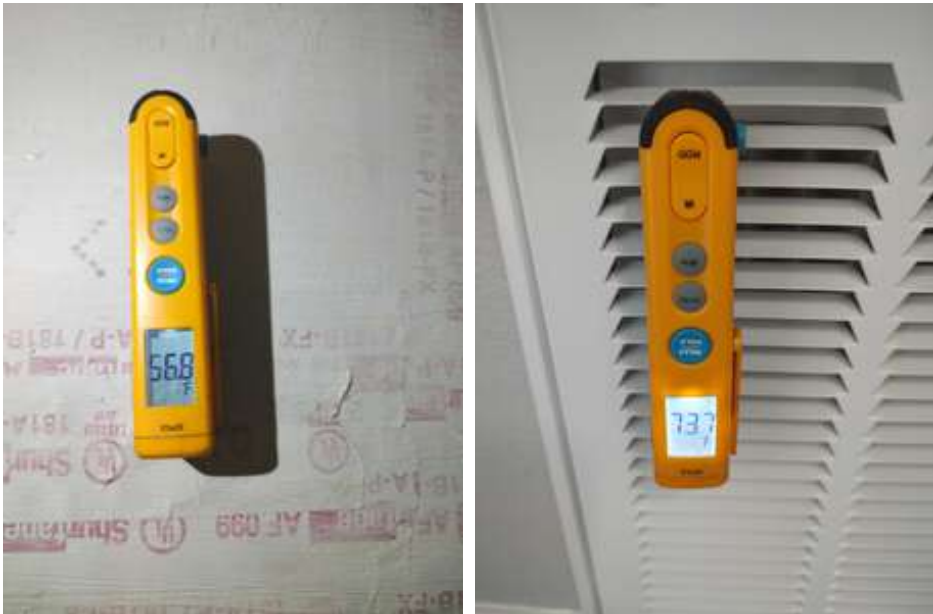
8.2.1 \*Proper Cooling Differential

An ambient air test was performed on the cooling system to determine if the difference in temperatures of the supply and return air are between 15 degrees and 22 degrees, which indicates that the unit is cooling within industry standards. The readings indicatethat the unit is cooling within industry standards.

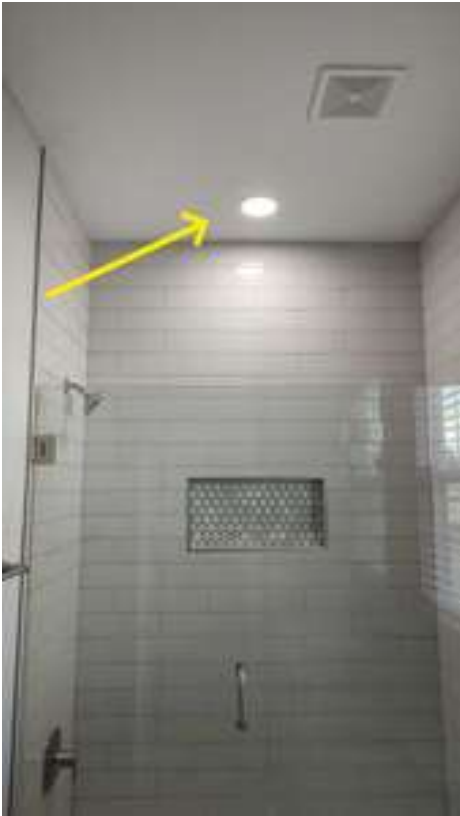
A light was present in the shower area. It is beyond the scope of this inspection to determine whether light fixtures are water or moisture proof. Client is advised to contact a licensed electrician for further information.

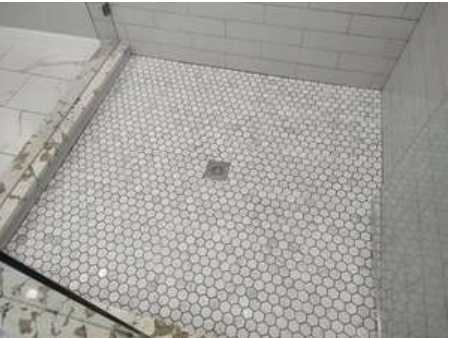
A definitive test for leaks in a tile shower base requires 2 - 3 inches of water left standing for up to 48 hours. There were no signs of leaks, but this definitive test is beyond the scope of this inspection and was not performed.

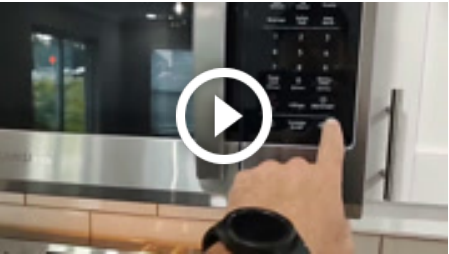
12.5 Built-In Microwave Conditions

The cooking fan reduces its speed when the microwave is operating. This may be a defect in the manufacturing of the microwave. We recommend checking the manual or with the manufacturer to determine if repairs are replacement are needed.

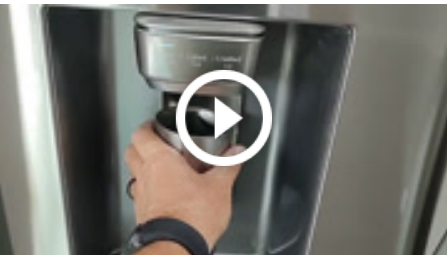
12.7.2 No Water Flow, Dispenser

No water flow was evident at the dispenser. This may indicate that the water supply is not connected, has been turned off, a filter change is needed and/or the unit is in need of repairs. Due to safety concerns and/or risk of property damage, operation of valves is not performed. Recommend having the owner demonstrate operation or a licensed plumber or appliance technician evaluate and repair as needed.

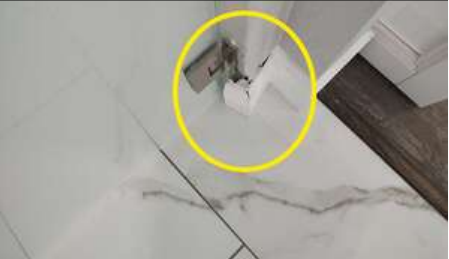
13.1.1 Damage - Interior Walls

LOCATION: WATER CLOSET DOOR, OWNERS SUITE  
BATHROOM

The interior walls were damaged at one or more locations. Recommend further evaluation and repair as needed by a qualified / licensed contractor.

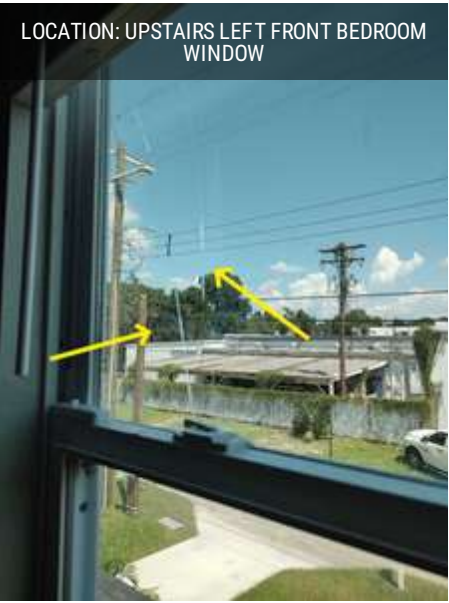
Broken glass pane(s) were observed at one or more locations. Recommend repair as needed by a licensed window and door specialist.

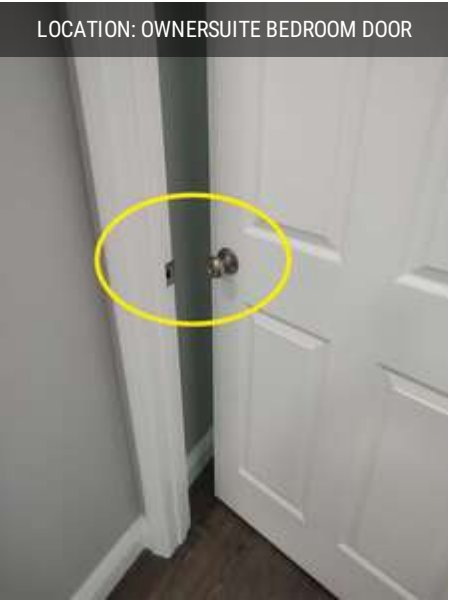
The latching hardware on one or more doors did not function properly. Although replacement is sometimes necessary, in most cases this can be repaired with minor adjustments. A qualified person can perform the work.
