**Robbins Services**  
Home Inspections

**3021 Barrow St, North Pole, Alaska 99705**  
**Sample Report - Pool Home**  
**Prepared for**  
**Bruce Wayne**  
**Jan 05, 2023 at 06:00 AM**

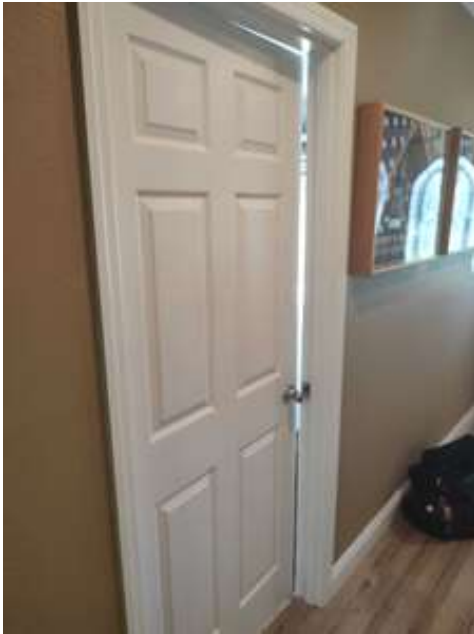
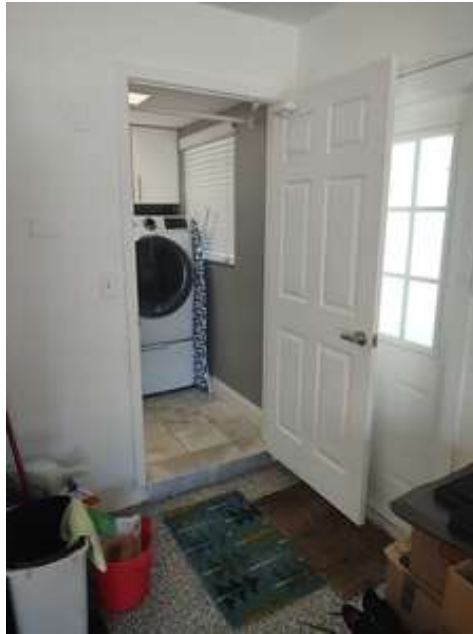
#### 4.5 Pedestrian Door Conditions

The passage door between the garage and the living space does not appear to be fire rated. Although, this may not have been required at the time of construction the lack of a fire rated door can allow a fire to spread more rapidly. Ideally, an mechanical self-closing fire rated door should be installed. A licensed window and door contractor can perform the work.

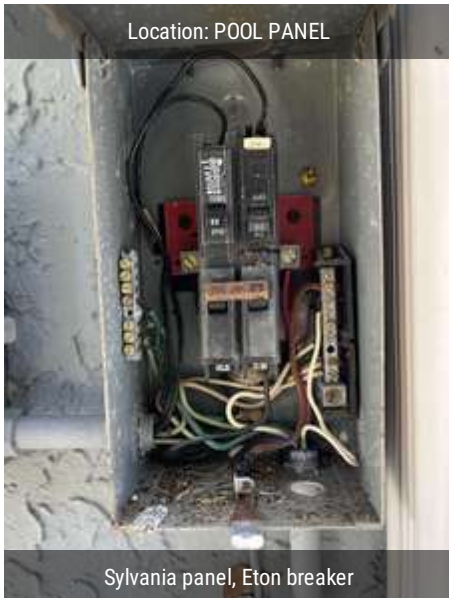
Sylvania panel, Eton breaker

One or more circuit breakers are of a different brand than panel manufacturer. The manufacturer requires only their brand is allowed to be used inside the panel. Even though these circuit breakers are all "UL approved," they are not approved to be used in panels of different manufacturers unless indicated on the panel label. A qualified electrician should replace all non-matching breakers with breakers of the same brand as the panel.

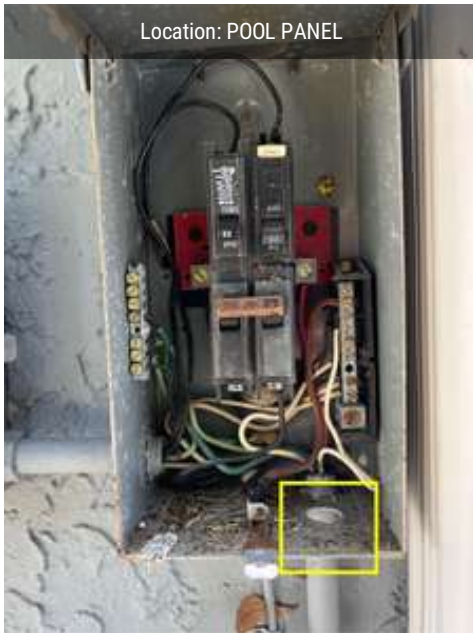
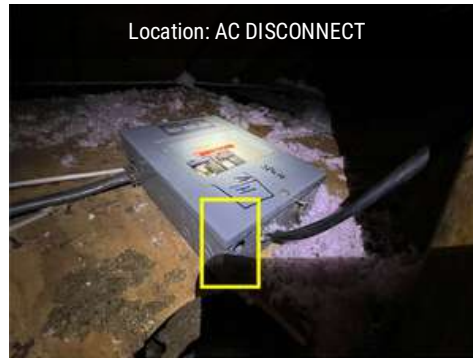
#### 5.4.3 Knock-Out, Missing

One or more panel knock-outs have been removed to accommodate the installation of a conduit run, but no conduit exists leaving an opening in the service panel housing. This opening could allow a person to come in contact with "live" electrical components inside the panel or allow pest entry into the panel. The holes should be closed with a special snap-in filler plug made for this purpose.

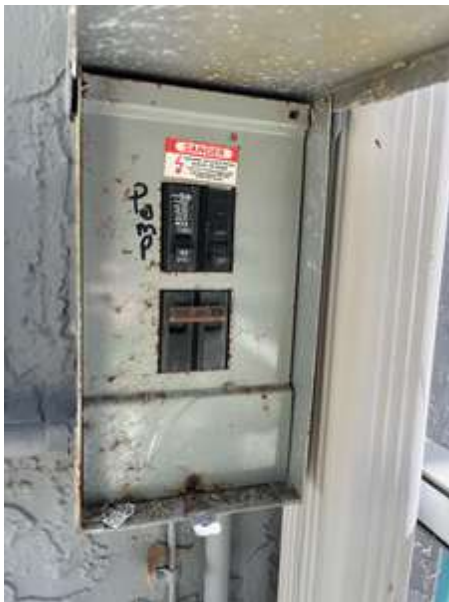
#### 5.4.6 Panel (Zinsco/Sylvania)

A Zinsco or Sylvania electric panel was present. These panels have numerous safety concerns and are considered a fire hazard. The panels and breakers have not been manufactured for some time. Replacement of this panel is recommended by a licensed electrician.

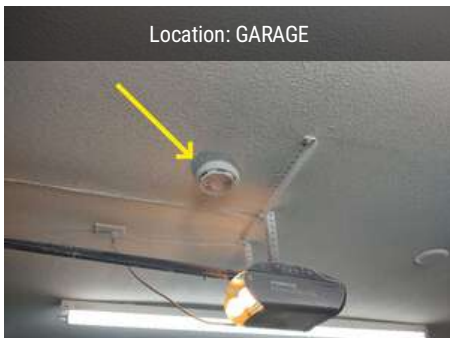
##### 5.9.1 Detector, Test Not Responsive

Location: GARAGE

One or more detectors did not respond to the test button. New batteries or replacement is recommend. Smoke detectors have a life expectancy of about 10 years, while carbon monoxide detectors have a useful lifespan of about 5-6 years, replacement is recommended after these time periods.

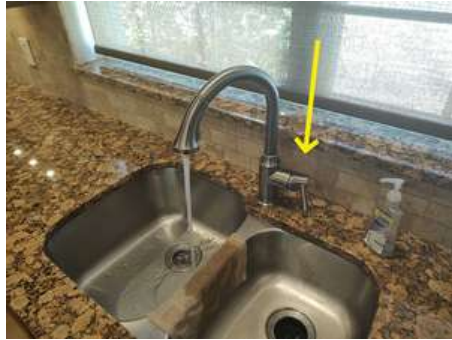
### 11.2.1 Faucet, Hot/Cold Reversed or Unsafe

The hot and cold water controls are reversed or in an unsafe orientation on the faucet. These conditions can result in hot water burns. Hot water should be situated on the left hand side of the faucet or in the up position on lever faucets for safety. Often this can be easily resolved by switching the flexible pipes to the fixture or rotating the faucet. Consult a qualified plumber for more complex problems.

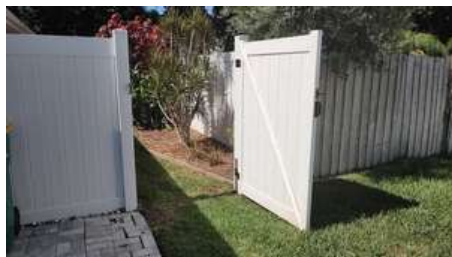
### 13.1.2 Gate, Auto-Close/Auto-Latch Bad

The gate auto-close/auto-latch device was missing or not functional. When a pool is present, gates should be equipped with auto-close and auto-latch devices that lock on the pool side of the gate for safety. Check current codes and make necessary repairs to meet current pool safety requirements.

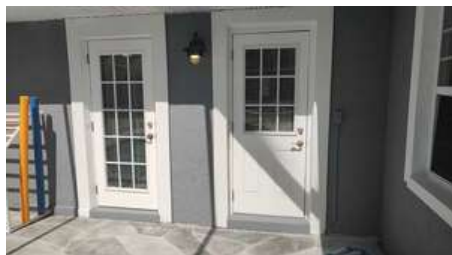
### 13.1.3 Doors Outswing to Pool

One or more doors swing outward toward the pool area. This can allow children to push doors open that fail to latch properly. Doors should self-latching, self-closing and swing away from the pool for safety. A licensed window & door contractor can perform the work.

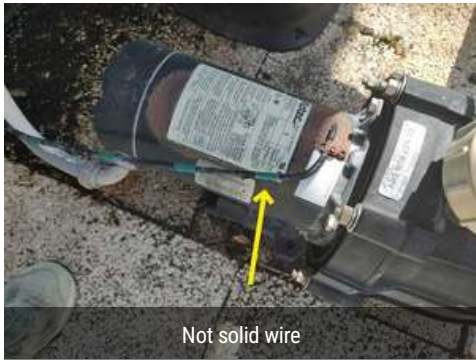
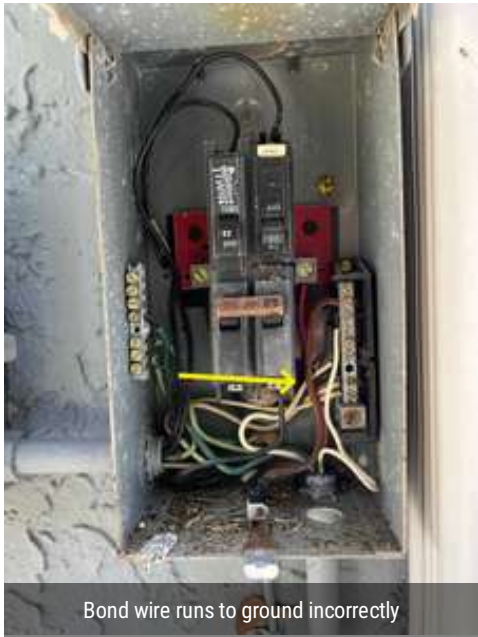
### 13.2.2 Bonding - General 1+ Bond Wire Bad/Missing (8 AWG Solid Copper Req)

The equipotential bonding wire at one or more locations is incorrect, damaged, disconnected, loose or missing. This is a safety hazard. Have a licensed pool contractor or electrician familiar with bonding evaluate and repair the bonding system to meet pool safety requirements.

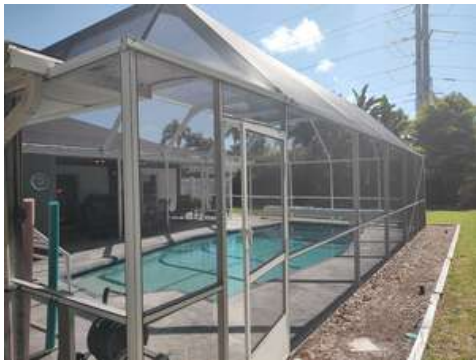
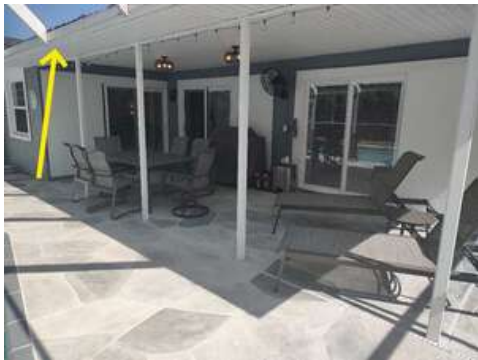
- 1. BONDING - GUTTERS NOT BONDED (WITHIN 5' HORZ X 12' H)  
The gutters do not appear to be bonded. This is a safety hazard. Have a licensed pool contractor or electrician familiar with bonding evaluate and repair the bonding system to meet pool safety requirements.
- 2. BONDING - LANAI NOT BONDED  
The lanai framing does not appear to be bonded. This is a safety hazard. Have a licensed pool contractor or electrician familiar with bonding evaluate and repair the bonding system to meet pool safety requirements.

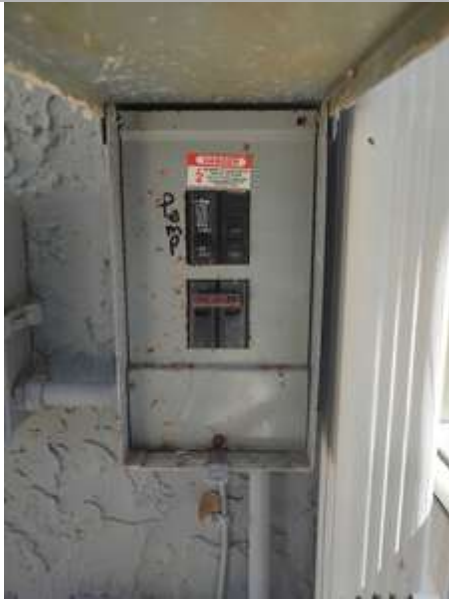
13.2.4 Pool Components, No GFCI Protection

Pool components did not appear to be GFCI protected. Current codes require electrical components such as; pool pumps, heaters and luminaries to have proper GFCI protection. Recommend further evaluation and repair by a licensed electrician.

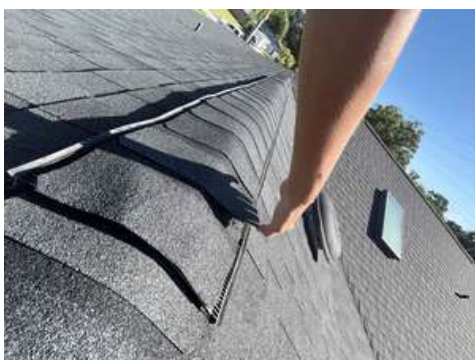
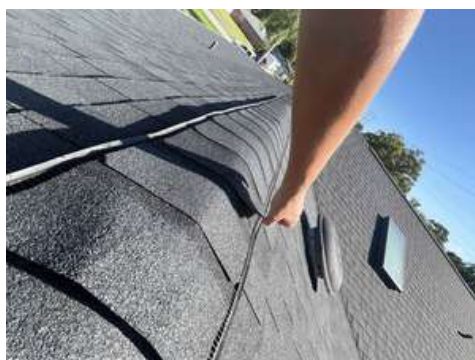
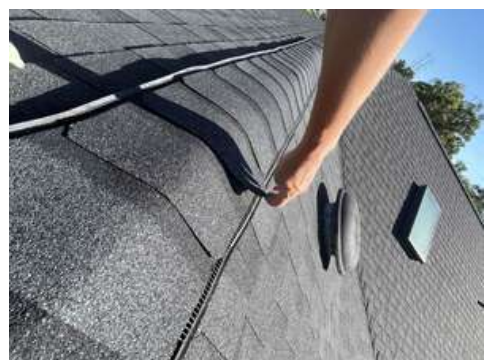
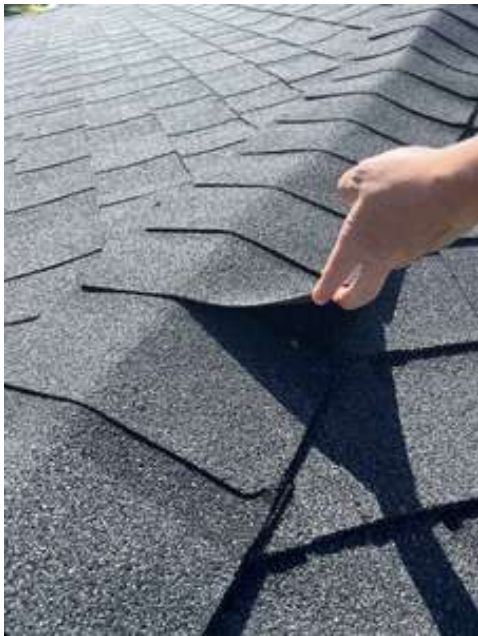
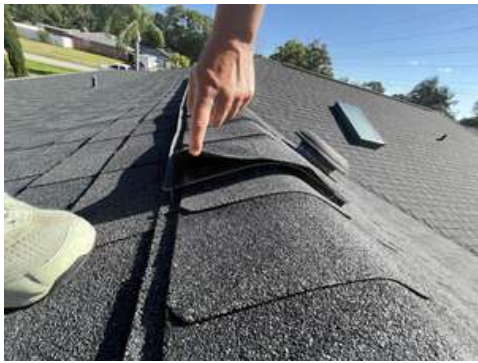
### 3.1.1 Damaged/Missing Shingles

Damaged or missing shingles were observed at one or more locations. The inspector can not offer an opinion as to whether the roof leaks today unless it is moderately raining at the time of inspection. A license roofing contractor should evaluate the roof and repair all damaged areas.

Note, when applicable we are required to note roof concerns on the 4 Point Inspection report. Insurance companies may request repairs prior to providing insurance.

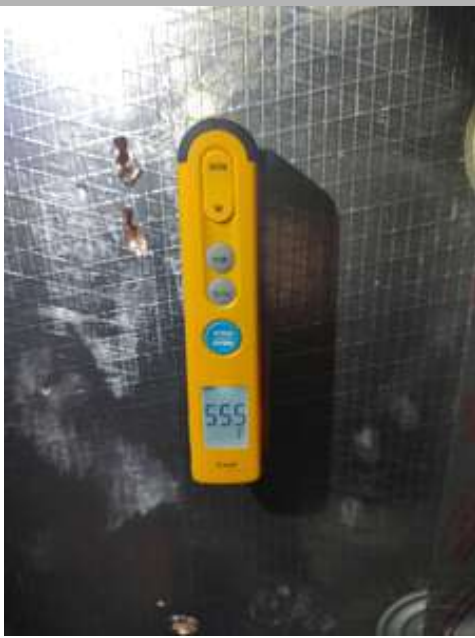
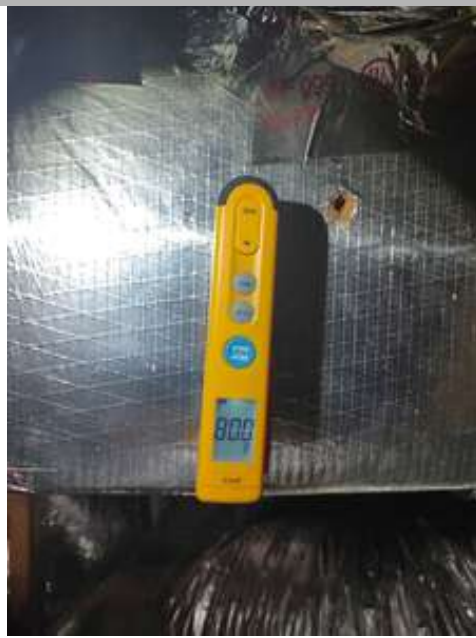
An ambient air test was performed on the cooling system to determine if the difference in temperatures of the supply and return air are between 15 degrees and 22 degrees, which indicates that the unit is cooling within industry standards. The readings indicate that the unit is NOT cooling within standards and may not be working properly. A licensed Heat/Air contractor should further evaluate the system and advise.

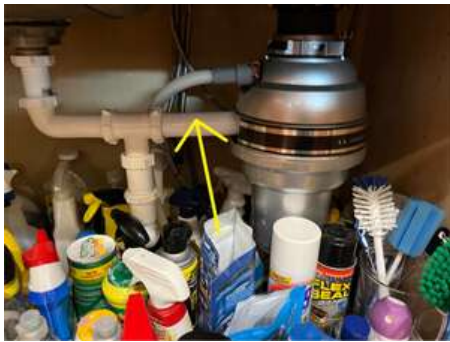
### 11.7.1 No High Loop

No high loop was evident for the drain hose for the dishwasher. A high loop is required to keep drainage from back flowing into the dishwasher. High loops are generally built into the newer dishwashers however, the manufacturers still recommend an additional high loop under the sink before the drain hose is connected. Recommend routing the hose so a high loop is present. A "Qualified person" can perform the work.

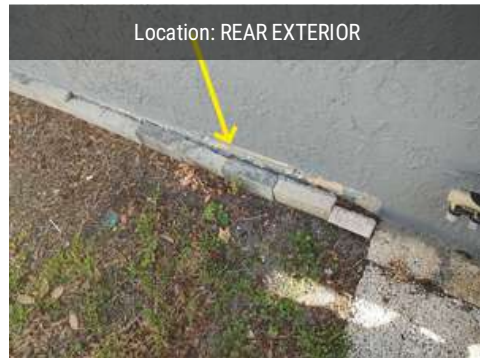
The decorative block at the back rear corner of the property is becoming detached from the wall. It is unusual to find decorative blocks attached to a home in this fashion. We recommend checking with the current owner for the reason these blocks were installed.

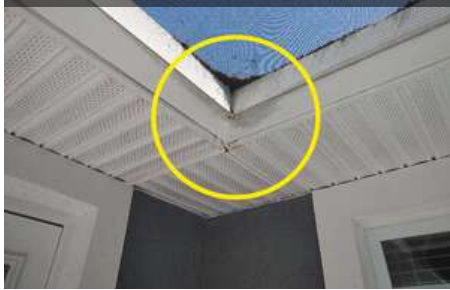
Leaks are present at the gutters or downspouts in one or more locations. We recommend all gutters be sealed to deter leaks.

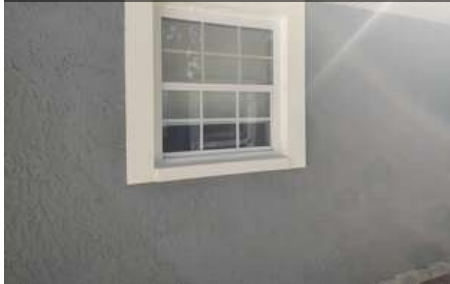
One or more screens are missing or damaged. We suggest contacting the "Current Owner" to verify if missing items are in storage.

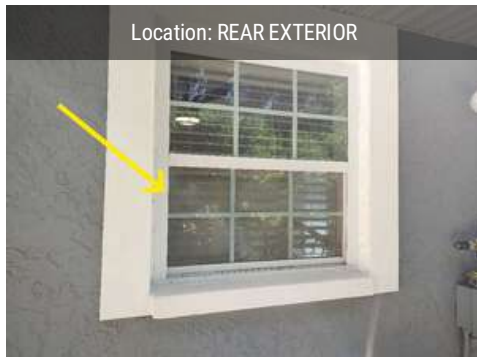
Location: REAR EXTERIOR

Note images are based on a random sampling of windows. The issue may exist in other locations.

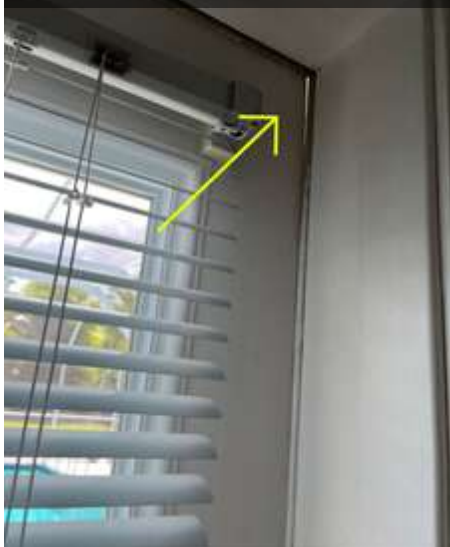
One or more exterior doors do not seal tightly. The weather-strip and/or door sweep should be repaired/replaced and/or the hardware adjusted to improve efficiency and prevent pest and/or water intrusion.

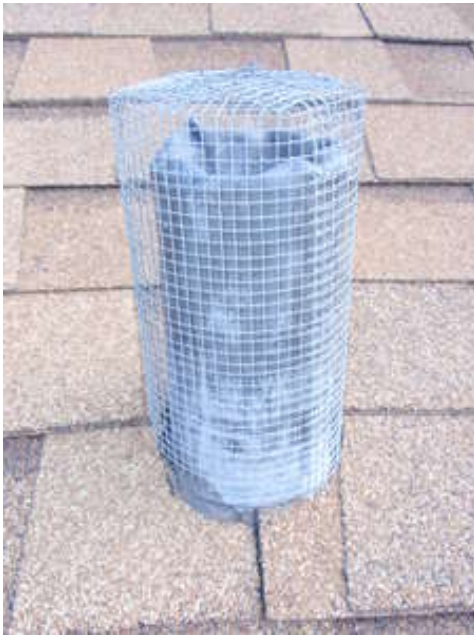
Rodents such as squirrels and rats like to chew on lead flashing materials. If not currently installed, we recommend adding rodent protection to plumbing vents to deter future damage.

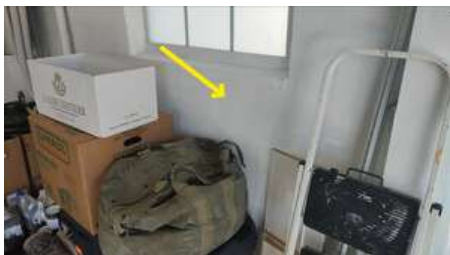
#### 4.1.1 Cracks - Typical

Typical settlement type cracks were observed. These appear aesthetic in nature. Patch and spackle as desired.

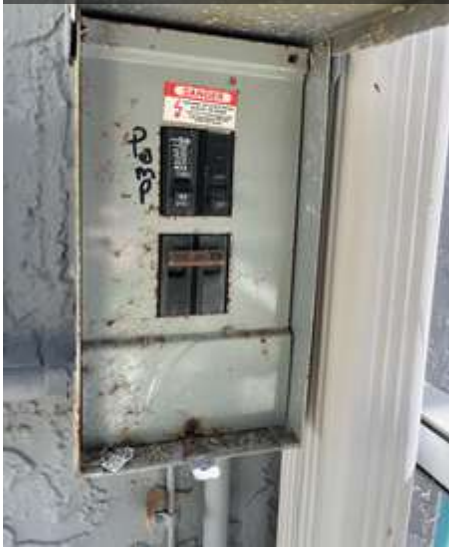
#### 5.4.4 Rust / Corrosion (Minimal), Monitor

Location: POOL PUMP PANEL

Rust and / or corrosion was observed at the panel box. No corrections appear necessary at this time. Keep an eye on the area and if conditions worsen consult an electrician.

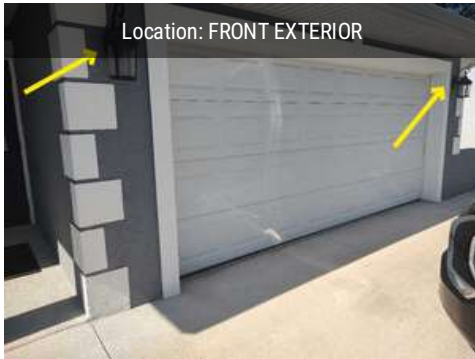
Location: FRONT EXTERIOR

Light(s) were out or inoperative at one or more locations. This may simply be a bulb is out or we were unable to locate the proper switch. Dismantling and testing of light fixtures is not performed as part of this inspection. Note, non-working items noted are based on a random sampling and this condition may exist at other locations. Recommend all lights be operable prior to close.

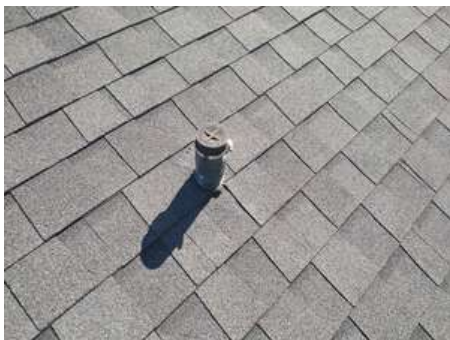
#### 6.4.2 Plumbing vent, abandoned

A plumbing van at one or more locations was abandoned and it was capped off at the roof. This is likely due to fixtures being moved within the structure. We recommend checking with the current owner as to what was moved and having the vent sealed off at the next roof replacement..

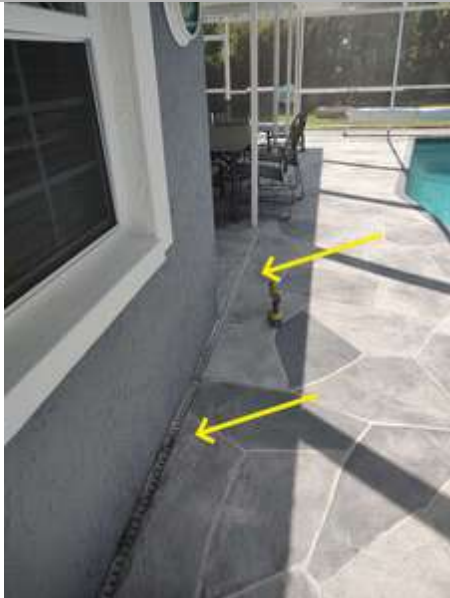
### 13.1.6 Subsurface drains - Not Inspected

Subsurface drains were observed. These drains were not tested as a part of this inspection and we are unable to comment on their performance. Condition of underground pipes or location of their termination points (if any) is not determined as part of this inspection.

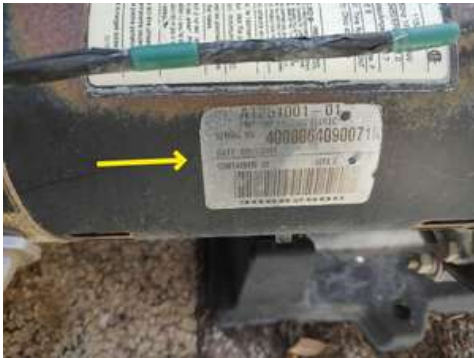
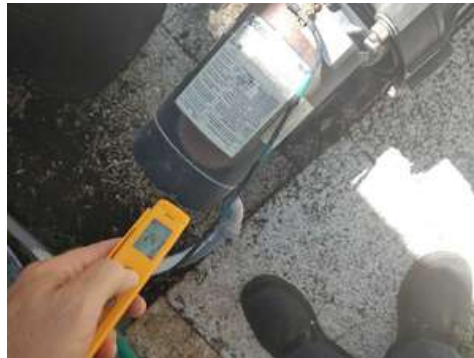
The pump motor was extremely hot during our inspection. These pumps generally have a life expectancy of 8 to 10 years. Although the pump is currently functional replacement may be needed in the near future.

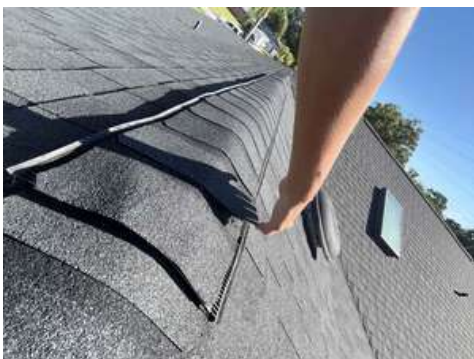
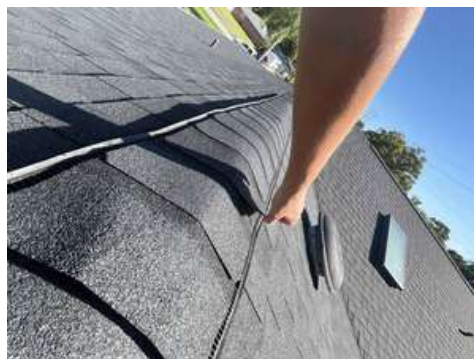
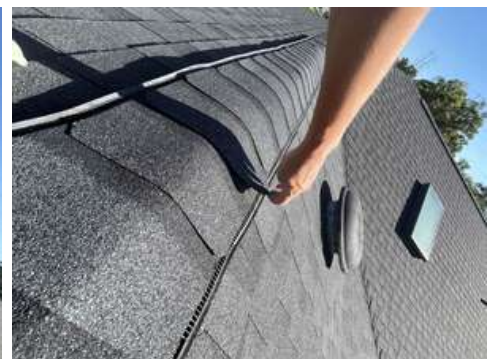
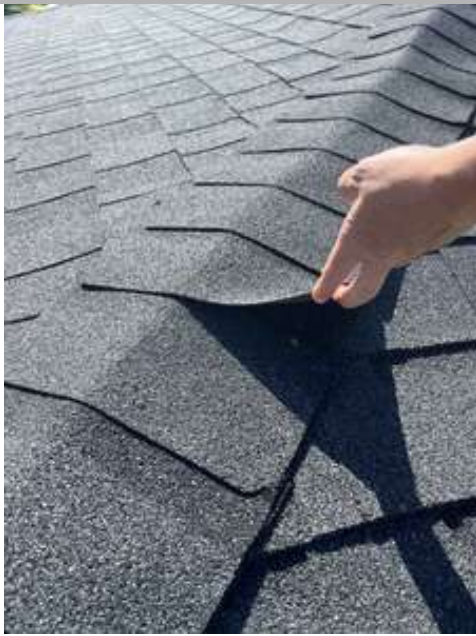
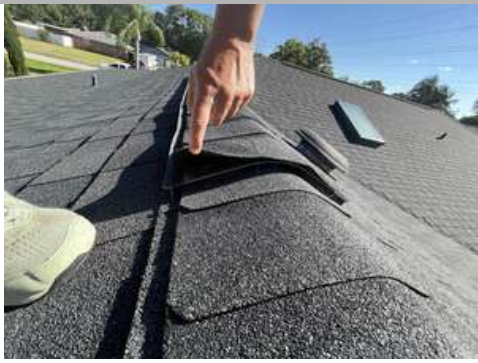
Damaged or missing shingles were observed at one or more locations. The inspector can not offer an opinion as to whether the roof leaks today unless it is moderately raining at the time of inspection. A license roofing contractor should evaluate the roof and repair all damaged areas.

Note, when applicable we are required to note roof concerns on the 4 Point Inspection report. Insurance companies may request repairs prior to providing insurance.

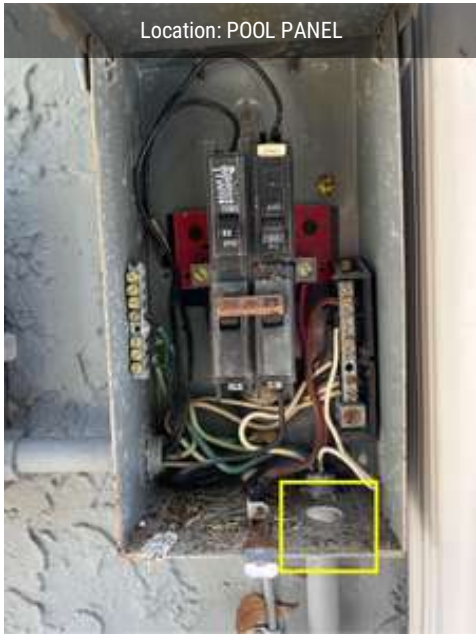
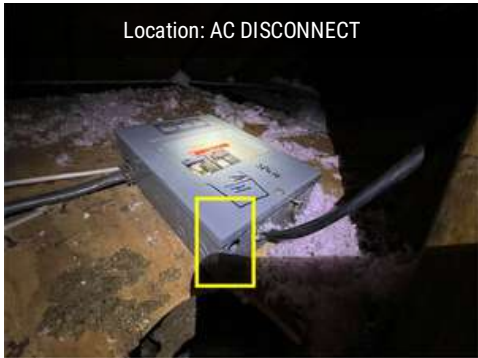
5.4.3 Knock-Out, Missing

One or more panel knock-outs have been removed to accommodate the installation of a conduit run, but no conduit exists leaving an opening in the service panel housing. This opening could allow a person to come in contact with "live" electrical components inside the panel or allow pest entry into the panel. The holes should be closed with a special snap-in filler plug made for this purpose.

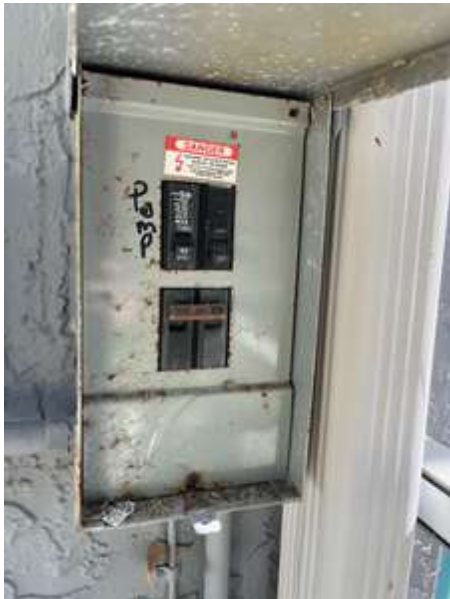
Note: many insurance companies deny coverage for homes with these types of electric panels. You should also check with your insurance agent regarding this panel.

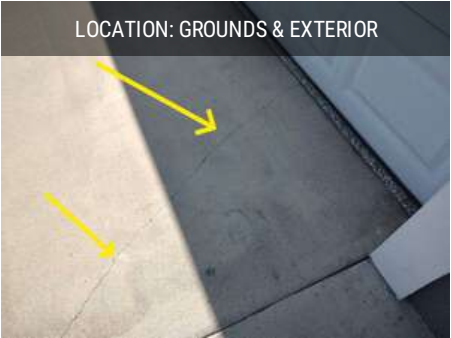
Typical settlement type cracks were observed. Minor settlement cracks are very common and occur as the building materials settle and cure over time. No additional attention is required at this time. No immediate attention is required however we recommend keeping these cracks sealed as part of normal maintenance.

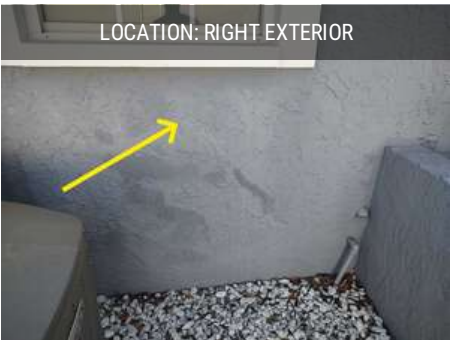
Typical cracks were found in the exterior walls. Minor settlement cracks are very common and occur as the dwelling settles and building materials cure over time. These cracks are not considered serious in nature until they reach a width of 1/8 inches or more. However, they can allow moisture to enter the building components. We recommend sealing and painting to reduce the possibility of water penetration.

Note, this comment may not include all areas requiring attention. The contractor should walk the perimeter of the home and address all areas that require attention.

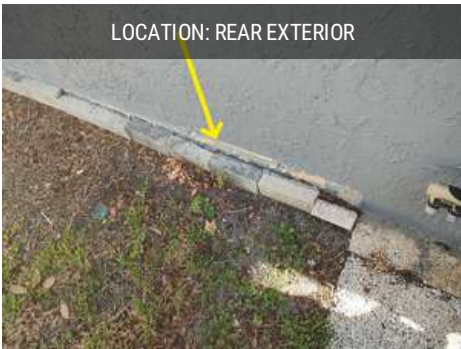
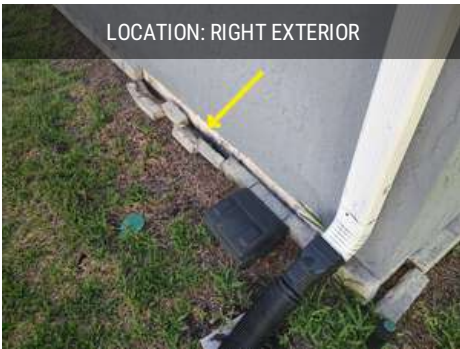
The decorative block at the back rear corner of the property is becoming detached from the wall. It is unusual to find decorative blocks attached to a home in this this fashion. We recommend checking with the current owner for the reason these blocks were installed.

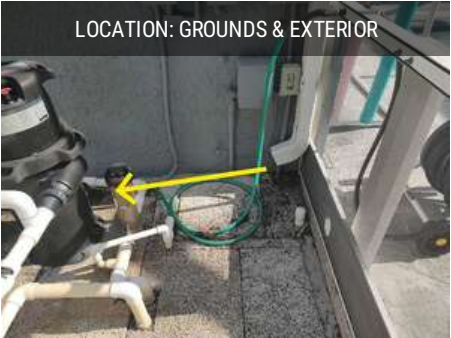
| <div><div>LOCATION: GROUNDS &amp; EXTERIOR</div></div> | | <div>Recommend gutter downspouts be kept in good condition and extended / routed away from the building for proper drainage. Ponding, flooding and water seepage into crawl spaces, basements and under foundations can be caused by inadequate removal of rainwater from the perimeter of the house.</div> | |

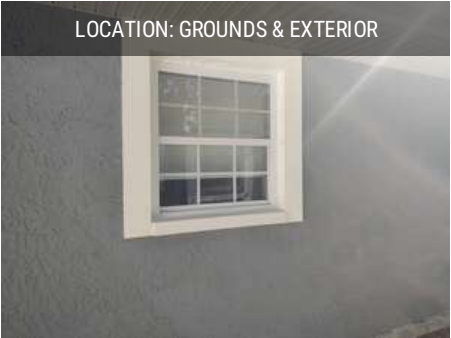
2.10.1 Screens - Damaged / Missing

One or more screens are missing or damaged. We suggest contacting the "Current Owner" to verify if missing items are in storage.

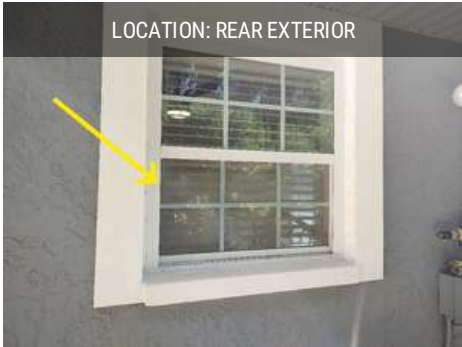
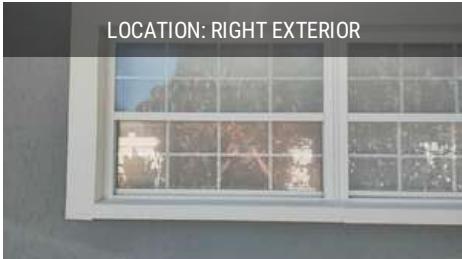
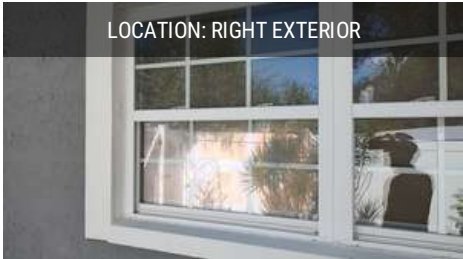
2.10.2 Thermal Seal Damaged

The thermal pane window(s) appear to have lost their thermal seal at one or more locations. Moisture, fogging, and hazing are common signs of this condition. While mostly cosmetic, this condition is generally not repairable. Correction would require replacement of the window(s) or window pane(s).

Note images are based on a random sampling of windows. The issue may exist in other locations.

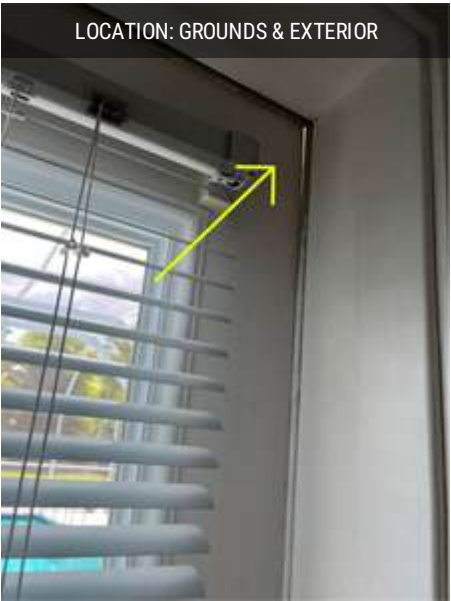
One or more exterior doors do not seal tightly. The weather-strip and/or door sweep should be repaired/replaced and/or the hardware adjusted to improve efficiency and prevent pest and/or water intrusion.

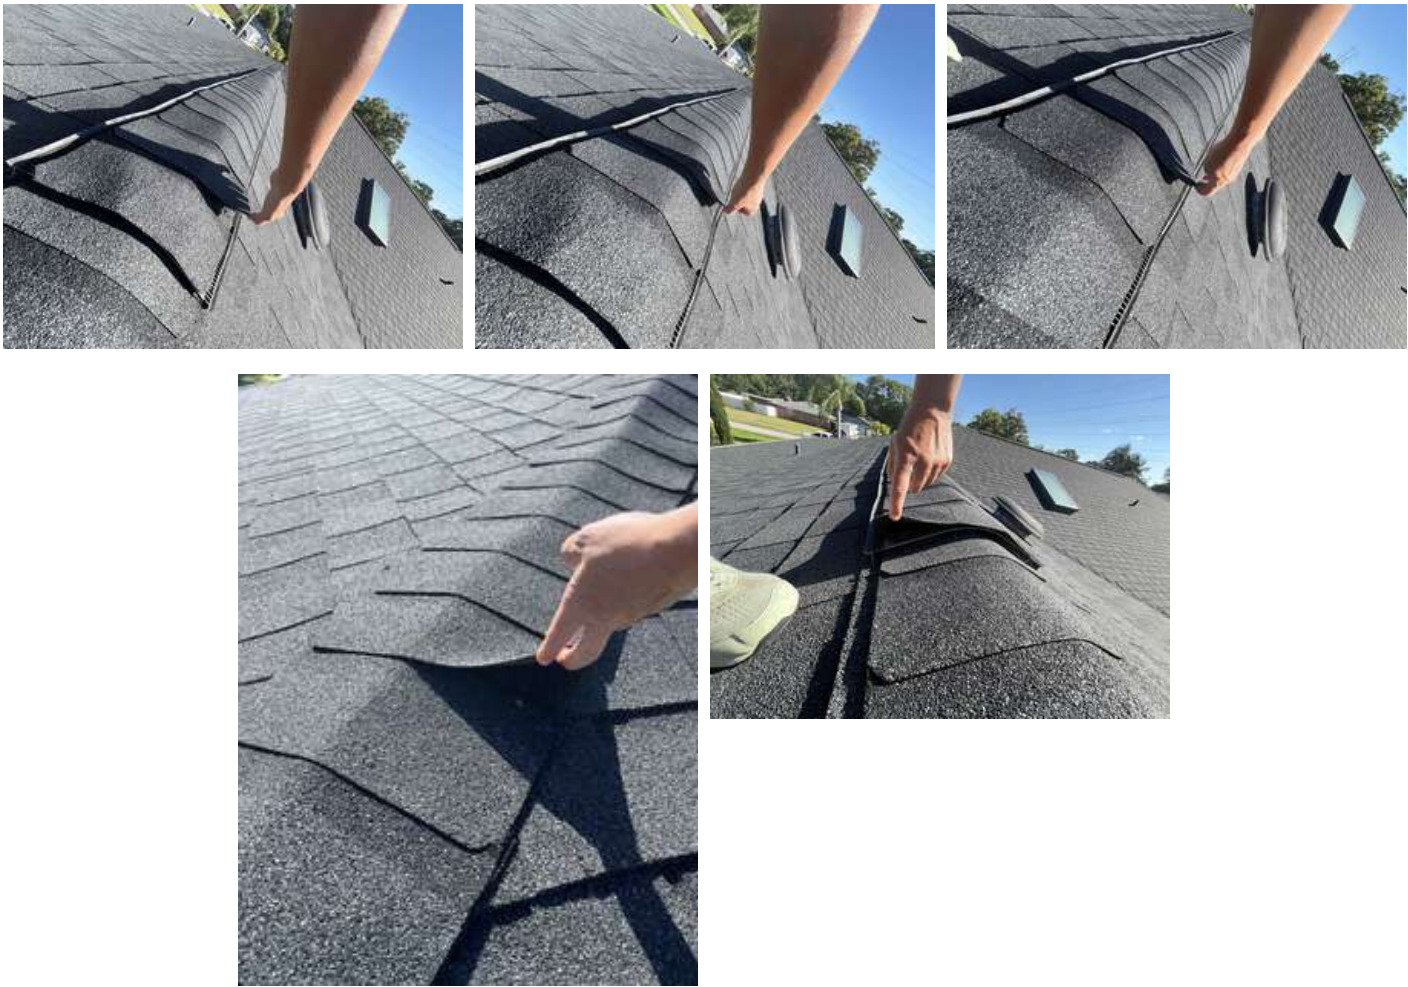
Damaged or missing shingles were observed at one or more locations. The inspector can not offer an opinion as to whether the roof leaks today unless it is moderately raining at the time of inspection. A license roofing contractor should evaluate the roof and repair all damaged areas.

Note, when applicable we are required to note roof concerns on the 4 Point Inspection report. Insurance companies may request repairs prior to providing insurance.

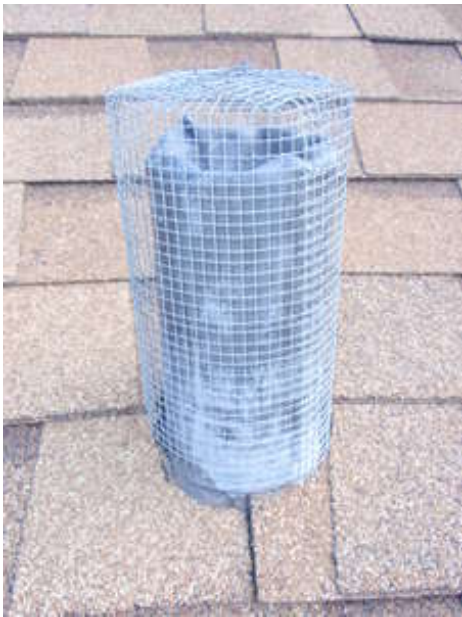
Rodents such as squirrels and rats like to chew on lead flashing materials. If not currently installed, we recommend adding rodent protection to plumbing vents to deter future damage.

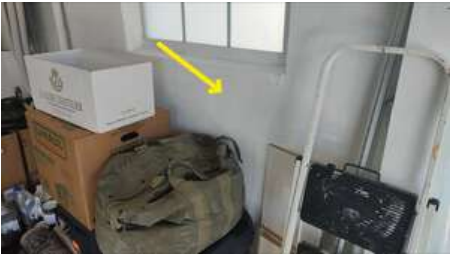
4.1.1 Cracks - Typical

Typical settlement type cracks were observed. These appear aesthetic in nature. Patch and spackle as desired.

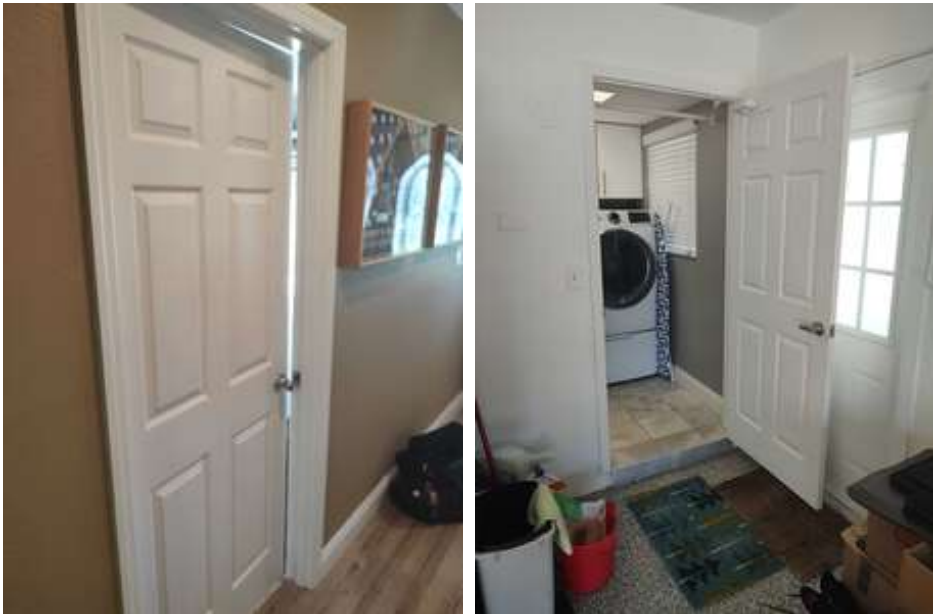
The passage door between the garage and the living space does not appear to be fire rated. Although, this may not have been required at the time of construction the lack of a fire rated door can allow a fire to spread more rapidly. Ideally, an mechanical self-closing fire rated door should be installed. A licensed window and door contractor can perform the work.

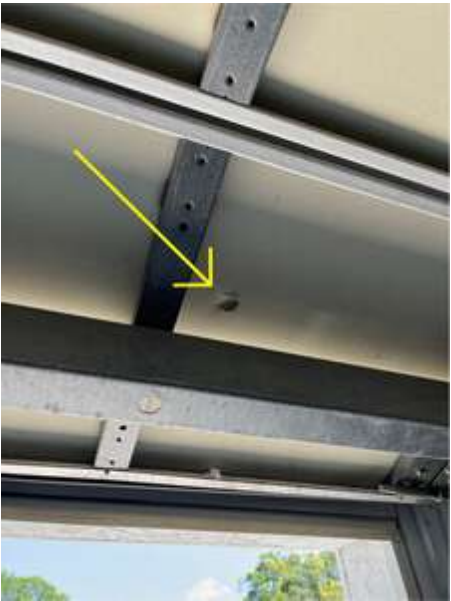
The vehicle door(s) had minor damaged. The damage appears to be cosmetic in nature and no immediate repairs are necessary.

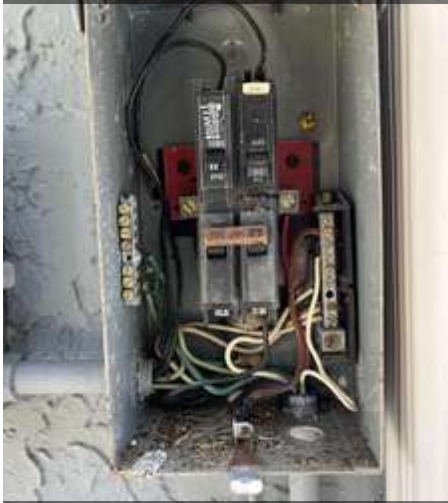
LOCATION: POOL PANEL

SYLVANIA PANEL, ETON BREAKER

One or more circuit breakers are of a different brand than panel manufacturer. The manufacturer requires only their brand is allowed to be used inside the panel. Even though these circuit breakers are all "UL approved," they are not approved to be used in panels of different manufacturers unless indicated on the panel label. A qualified electrician should replace all non-matching breakers with breakers of the same brand as the panel.

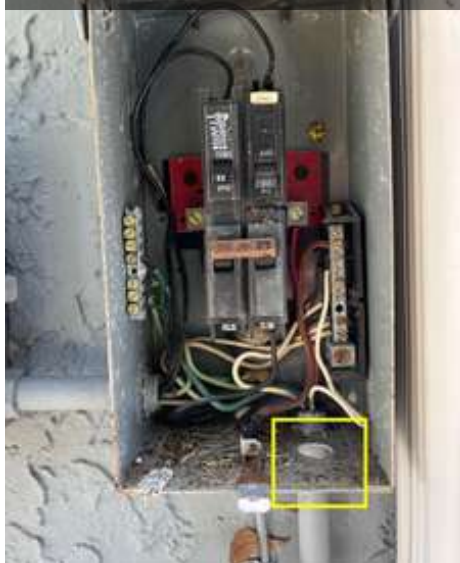
LOCATION: POOL PANEL

One or more panel knock-outs have been removed to accommodate the installation of a conduit run, but no conduit exists leaving an opening in the service panel housing. This opening could allow a person to come in contact with "live" electrical components inside the panel or allow pest entry into the panel. The holes should be closed with a special snap-in filler plug made for this purpose.

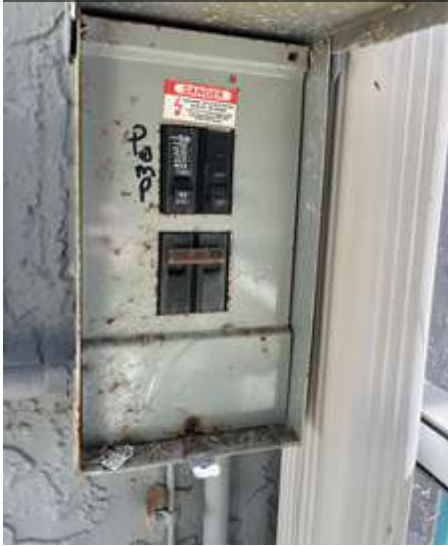
#### 5.4.4 Rust / Corrosion (Minimal), Monitor

Rust and / or corrosion was observed at the panel box. No corrections appear necessary at this time. Keep an eye on the area and if conditions worsen consult an electrician.

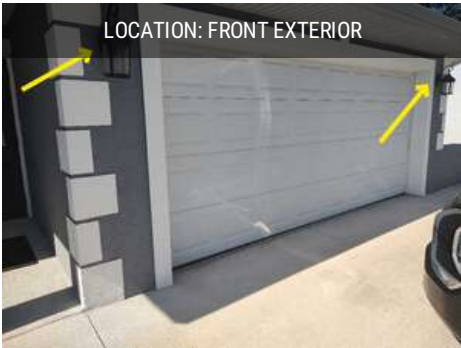
Light(s) were out or inoperative at one or more locations. This may simply be a bulb is out or we were unable to locate the proper switch. Dismantling and testing of light fixtures is not performed as part of this inspection. Note, non-working items noted are based on a random sampling and this condition may exist at other locations. Recommend all lights be operable prior to close.

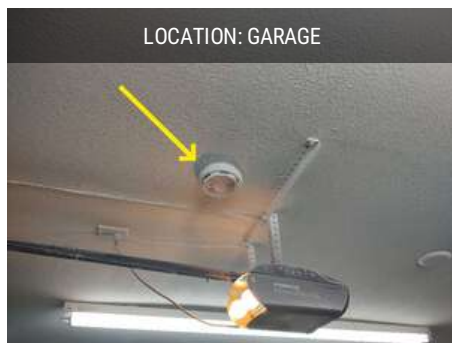
### 5.9.1 Detector, Test Not Responsive

One or more detectors did not respond to the test button. New batteries or replacement is recommend. Smoke detectors have a life expectancy of about 10 years, while carbon monoxide detectors have a useful lifespan of about 5-6 years, replacement is recommended after these time periods.

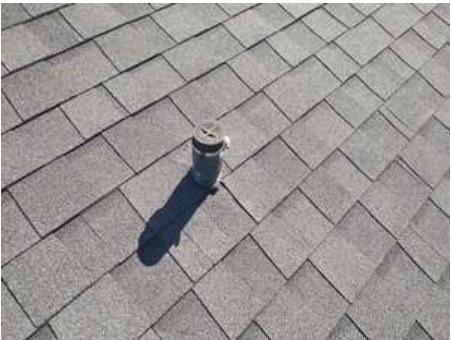
A plumbing van at one or more locations was abandoned and it was capped off at the roof. This is likely due to fixtures being moved within the structure. We recommend checking with the current owner as to what was moved and having the vent sealed off at the next roof replacement..

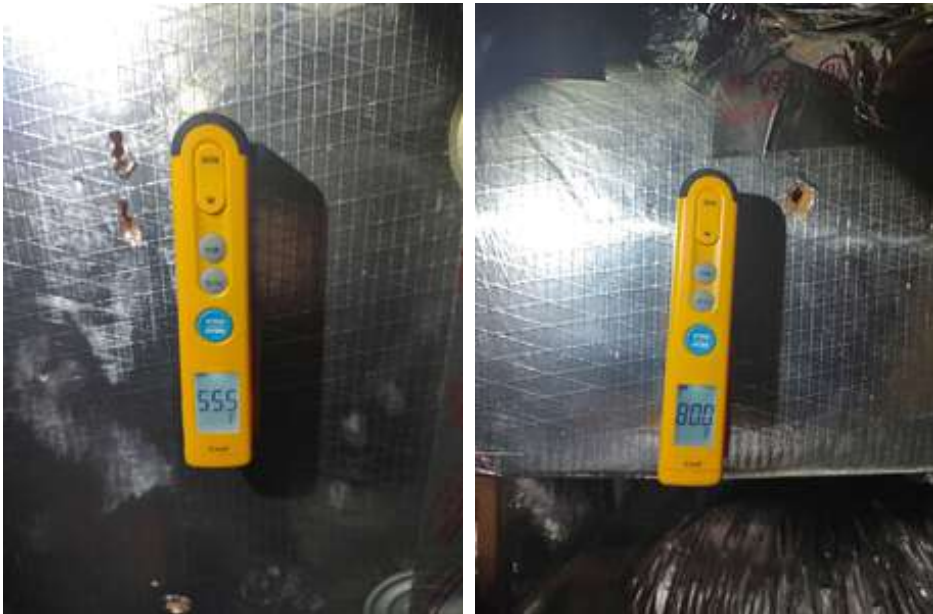
An ambient air test was performed on the cooling system to determine if the difference in temperatures of the supply and return air are between 15 degrees and 22 degrees, which indicates that the unit is cooling within industry standards. The readings indicate that the unit is NOT cooling within standards and may not be working properly. A licensed Heat/Air contractor should further evaluate the system and advise.

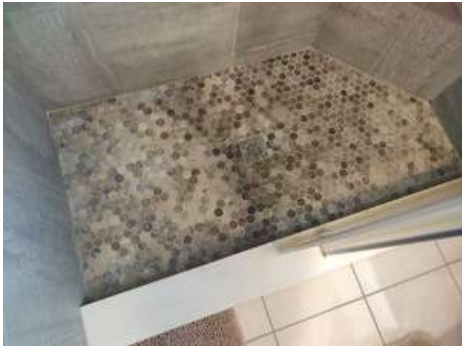
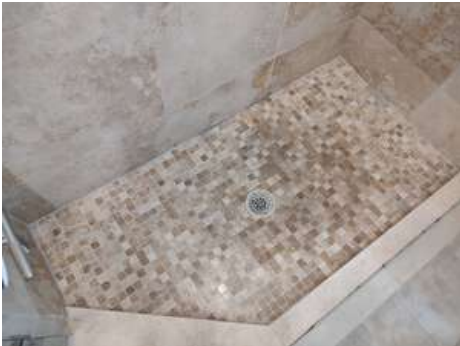
A definitive test for leaks in a tile shower base requires 2 - 3 inches of water left standing for up to 48 hours. There were no signs of leaks, but this definitive test is beyond the scope of this inspection and was not performed.

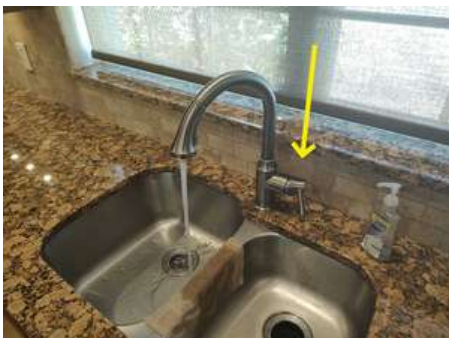
The hot and cold water controls are reversed or in an unsafe orientation on the faucet. These conditions can result in hot water burns. Hot water should be situated on the left hand side of the faucet or in the up position on lever faucets for safety. Often this can be easily resolved by switching the flexible pipes to the fixture or rotating the faucet. Consult a qualified plumber for more complex problems.

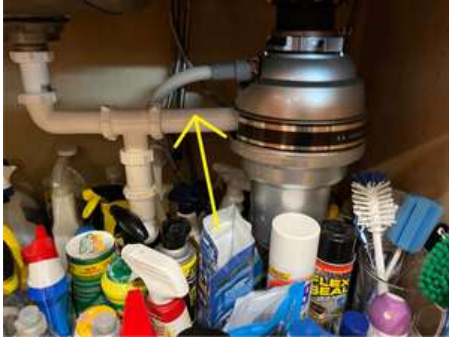
No high loop was evident for the drain hose for the dishwasher. A high loop is required to keep drainage from back flowing into the dishwasher. High loops are generally built into the newer dishwashers however, the manufacturers still recommend an additional high loop under the sink before the drain hose is connected. Recommend routing the hose so a high loop is present. A "Qualified person" can perform the work.

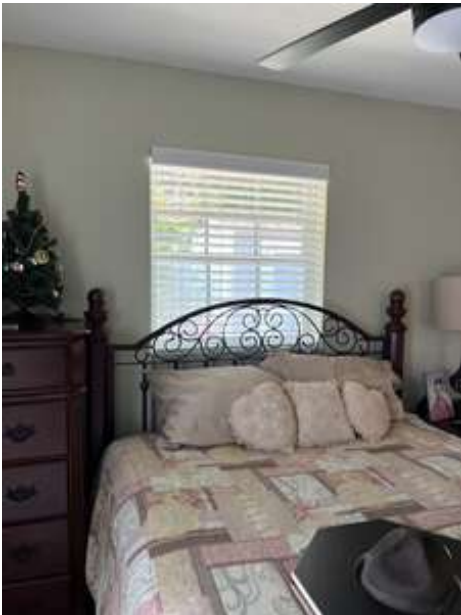
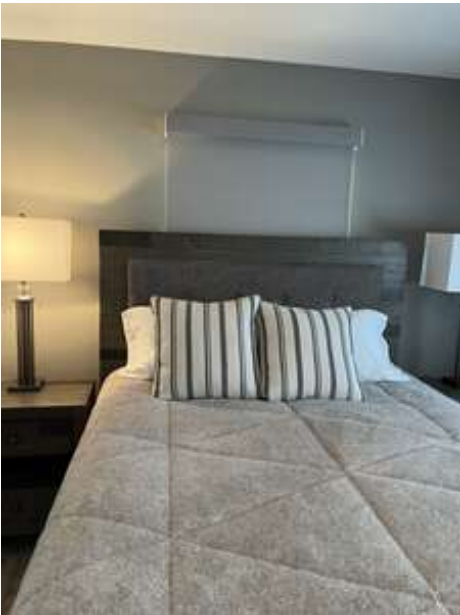
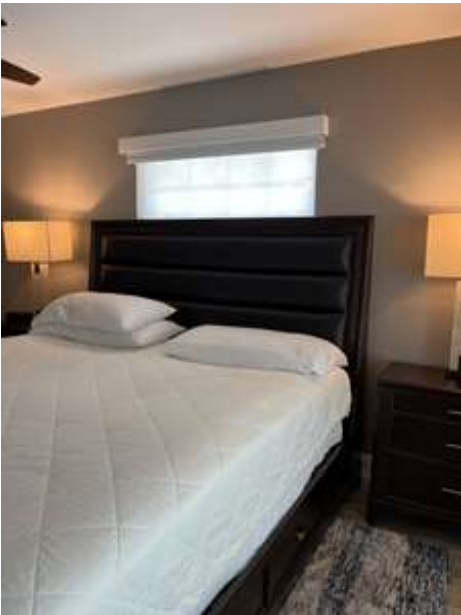
Furnishings, personal item storage, and window treatments prevented a full visual inspection of all windows and window areas. Conditions can change between the time of inspection and closing. Please do a careful check of all windows during your final walk through.

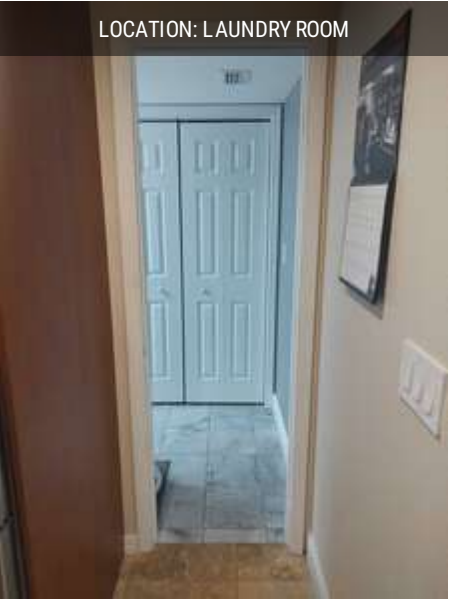
Closet doors were missing at one or more locations. A licensed window and door contractor can perform the work.

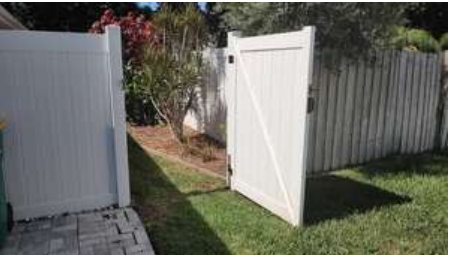
13.1.2 Gate, Auto-Close/Auto-Latch Bad

The gate auto-close/auto-latch device was missing or not functional. When a pool is present, gates should be equipped with auto-close and auto-latch devices that lock on the pool side of the gate for safety. Check current codes and make necessary repairs to meet current pool safety requirements.

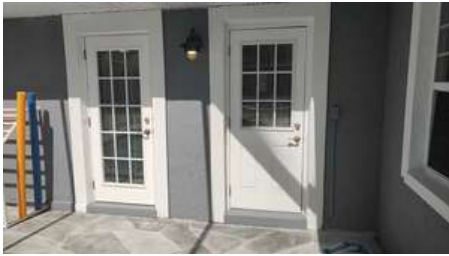
### 13.1.3 Doors Outswing to Pool

One of more doors swing outward toward the pool area. This can allow children to push doors open that fail to latch properly. Doors should self-latching, self-closing and swing away from the pool for safety. A licensed window & door contractor can perform the work.

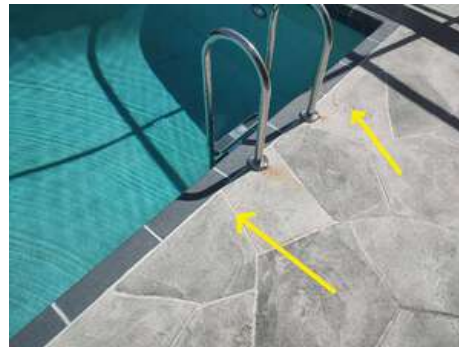
### 13.1.4 Pool deck - common cracks

Common cracks were found. Minor settlement cracks are very common and occur as the concrete settles and building materials cure over time. These cracks are not considered serious in nature and are considered aesthetic in nature. We recommend sealing and painting as desired.

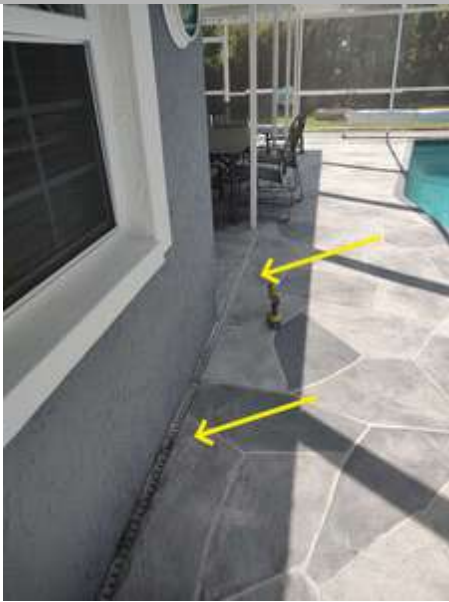
Subsurface drains were observed. These drains were not tested as a part of this inspection and we are unable to comment on their performance. Condition of underground pipes or location of their termination points (if any) is not determined as part of this inspection.
