**Robbins Services**  
Home Inspections

**3021 Barrow St, North Pole, Alaska 99705**  
**Sample Report - Pool Home**  
**Prepared for**  
**Bruce Wayne**  
**Jan 05, 2023 at 06:00 AM**

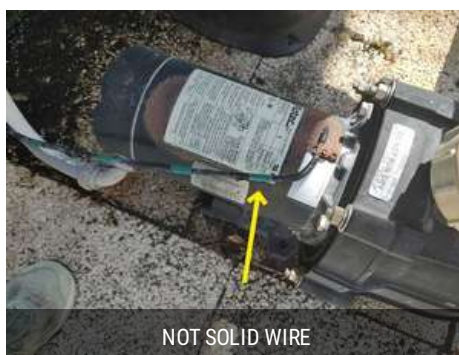
#### 13.2.2 Bonding - General 1 + Bond Wire Bad/Missing (8 AWG Solid Copper Req)

The equipotential bonding wire at one or more locations is incorrect, damaged, disconnected, loose or missing. This is a safety hazard. Have a licensed pool contractor or electrician familiar with bonding evaluate and repair the bonding system to meet pool safety requirements.

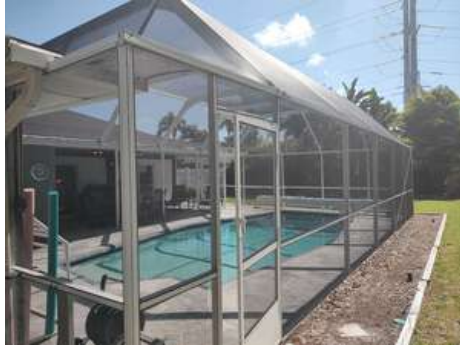
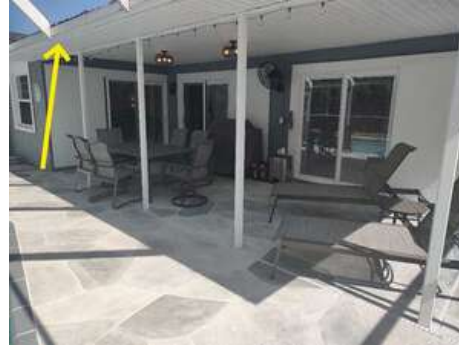
**2. BONDING - LANAI NOT BONDED**

The lanai framing does not appear to be bonded. This is a safety hazard. Have a licensed pool contractor or electrician familiar with bonding evaluate and repair the bonding system to meet pool safety requirements.

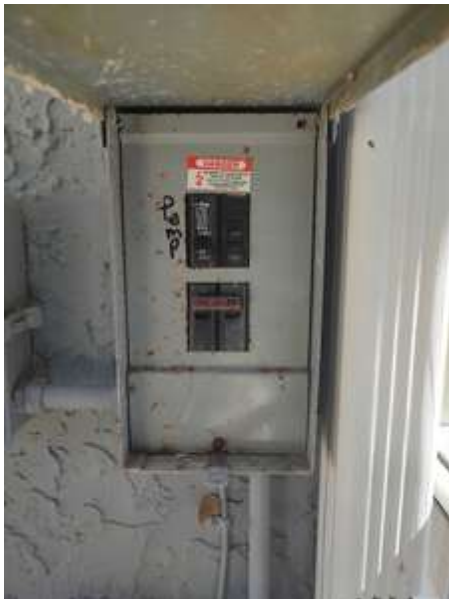
**13.2.4 Pool Components, No GFCI Protection**

Pool components did not appear to be GFCI protected. Current codes require electrical components such as; pool pumps, heaters and luminaries to have proper GFCI protection. Recommend further evaluation and repair by a licensed electrician.

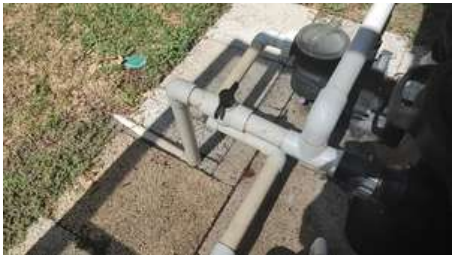
Valves that are not used regularly have a tendency to leak and/or break when used. Due to the risk of property damage, testing of valves is not performed. We recommend having the current owner demonstrate their operation prior to closing.

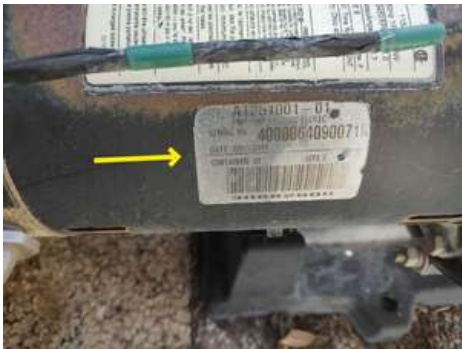
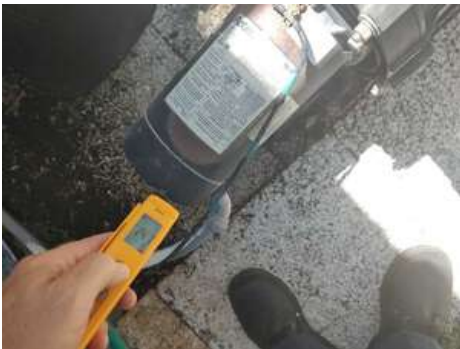
The pump motor was extremely hot during our inspection. These pumps generally have a life expectancy of 8 to 10 years. Although the pump is currently functional replacement may be needed in the near future.
