**3021 Barrow St, North Pole, Alaska 99705**  
**Sample Report - Condo**  
**Prepared for**  
**Bruce Wayne**  
**Jan 05, 2023 at 06:00 AM**

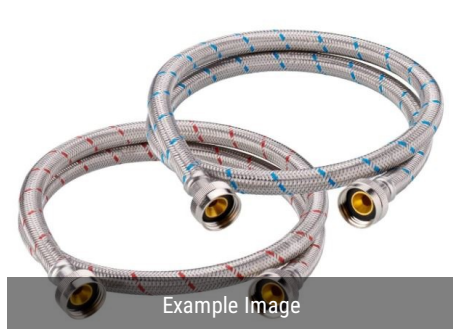
### 3.2.1 Anti-Burst Hoses, Recommendation (If Not Installed)

Example Image

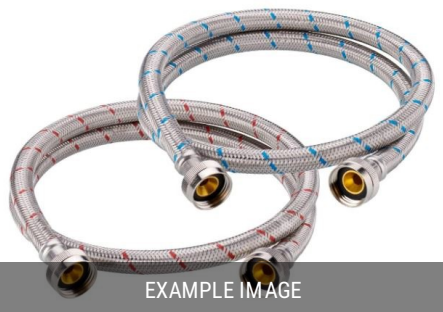
Consideration / Recommendation

EXAMPLE IMAGE

If not currently installed, as a preventive measure we recommend installing anti-burst water supply hoses at interior plumbing connections, such as clothes washers, toilets, sinks, and refrigerators. These hoses reduce the risk of excessive water damage due to burst connections.
