**Robbins Services**  
Home Inspections

**3021 Barrow St, North Pole, Alaska 99705**  
**Sample Report - Older Home**  
**Prepared for**  
**Bruce Wayne**  
**Jan 05, 2023 at 06:00 AM**

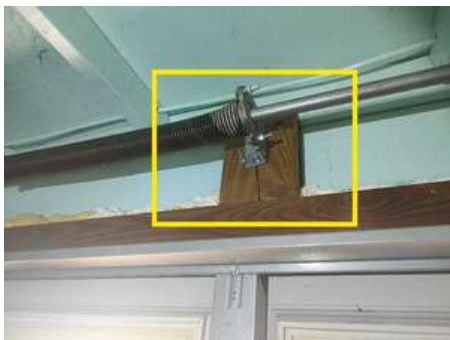
##### 5.6.1 Spring Tensioner Mounting Board - Loose/Damaged At Wall

The spring tensioner mounting board is loose and/or damaged at the wall. This is a safety issue that may cause injury. Recommend further evaluation and repair by licensed garage door specialist.

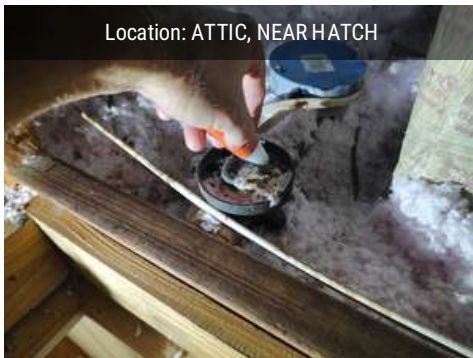
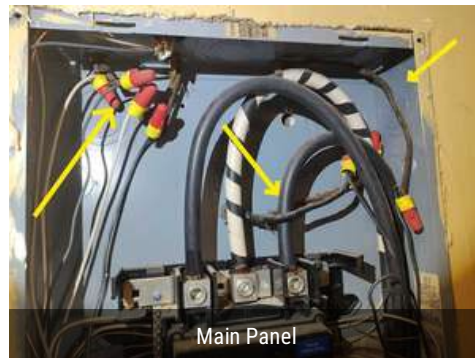
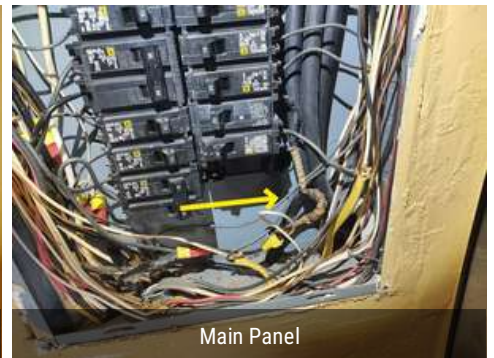
Location: ATTIC, NEAR HATCH

**Important Note:** This observation requires the inspector to specify the existence of cloth wiring on the separate 4 Point Inspection Report that most insurance companies require - some insurance companies will not insure a house with this type of wiring. We advise you consult with your insurance agent or underwriter regarding insurability.

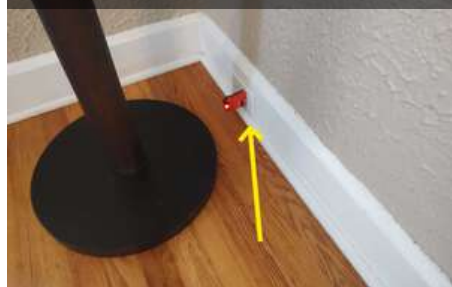
Location: LIVING ROOM, NEAR FRONT ENTRY

##### 6.6.1 Open ground

An open ground wire condition was observed at outlet(s) located at one or more locations. It is possible this condition could be resolved with minor wiring adjustments or it may be due to an older wiring system within the home. When a number of these conditions are observed, client should consult a licensed electrician.

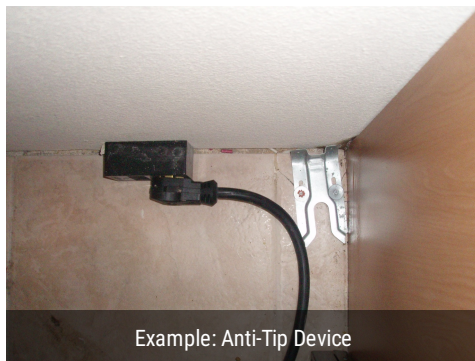
Safety Notice: Anti-Tip Device

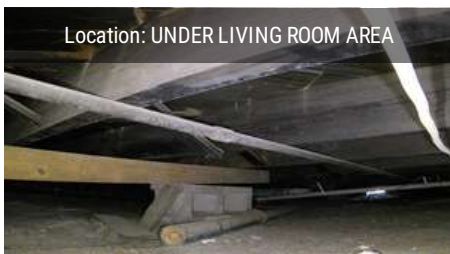
Location: UNDER LIVING ROOM AREA

### 1.1.3 Unprofessional / temporary support

Unprofessional / temporary support was observed. Although no immediate concern was observed, client should contact a qualified foundation contractor for further information and / or evaluation.

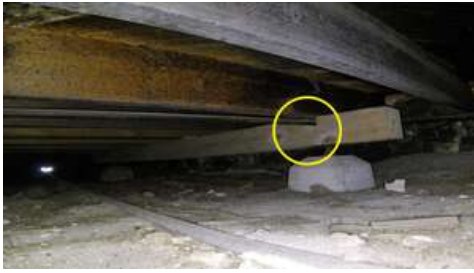
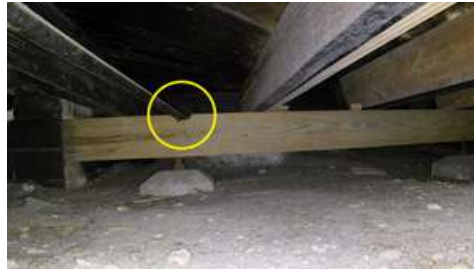
A structural support beam at one or more locations has been notched to allow for plumbing or electrical runs. Generally notching of support beams is not acceptable. We recommend a licensed foundation contractor evaluate and repair as needed.

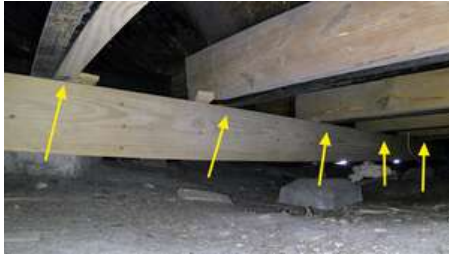
#### 1.1.6 Sistered Joists

Joists were sistered at one or more locations. This generally indicates the original beams have been damaged and/or where not adequately supporting the load. We recommend further evaluation by a licensed foundation contractor.

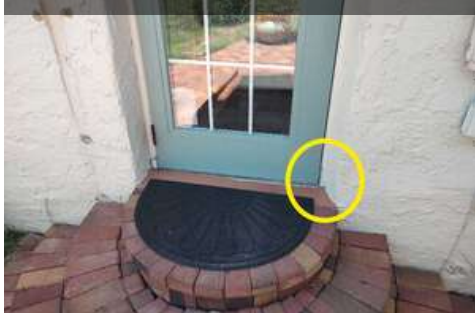
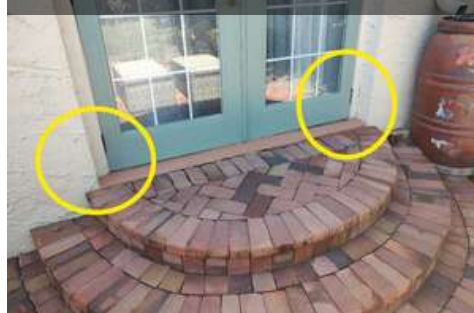
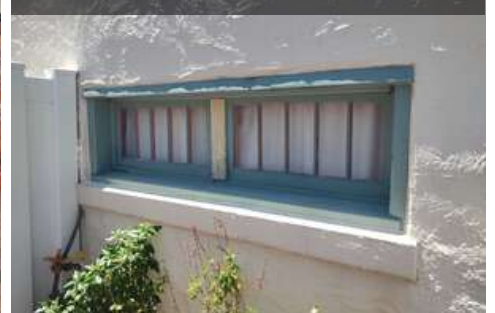
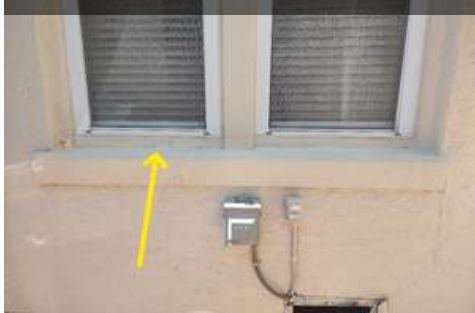
Note: The defects noted in images are based on a random sampling and may not indicate all affected areas - Contractor should review for additional damage and probe where suspect to insure that all damage is identified and replaced.

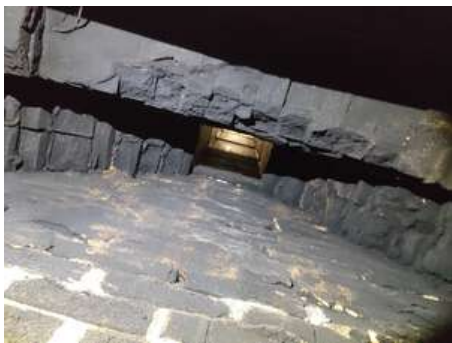
##### 4.3.3 Damper Missing

The unit is not equipped with a flue damper. A qualified chimney sweep can evaluate and repair.

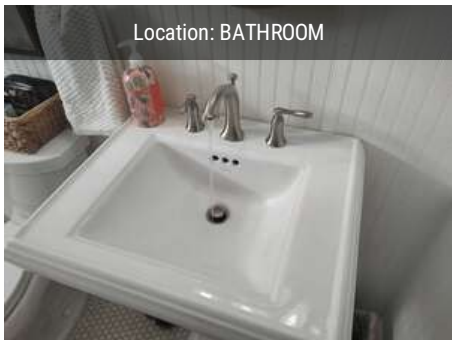
##### 7.3.3 Low Pressure - 1+ Locations

There was visible evidence of low water pressure at one or more locations when multiple fixtures were operating. A licensed plumber can evaluate and repair as needed.

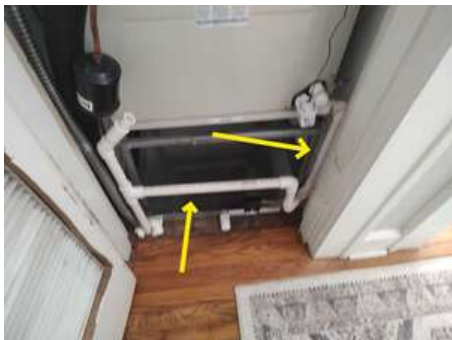
##### 8.4.1 Line Insulation - Condensation Line

Insulation pipe wrap should be installed on the condensate line until it exits the structure to stop the condensation from forming and dripping from the line causing damage to the surrounding areas. A "Qualified Person" can perform the work.

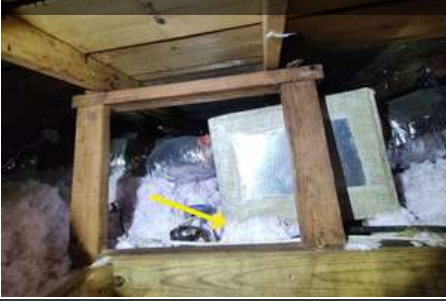
##### 8.5.1 Ductwork - Leak

One or more leaks are evident in the ductwork in allowing conditioned air to escape. It is recommended a qualified HVAC contractor make repairs as needed.

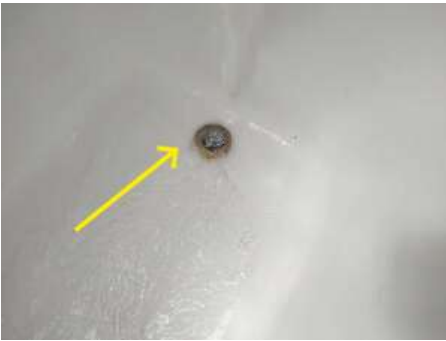
The drain stopper was missing, damaged or not operational. A qualified plumber should make repairs.

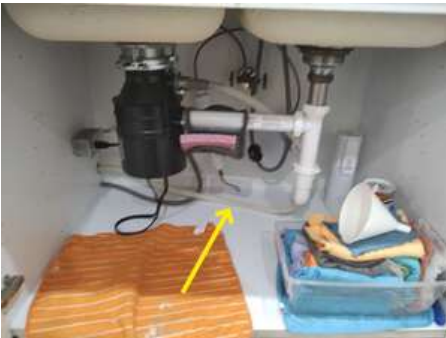
No high loop was evident for the drain hose for the dishwasher. A high loop is required to keep drainage from back flowing into the dishwasher. High loops are generally built into the newer dishwashers however, the manufacturers still recommend an additional high loop under the sink before the drain hose is connected. Recommend routing the hose so a high loop is present. A "Qualified person" can perform the work.

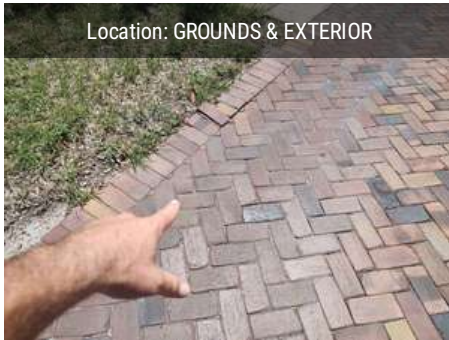
### 2.4.1 Raised or Settled

The driveway surface was raised or settled. Trip hazards may be present or become present in time. A slab leveling contractor can evaluate and repair as desired.

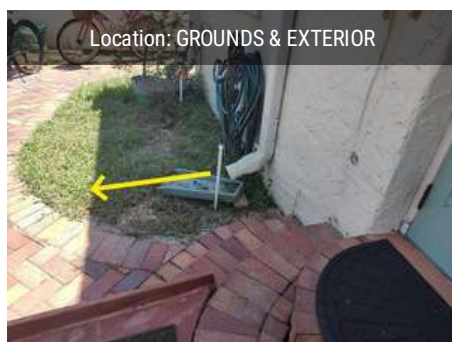
Location: GROUNDS & EXTERIOR

### 2.9.1 Extend Downspouts

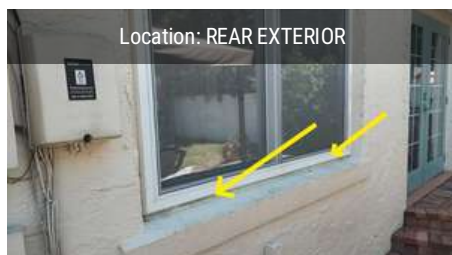
Location: REAR EXTERIOR

### 2.10.1 Caulking or Glazing Deteriorated

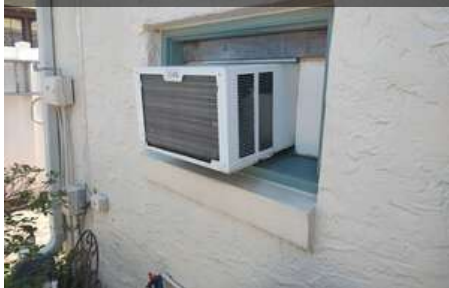
A window is been removed at one or more locations to accommodate a window style air conditioning unit. Although no adverse conditions are noted we recommend checking with the current owners see if the original window is still in storage.

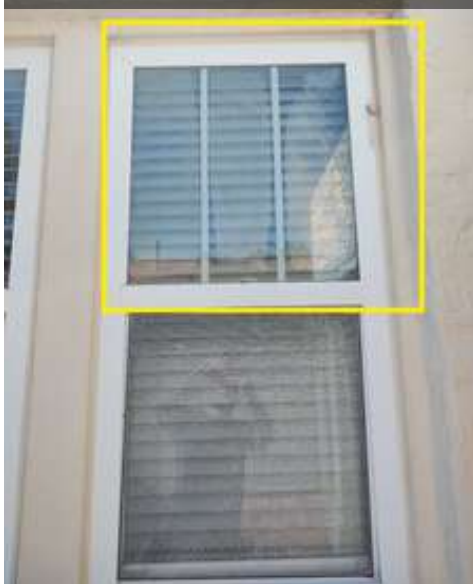
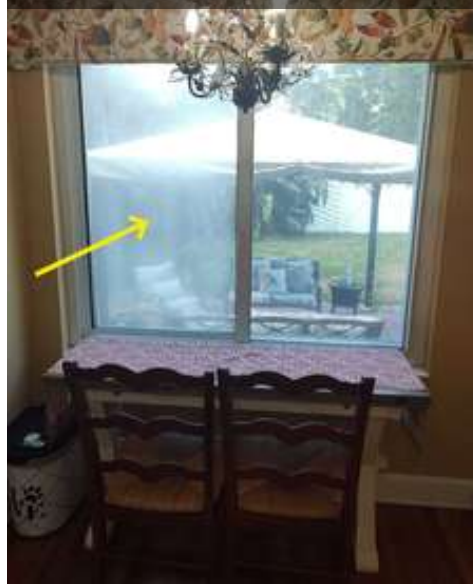
### 2.10.3 Thermal Seal Damaged

Note images are based on a random sampling of windows. The issue may exist in other locations.

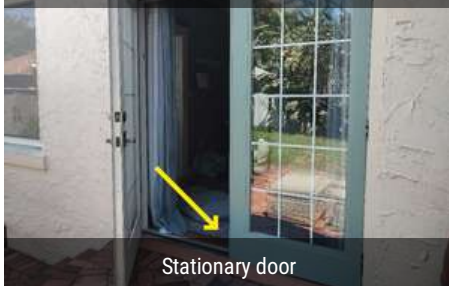
Stationary door

#### 2.11.1 Door - Latching Hardware Problem

The latching hardware on one or more doors did not function properly. Although replacement is sometimes necessary, in most cases this can be repaired with minor adjustments. A qualified person can perform the work.

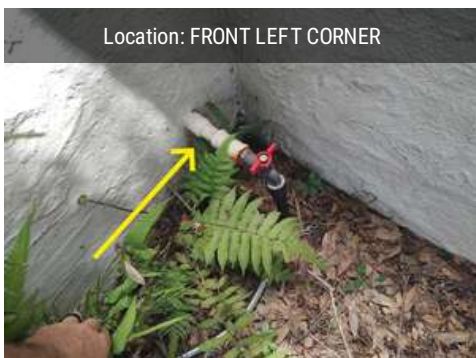
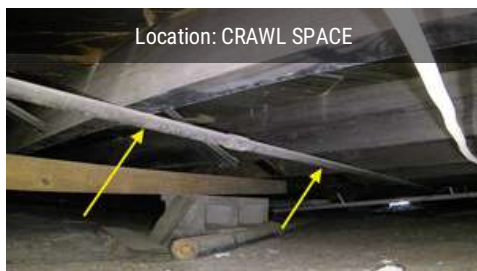
Galvanized piping was observed. Although this type of piping was commonly used in older homes, galvanized piping is no longer used in today's construction. Galvanized piping has a tendency to rust from the inside out resulting in water clarity conditions, leaks, and reduced water flow/pressure. The best-known remedy for this type of piping is replacement. The client is advised to consult with a licensed plumber for additional information.

Note: This observation requires the inspector to specify the existence of this piping on the separate 4 Point Inspection Report that most insurance companies require. Some insurance companies may not insure a house with this type of piping. We advise you to consult with your insurance agent or underwriter regarding insurability.

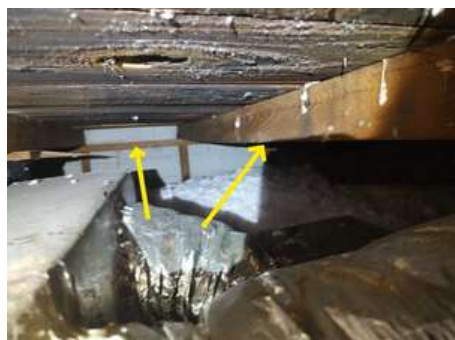
##### 9.3.1 Old Frame 2x4

The roof framing consists of old style 2x4 frame. This is not considered adequate in today's building practices. Deflection and sagging may exist and/or occur overtime. Recommend review by a general contractor if you have concerns about this area.

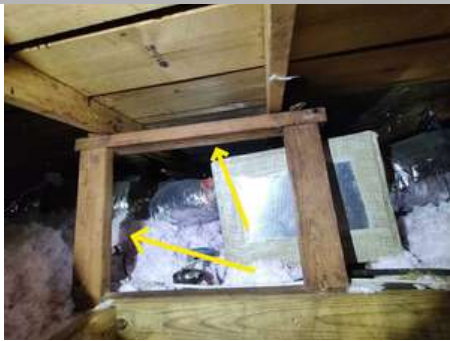
##### 9.3.2 Additional Supports Added, Structural Consideration

One or more additional supports have been added. Additional supports are typically considered structural and should be planned by an engineer. Although this appears satisfactory, we recommend checking with the current owner for documentation regarding this repair.

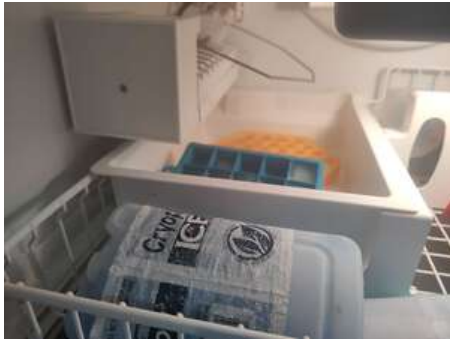
#### 12.7.1 No Ice Fridge

No ice was present in the ice machine at the time of inspection, therefore the ice maker could not be tested. We recommend ensuring the ice maker is turned on and the water supply for the refrigerator is available and properly installed.

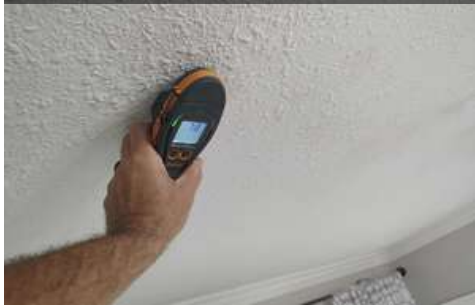
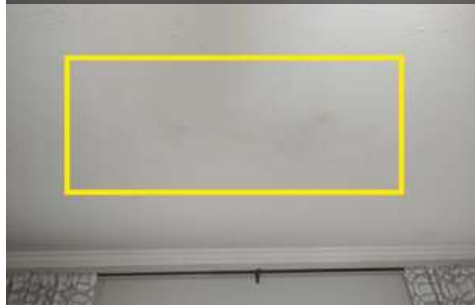
Location: FRONT BEDROOM

#### 13.2.1 Moisture Stains - Not Active

Moisture stains and/or damage was observed at one or more locations. A moisture meter indicated the area(s) are currently within normal moisture levels and considered dry. However, if the leak source has not been identified and properly repaired, the leak may return. Contact the current owner to verify this condition has been addressed -or- contact a licensed contractor for repairs.

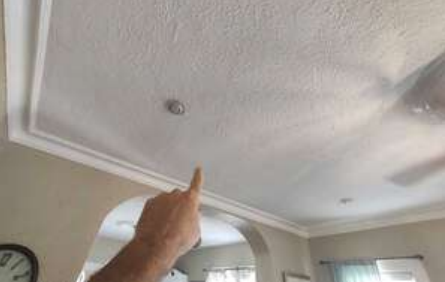
Location: LIVING ROOM

The ceilings were damaged at one or more locations. Recommend further evaluation and repair as needed by a qualified / licensed contractor.

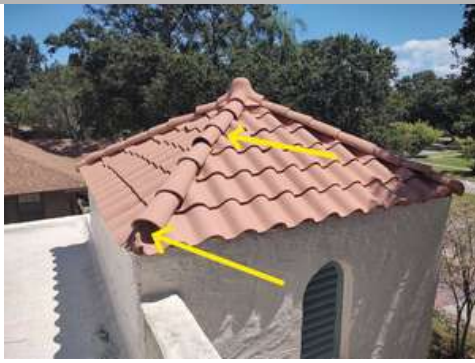
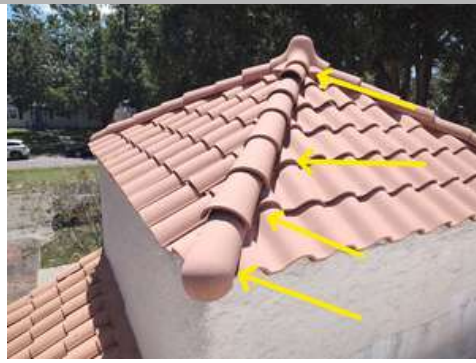
#### 3.1.2 Tile Roof - Tiles Damaged

Damaged and/or missing tiles were observed at one or more locations. The inspector can not offer an opinion as to whether the roof leaks today unless it is moderately raining at the time of inspection.

Note: The conditions noted are an indication that repairs are warranted and are not intended to define all areas that may require repairs. It is recommended a professional roofing contractor evaluate the entire system and repair all areas as needed.

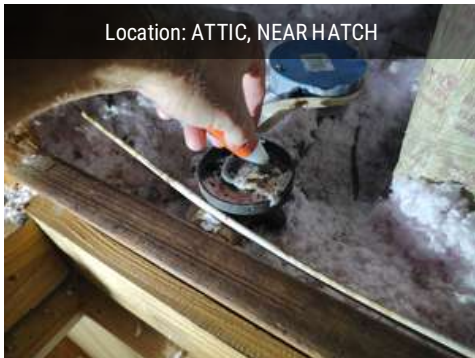
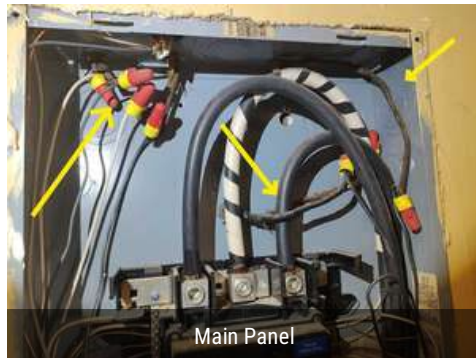
Location: ATTIC, NEAR HATCH

Cloth jacketed cable was observed at one or more locations in the home. This type of wiring was commonly used in structures built in the 1950's and 1960's and may or may not contain a ground wire for safety. Although it is still functional, given the age of this wiring system repairs may be warranted and replacement should be considered. It is beyond the scope of the inspection to determine the overall condition of this wiring and/or identify every location it may exist in the structure. A "Licensed Electrician" can evaluate the system and repair or replace as needed.

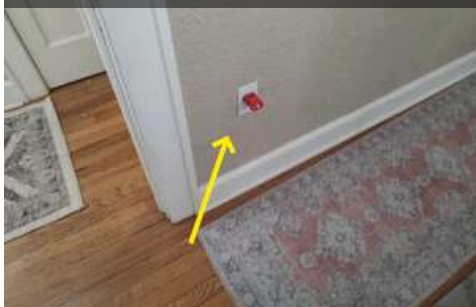
Location: DINING ROOM

Reverse polarity was noted at one or more outlet(s). Reverse polarity, (hot and ground / neutral reversed) are usually corrected by minor wiring adjustments at the specified item. However, when a number of these conditions are observed, client should consult a licensed electrician.

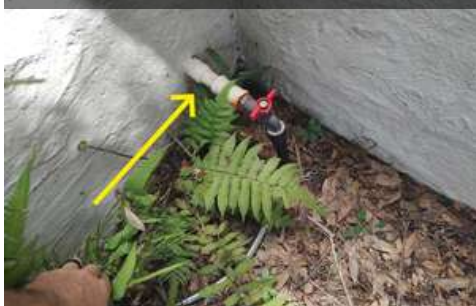
Location: FRONT LEFT CORNER

Galvanized piping was observed. Although this type of piping was commonly used in older homes, galvanized piping is no longer used in today's construction. Galvanized piping has a tendency to rust from the inside out resulting in water clarity conditions, leaks, and reduced water flow/pressure. The best-known remedy for this type of piping is replacement. The client is advised to consult with a licensed plumber for additional information.

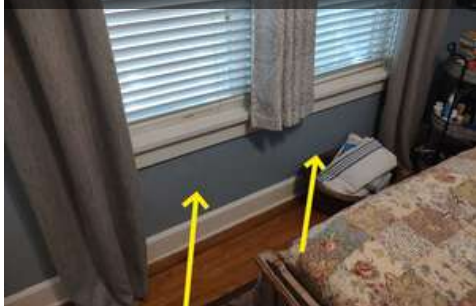
Location: REAR BEDROOM

Moisture stains were observed at one or more locations. When checked with a moisture meter the area indicated a wet / active leak condition. Recommend further evaluation and repair as needed by a licensed contractor. Please refer to limitations of inspection regarding mold / moisture related conditions.

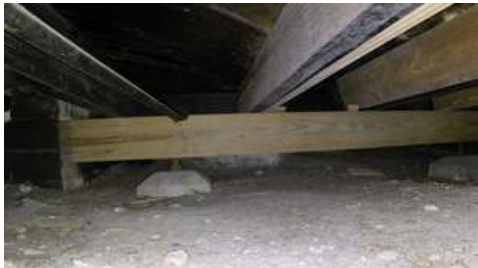
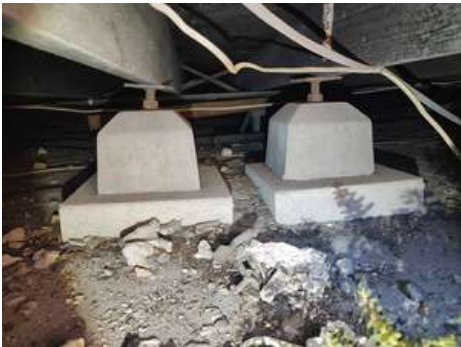
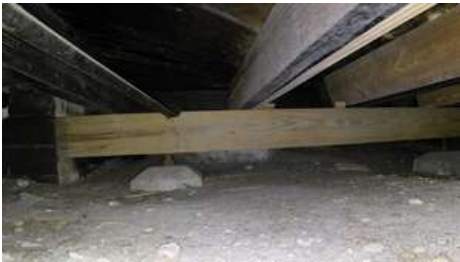
#### 1.1.4 Foundation Repairs, Appear Professional

Foundation repairs with added structural support jacks or evident in one or more locations. These appear to be professionally done and we advise obtaining all documentation and warranty information from the current owner prior to close.

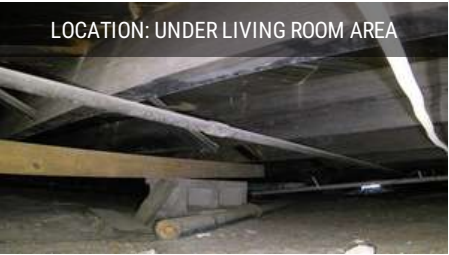
Unprofessional / temporary support was observed. Although no immediate concern was observed, client should contact a qualified foundation contractor for further information and / or evaluation.

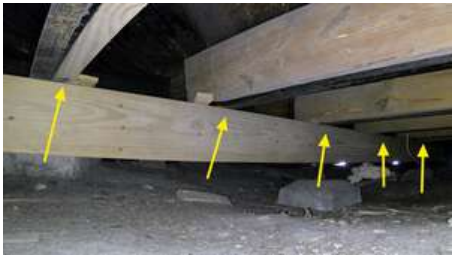
Joists were sistered at one or more locations. This generally indicates the original beams have been damaged and/or where not adequately supporting the load. We recommend further evaluation by a licensed foundation contractor.

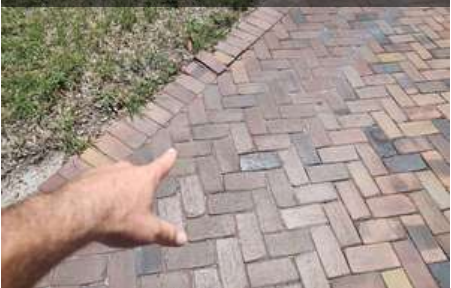
LOCATION: GROUNDS & EXTERIOR

The driveway surface was raised or settled. Trip hazards may be present or become present in time. A slab leveling contractor can evaluate and repair as desired.

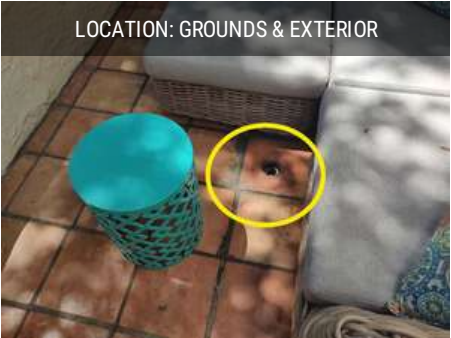
We recommend adding a drain grate to the floor drain on the front patio for safety from trip hazards and to deter debris from entering.

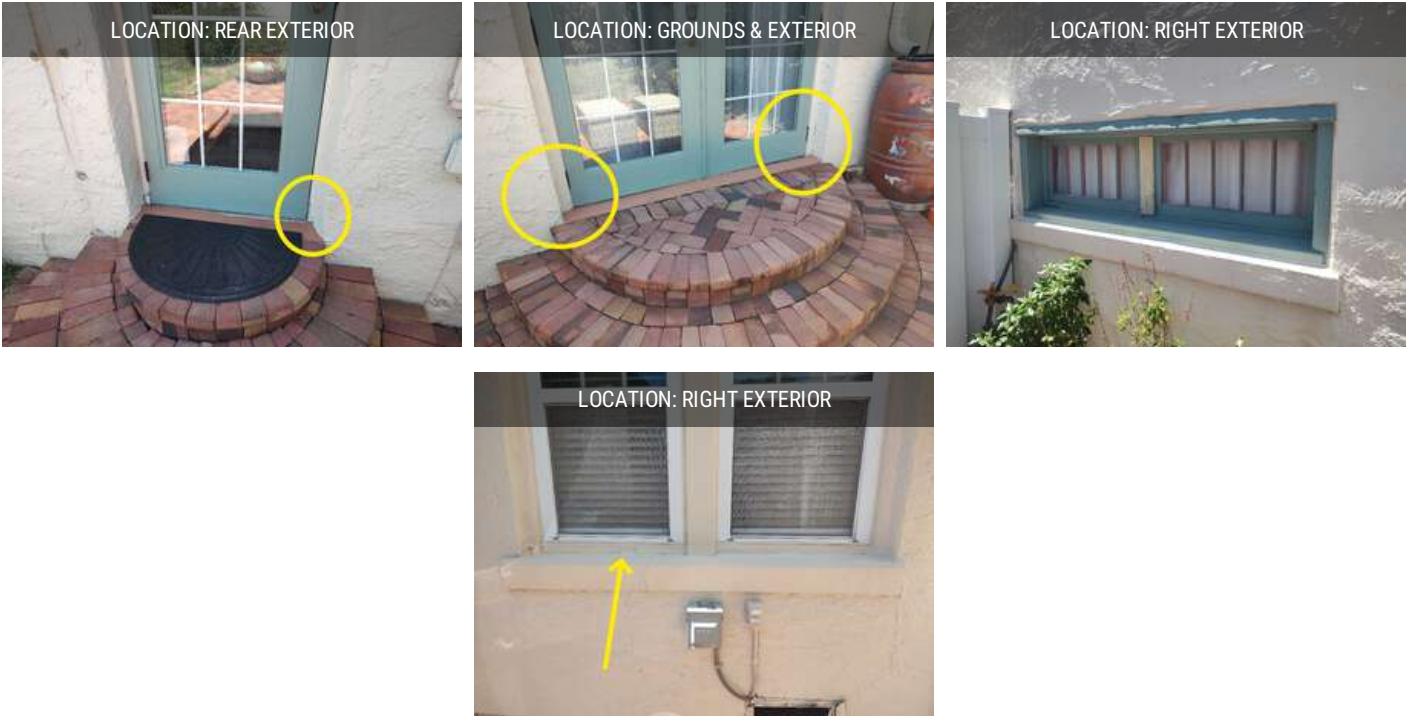
Note: The defects noted in images are based on a random sampling and may not indicate all affected areas - Contractor should review for additional damage and probe where suspect to insure that all damage is identified and replaced.

Repair the area of wood decayat the one or more locations. Replacement of affected materials is considered the best solution.

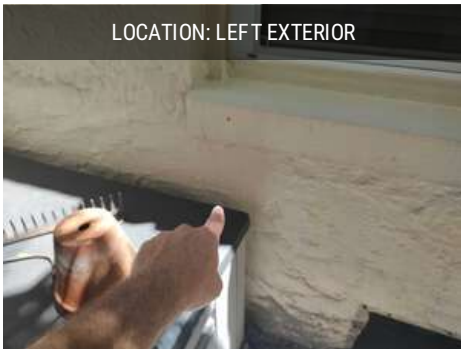
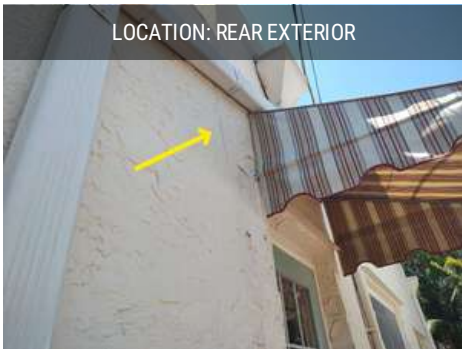
Typical cracks were found in the exterior walls. Minor settlement cracks are very common and occur as the dwelling settles and building materials cure over time. These cracks are not considered serious in nature until they reach a width of 1/8 inches or more. However, they can allow moisture to enter the building components. We recommend sealing and painting to reduce the possibility of water penetration.

Note, this comment may not include all areas requiring attention. The contractor should walk the perimeter of the home and address all areas that require attention.

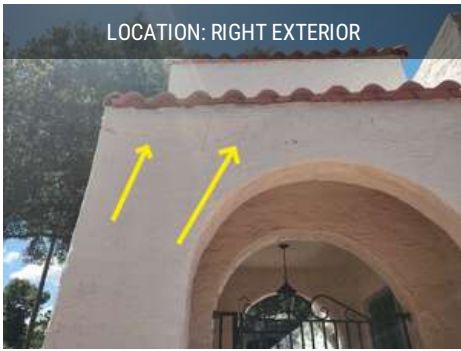
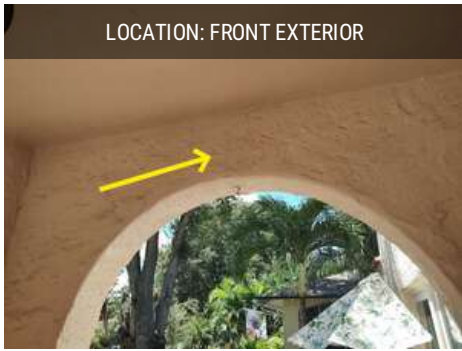
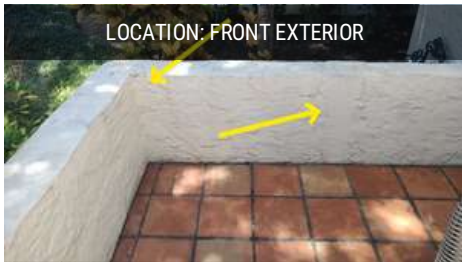
2.8.2 Past Repairs - Exterior Walls

Past repairs were noted at one or more locations on exterior walls. Recommend checking with the current owner for information / documentation.

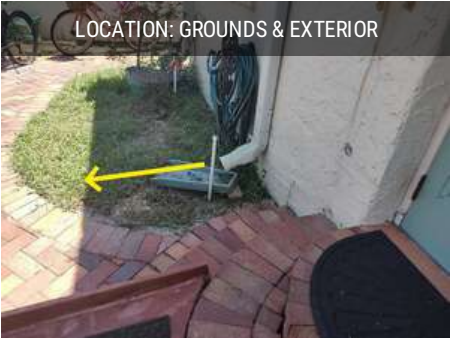
LOCATION: GROUNDS & EXTERIOR

Recommend gutter downspouts be kept in good condition and extended / routed away from the building for proper drainage. Ponding, flooding and water seepage into crawl spaces, basements and under foundations can be caused by inadequate removal of rainwater from the perimeter of the house.

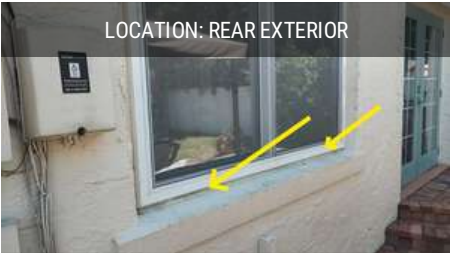
LOCATION: REAR EXTERIOR

The window caulking, putty and/or glazing compound was cracking or deteriorated. We recommend caulking to deter moisture and pest intrusion. A qualified person can perform the work.

Note, this condition is based on a random sampling and likely exists in other locations. The contractor obtained to do this job should check all windows and doors and reseal as needed.

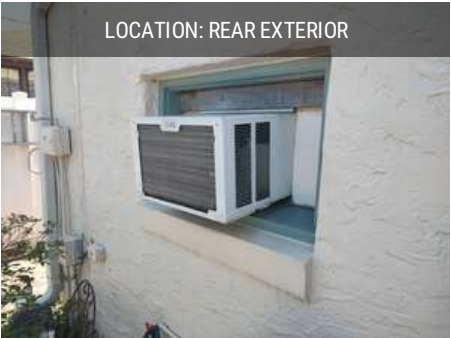
LOCATION: REAR EXTERIOR

A window is been removed at one or more locations to accommodate a window style air conditioning unit. Although no adverse conditions are noted we recommend checking with the current owners see if the original window is still in storage.

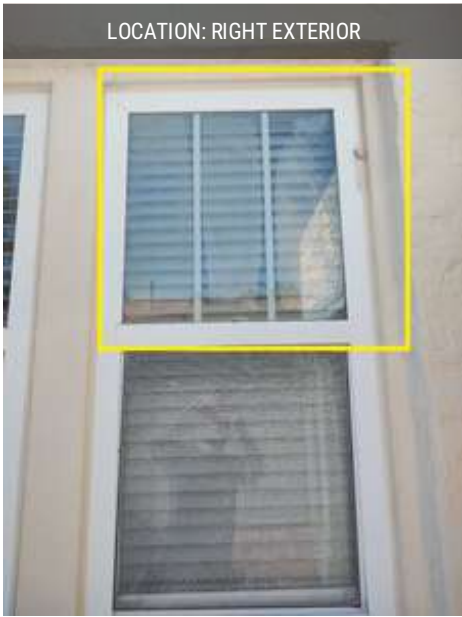
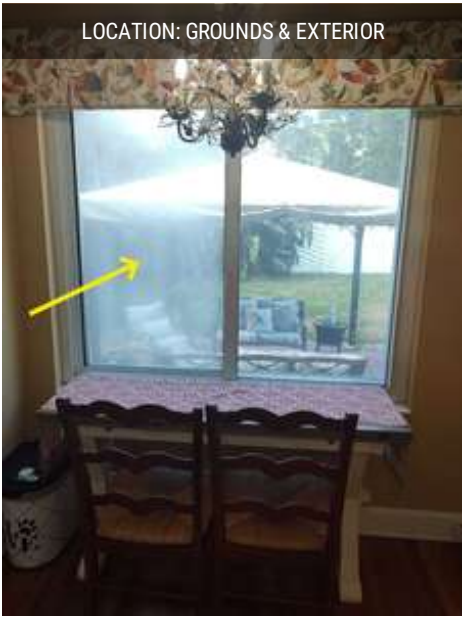
2.10.3 Thermal Seal Damaged

The thermal pane window(s) appear to have lost their thermal seal at one or more locations. Moisture, fogging, and hazing are common signs of this condition. While mostly cosmetic, this condition is generally not repairable. Correction would require replacement of the window(s) or window pane(s).

Note images are based on a random sampling of windows. The issue may exist in other locations.

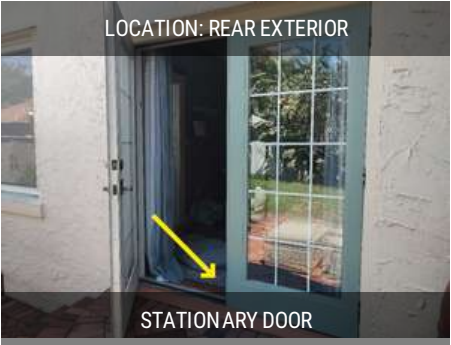
The latching hardware on one or more doors did not function properly. Although replacement is sometimes necessary, in most cases this can be repaired with minor adjustments. A qualified person can perform the work.

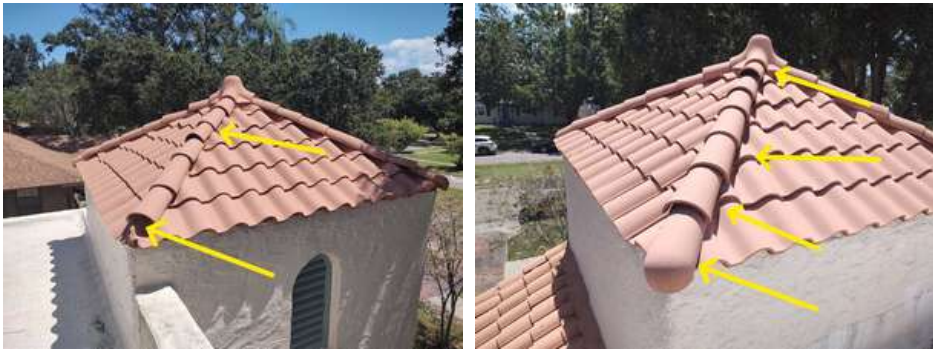
3.1.2 Tile Roof - Tiles Damaged

Damaged and/or missing tiles were observed at one or more locations. The inspector can not offer an opinion as to whether the roof leaks today unless it is moderately raining at the time of inspection.

Note: The conditions noted are an indication that repairs are warranted and are not intended to define all areas that may require repairs. It is recommended a professional roofing contractor evaluate the entire system and repair all areas as needed.

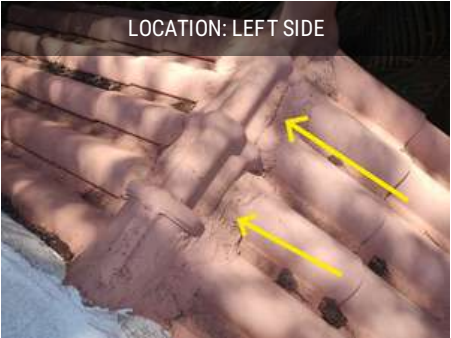
3.1.3 Tile roof - Common cracks

Minor cracking noted at mortar joints. Minor cracking at mortar joints on tile roofing is fairly common. We suggest annual review with maintenance and repair performed as needed. This usually consists of repair or replacement of any damaged mortar or missing shingles. This maintenance should help to ensure the water tightness of the building and should be performed on a regular basis.

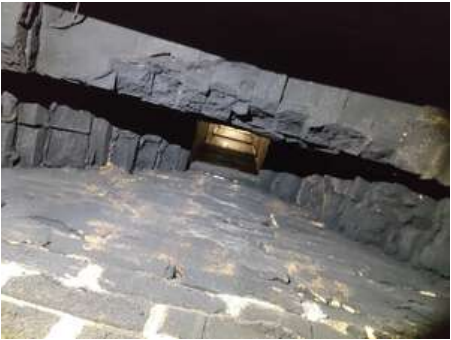
4.3.3 Damper Missing

The unit is not equipped with a flue damper. A qualified chimney sweep can evaluate and repair.

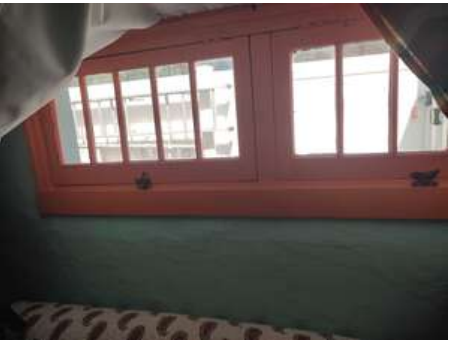
5.4 Window Conditions

The windows are an old wood frame style window and although they are operational they reflected moderate to heavy wear and tear. Replacement may be required in the future.

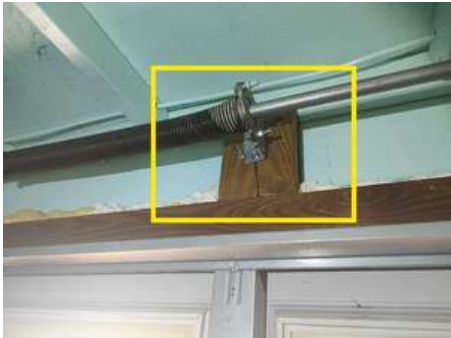
5.6.1 Spring Tensioner Mounting Board - Loose/Damaged At Wall

The spring tensioner mounting board is loose and/or damaged at the wall. This is a safety issue that may cause injury. Recommend farther evaluation and repair by licensed garage door specialist.

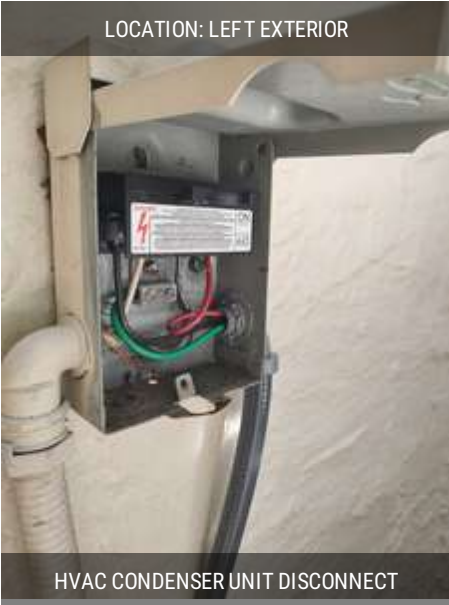
6.5.1 Panel/J-box - HVAC Quk Disc Cover Missing

The deadfront cover plate at the HVAC quick disconnect box is missing. Lack of proper covers on junction boxes is a shockhazard. It is suggested that a "Licensed Electrical Contractor" be contacted for further evaluation and repair.

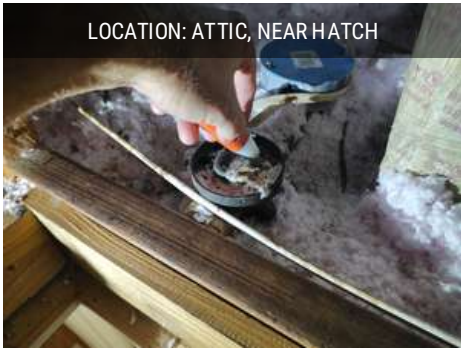
Cloth jacketed cable was observed at one or more locations in the home. This type of wiring was commonly used in structures built in the 1950's and 1960's and may or may not contain a ground wire for safety. Although it is still functional, given the age of this wiring system repairs may be warranted and replacement should be considered. It is beyond the scope of the inspection to determine the overall condition of this wiring and/or identify every location it may exist in the structure. A "Licensed Electrician" can evaluate the system and repair or replace as needed.

Important Note: This observation requires the inspector to specify the existence of cloth wiring on the separate 4 Point Inspection Report that most insurance companies require - some insurance companies will not insure a house with this type of wiring. We advise you consult with your insurance agent or underwriter regarding insurability.

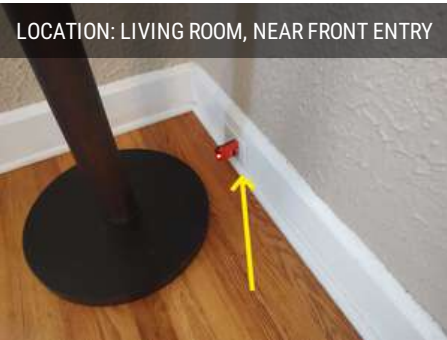
An open ground wire condition was observed at outlet(s) located at one or more locations. It is possible this condition could be resolved with minor wiring adjustments or it may be due to an older wiring system within the home. When a number of these conditions are observed, client should consult a licensed electrician.

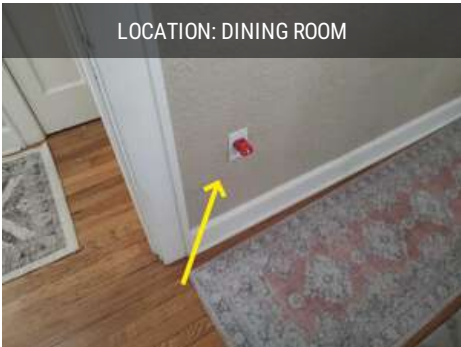
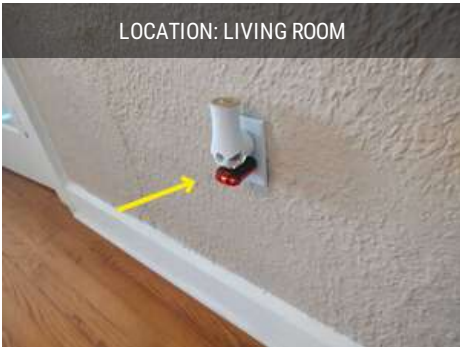
6.6.2 Reverse Polarity

Reverse polarity was noted at one or more outlet(s). Reverse polarity, (hot and ground / neutral reversed) are usually corrected by minor wiring adjustments at the specified item. However, when a number of these conditions are observed, client should consult a licensed electrician.

Note, findings are based on a random sampling. The hired licensed contractor should verify that corrections are not required in other locations.

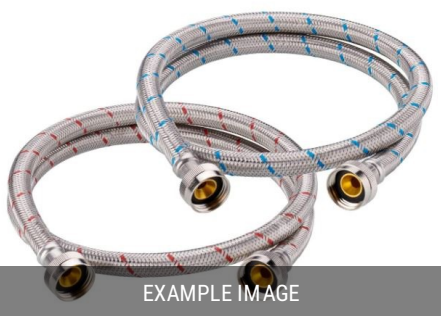
If not currently installed, as a preventive measure we recommend installing anti-burst water supply hoses at interior plumbing connections, such as clothes washers, toilets, sinks, and refrigerators. These hoses reduce the risk of excessive water damage due to burst connections.

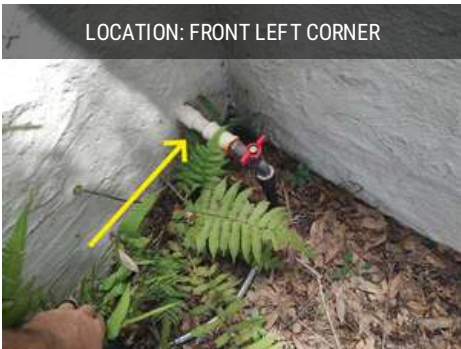
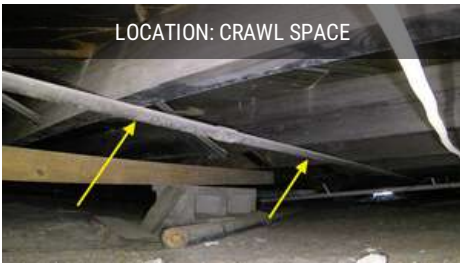
#### 7.3.2 Galvanized piping

Galvanized piping was observed. Although this type of piping was commonly used in older homes, galvanized piping is no longer used in today's construction. Galvanized piping has a tendency to rust from the inside out resulting in water clarity conditions, leaks, and reduced water flow/pressure. The best-known remedy for this type of piping is replacement. The client is advised to consult with a licensed plumber for additional information.

Note: This observation requires the inspector to specify the existence of this piping on the separate 4 Point Inspection Report that most insurance companies require. Some insurance companies may not insure a house with this type of piping. We advise you to consult with your insurance agent or underwriter regarding insurability.

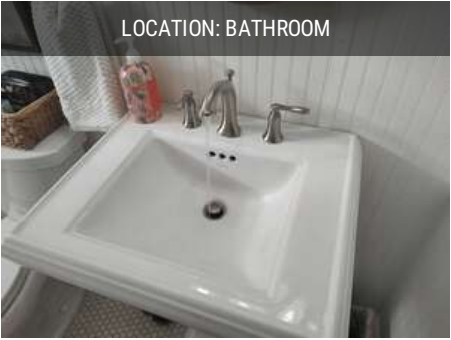
There was visible evidence of low water pressure at one or more locations when multiple fixtures were operating. A licensed plumber can evaluate and repair as needed.

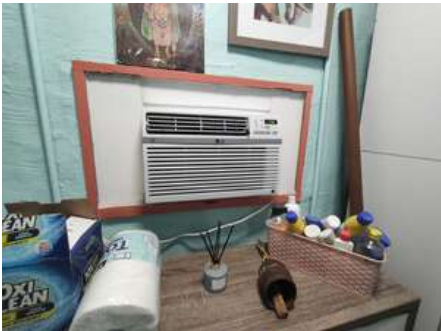
## Window units - Not inspected

Inspection of window or wall air conditioning units are beyond the scope of the inspection and are not tested. Only central air conditioning units are inspected as part of our services.

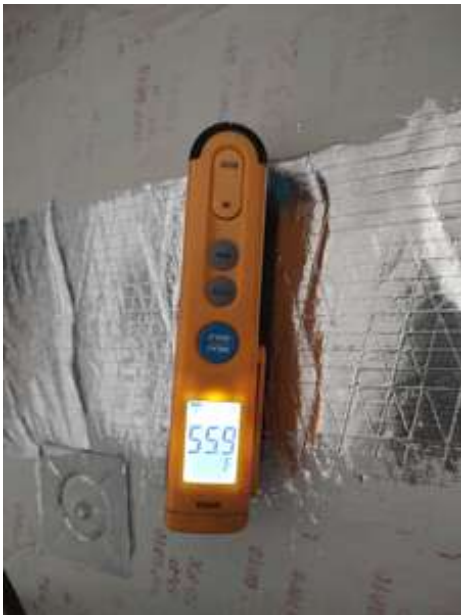
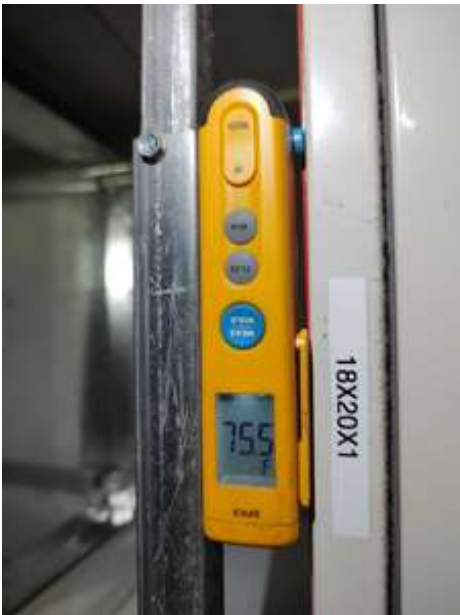
8.2.1 \*Proper Cooling Differential

An ambient air test was performed on the cooling system to determine if the difference in temperatures of the supply and return air are between 15 degrees and 22 degrees, which indicates that the unit is cooling within industry standards. The readings indicatethat the unit is cooling within industry standards.

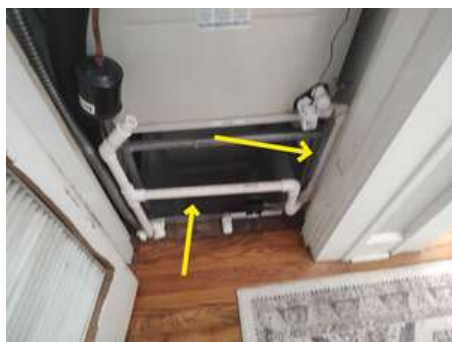
Insulation pipe wrap should be installed on the condensation line until it exits the structure to stop the condensation from forming and dripping from the line causing damage to the surrounding areas. A "Qualified Person" can perform the work.

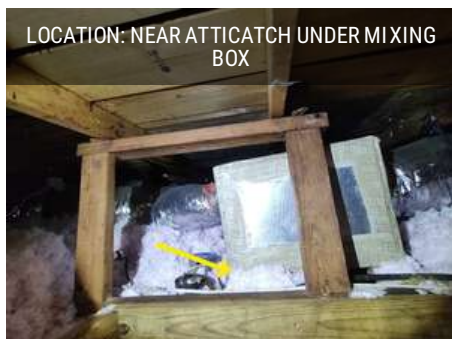
### 8.5.1 Ductwork - Leak

One or more leaks are evident in the ductwork in allowing conditioned air to escape. It is recommended a qualified HVAC contractor make repairs as needed.

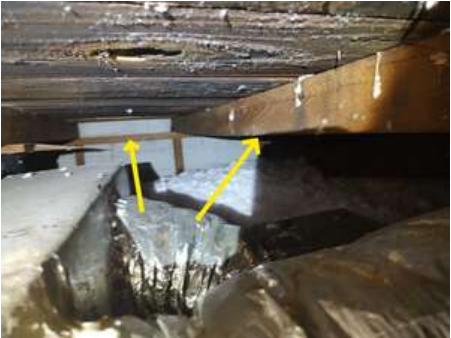
The roof framing consists of old style 2x4 frame. This is not considered adequate in today's building practices. Deflection and sagging may exist and/or occur overtime. Recommend review by a general contractor if you have concerns about this area.

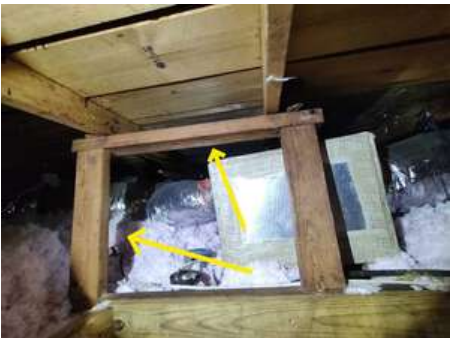
9.3.2 Additional Supports Added, Structural Consideration

One or more additional supports have been added. Additional supports are typically considered structural and should be planned by an engineer. Although this appears satisfactory, we recommend checking with the current owner for documentation regarding this repair.

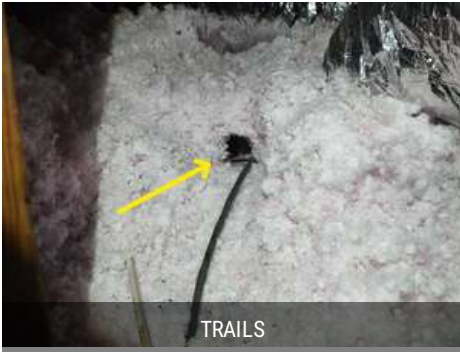
There is evidence of rodent activity in the attic (trails, droppings, carcasses, etc.). Rodent activity is very common but is fixable. These pests can damage wiring, ductwork, etc. All possible openings (cracks, holes, gaps, etc.) should be properly sealed to eliminate rodent entry. A qualified exterminator is recommended.

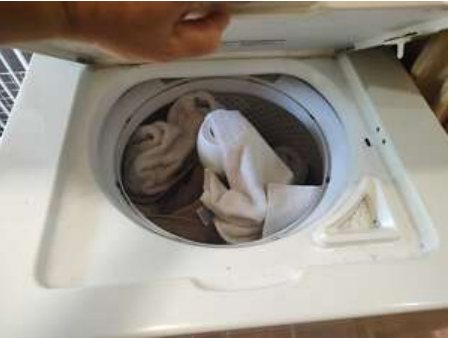
Personal belongings inhibited the ability to inspect the unit during the inspection. We recommend having the "Current Owner" demonstrate the operation of this unit prior to closing.

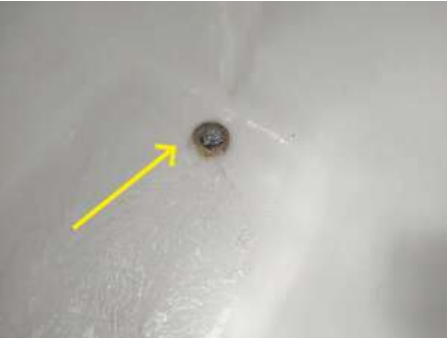
The drain stopper was missing, damaged or not operational. A qualified plumber should make repairs.

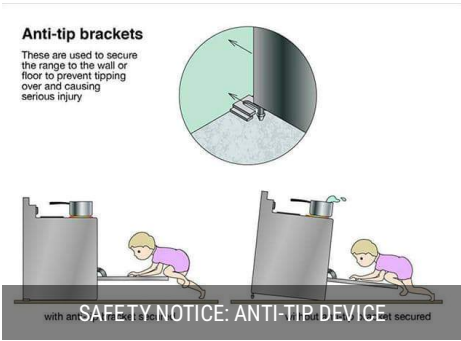
Our inspection does not include moving appliances. However, we strongly recommend verifying that the anti-tip safety device, provided by the range manufacturer and required in installation specifications, is correctly in place. Typically, this device is mounted to the floor or wall behind the unit and placed to catch a leveling bolt to prevent the unit from tipping forward. This safety measure is crucial to prevent injury or fatalities, especially involving children.

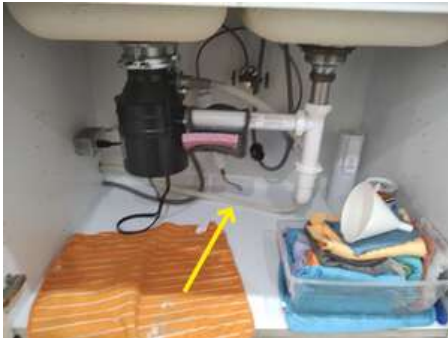
No high loop was evident for the drain hose for the dishwasher. A high loop is required to keep drainage from back flowing into the dishwasher. High loops are generally built into the newer dishwashers however, the manufacturers still recommend an additional high loop under the sink before the drain hose is connected. Recommend routing the hose so a high loop is present. A "Qualified person" can perform the work.

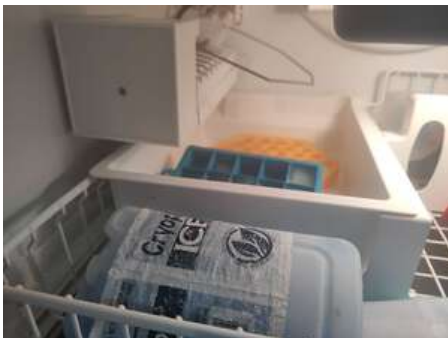
No ice was present in the ice machine at the time of inspection, therefore the ice maker could not be tested. We recommend ensuring the ice maker is turned on and the water supply for the refrigerator is available and properly installed.

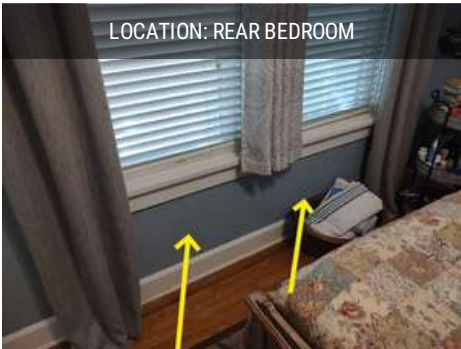
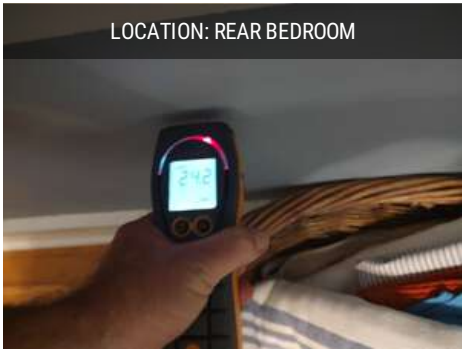
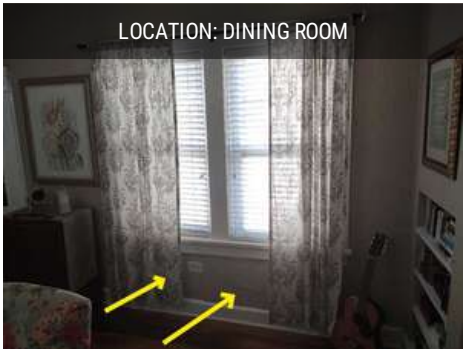
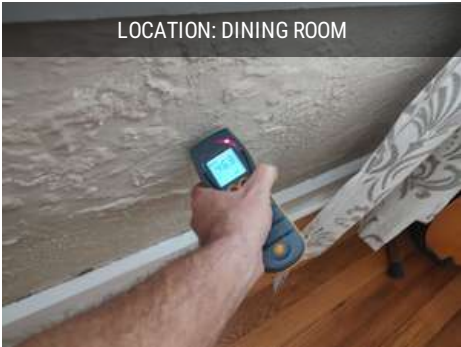
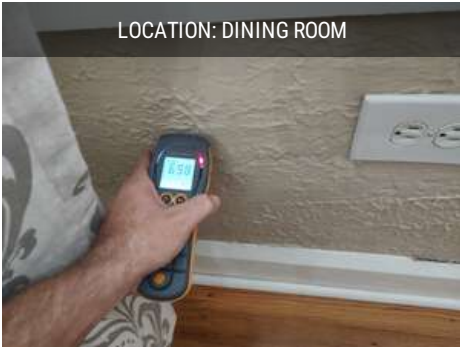
13.1.1 Moisture Stains - Active

Moisture stains were observed at one or more locations. When checked with a moisture meter the area indicated a wet / active leak condition. Recommend further evaluation and repair as needed by a licensed contractor. Please refer to limitations of inspection regarding mold / moisture related conditions.

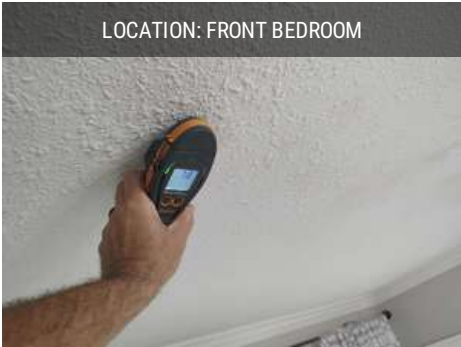
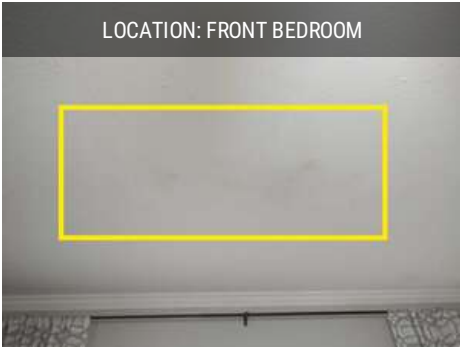
13.2.1 Moisture Stains - Not Active

Moisture stains and/or damage was observed at one or more locations. A moisture meter indicated the area(s) are currently within normal moisture levels and considered dry. However, if the leak source has not been identified and properly repaired, the leak may return. Contact the current owner to verify this condition has been addressed -or- contact a licensed contractor for repairs.

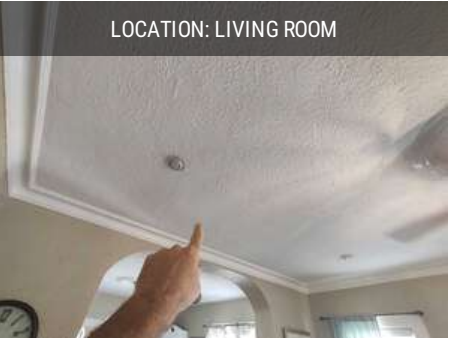
13.2.2 Damage - Ceilings

The ceilings were damaged at one or more locations. Recommend further evaluation and repair as needed by a qualified / licensed contractor.
