**Robbins Services**  
Home Inspections

**3021 Barrow St, North Pole, Alaska 99705**  
**Sample Report - Older Home**  
**Prepared for**  
**Bruce Wayne**  
**Jan 05, 2023 at 06:00 AM**

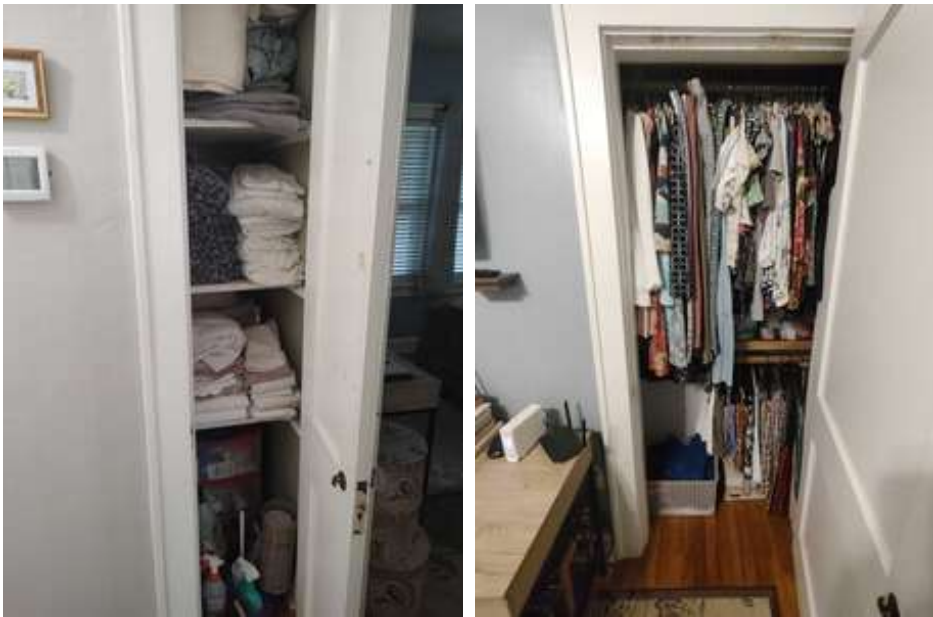
13.6 Closet Conditions

Personal belongings within and/or in front of closets prevented full access for inspection. We suggest further inspection of these areas during your final walk through.
